TEXAS COMMISSION ON ENVIRONMENTAL QUALITY

Re: Compliance with Notice of Violation (NOV) dated August 29, 2011:

City of San Marcos Water System

Regulated Entity No. RN101416337, TCEQ Public Water Supply ID 1050001

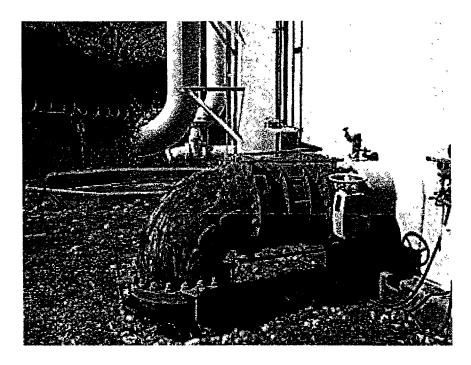
Alleged Violation: The City failed to paint and maintain a potable water storage tank in strict accordance with standards of the American Water Works Association. Specifically, the outer surface of the effluent line for the 1.5 MG storage tank at the Spring Lake Plant was corroded.

City of San Marcos Spring Lake 1.5 MG Storage Tank. Discharge piping painting completed on October 6, 2011.

The City failed to paint and maintain a potable water storage tank in strict accordance with standards of the American Water Works Association. Specifically, the outer surface of the effluent line for the 1.5 MG storage tank at the Spring Lake Plant was corroded.

Corrective Action: The effluent line was prepped and painted on October 6, 2011. Before and after photos are attached.

Recommended Corrective Action: The City shall recoat the outer surface of the effluent line and submit documentation, such as a photograph, to the Austin Region Office which demonstrates that the work has been completed.
