PHOTOGRAPHIC DOCUMENTATION

Facility Name: Frontier Park	Facility County: Sabine	Investigator: REDACTED Gerald Hebert
Investigation Number:		Investigation Date: 7/29/2013

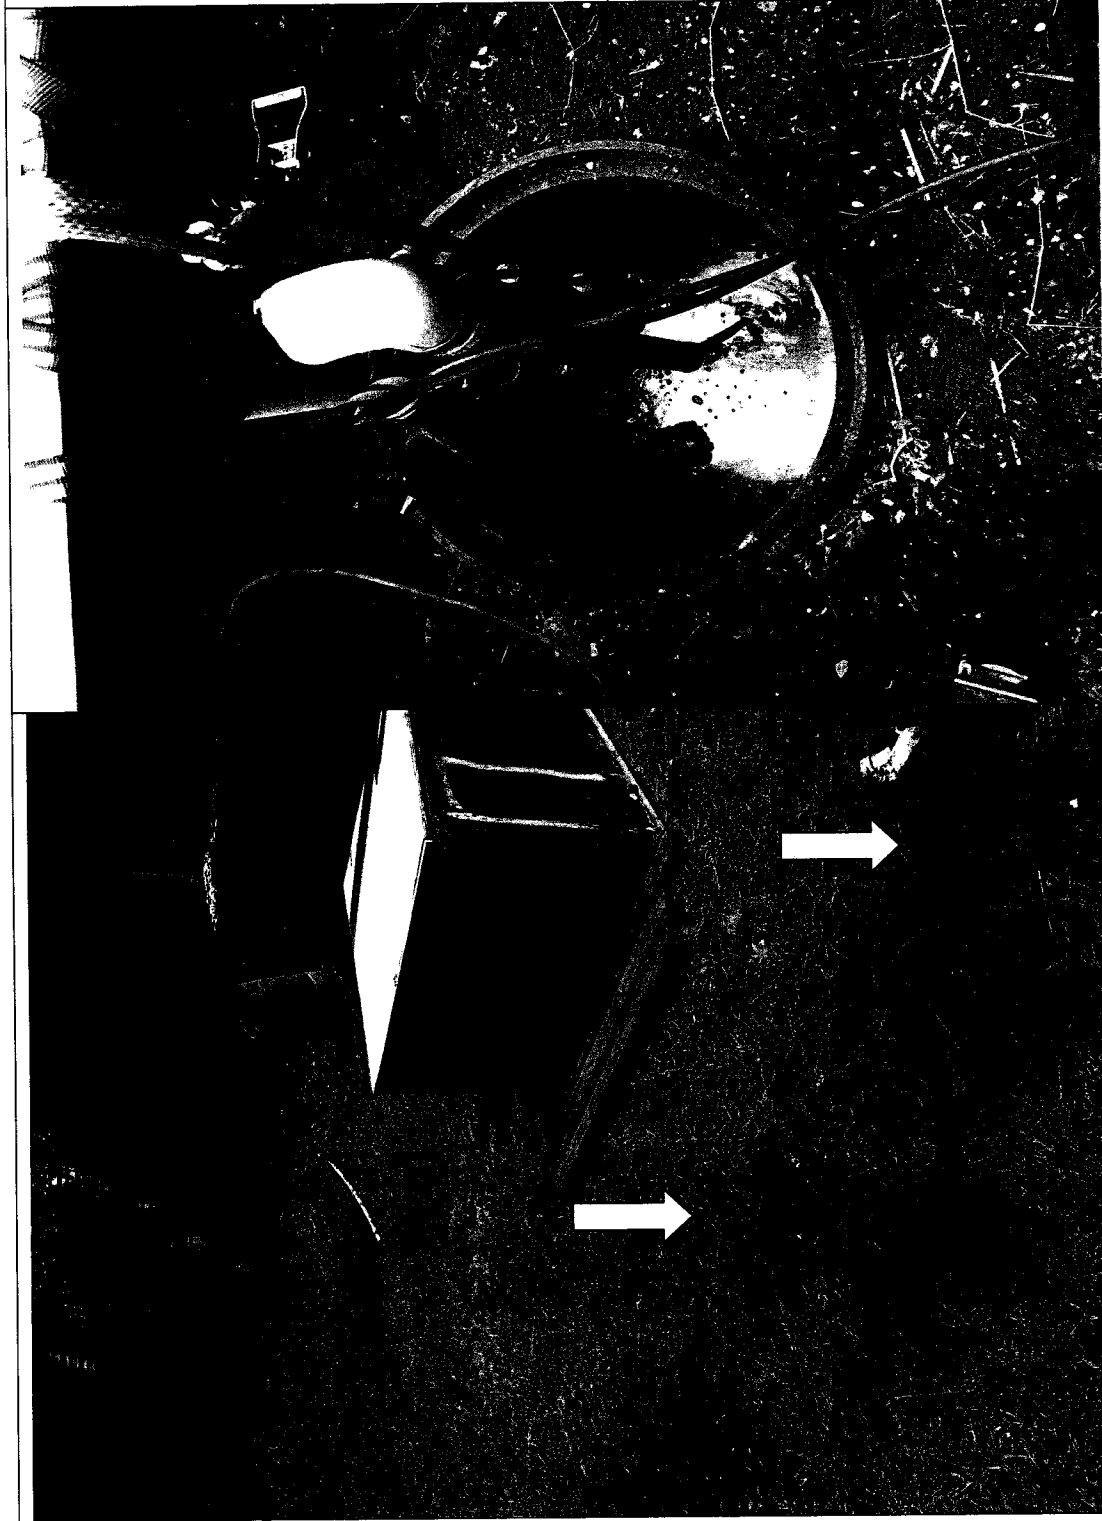
Collection system lift station. Note only one functional pump. The pump was running but was not pumping down the lift station. The Station had about 2 feet of capacity before overflowing.

Collection system lift station inside of wooden box. Note wet area around lift station evident of recent overflow.

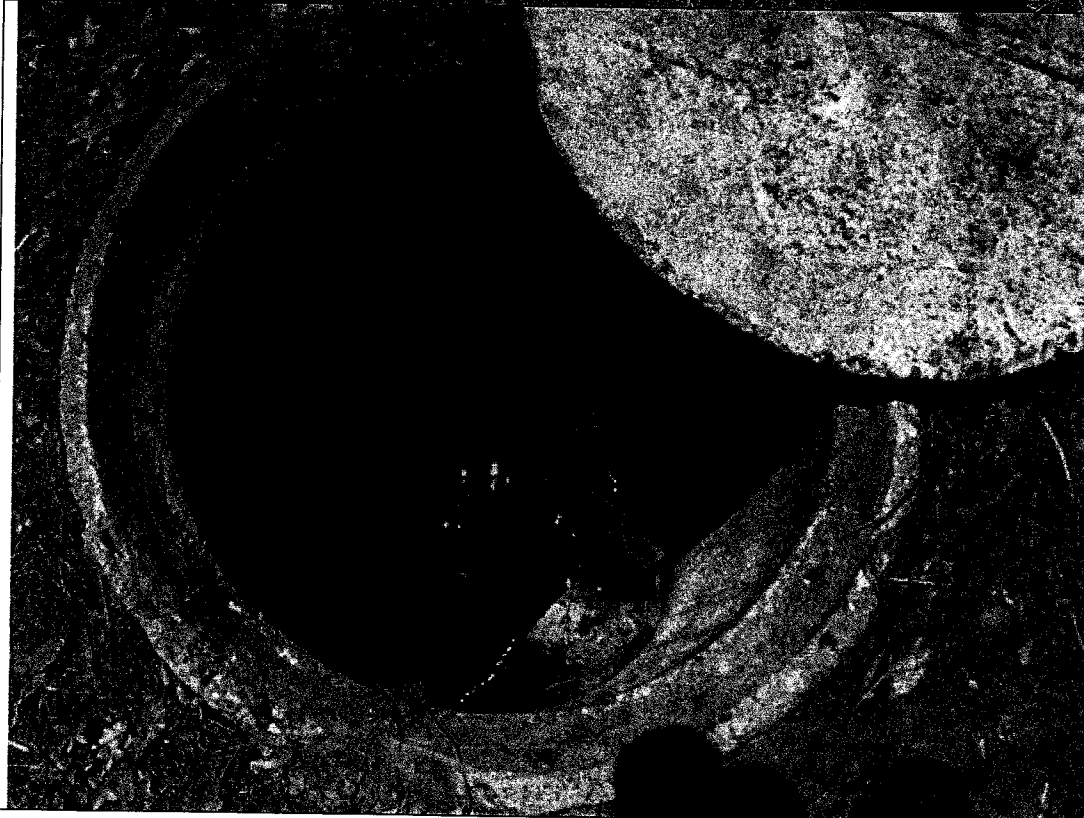
Open manhole just upstream of treatment plant. Note flow in manhole.

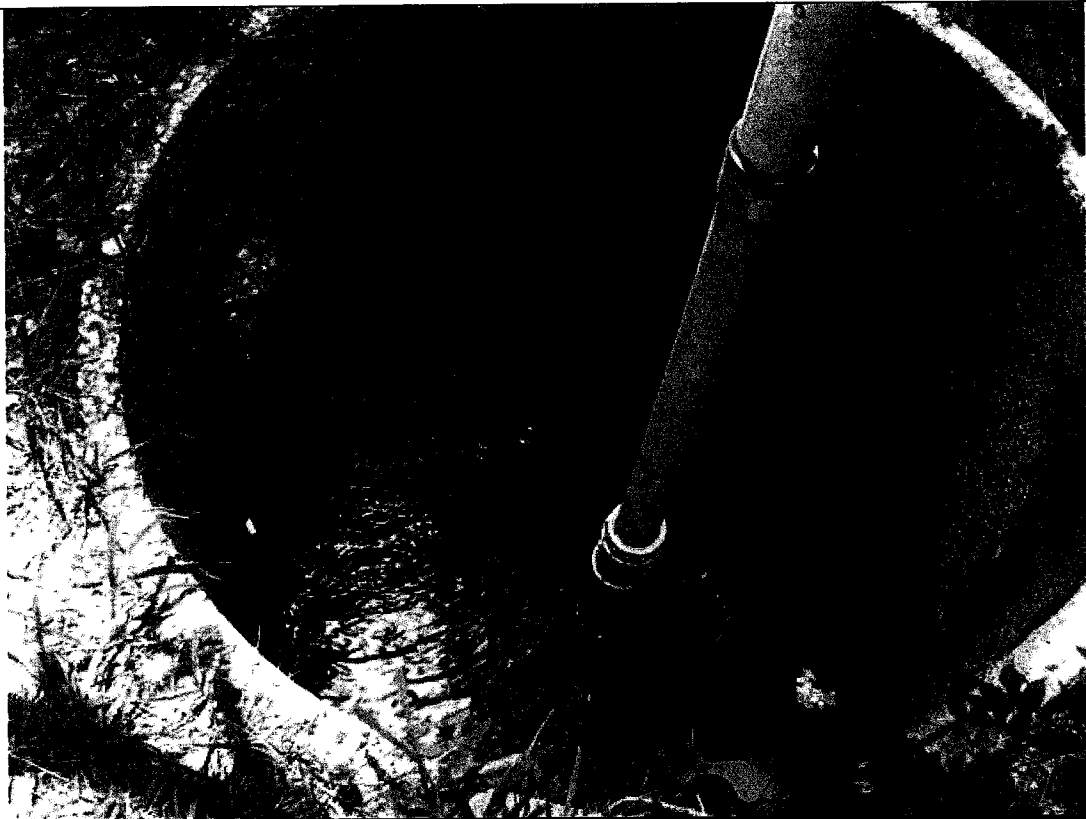
On-site lift station just upstream of treatment plant. Note only one functional pump present. Note flow into lift station.

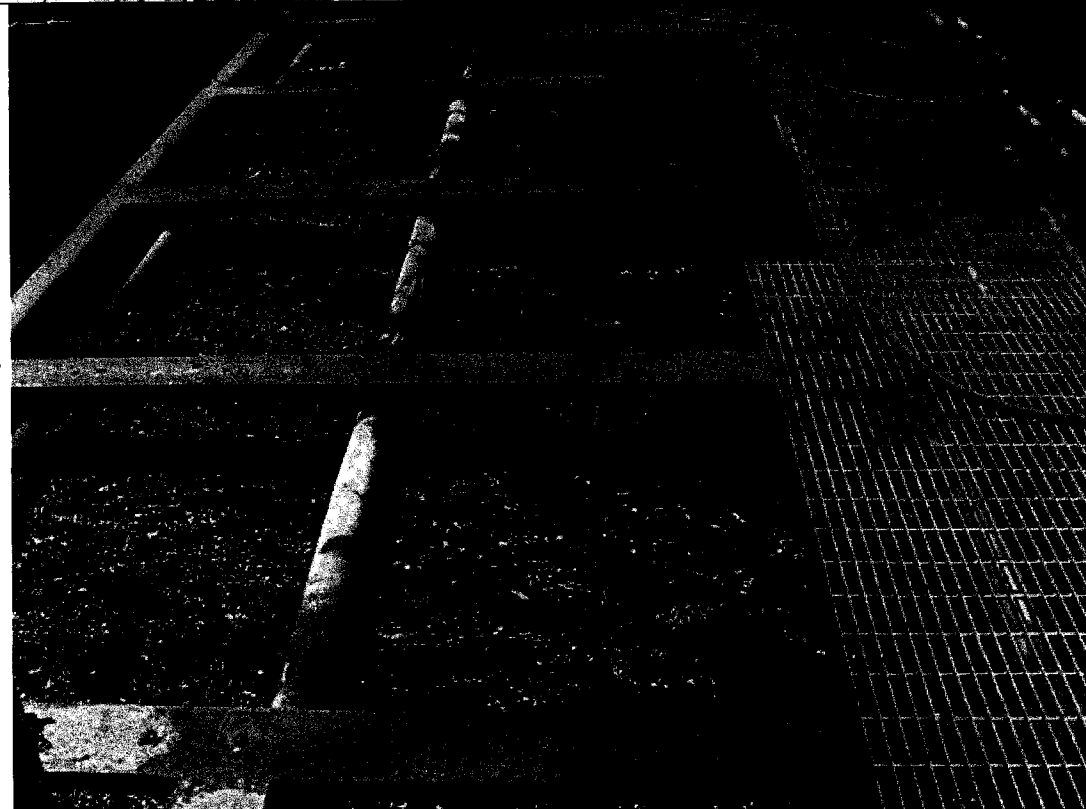
Aeration basin in treatment plant. Note that the air was on. The mixed liquor is dark brown and appears thick.

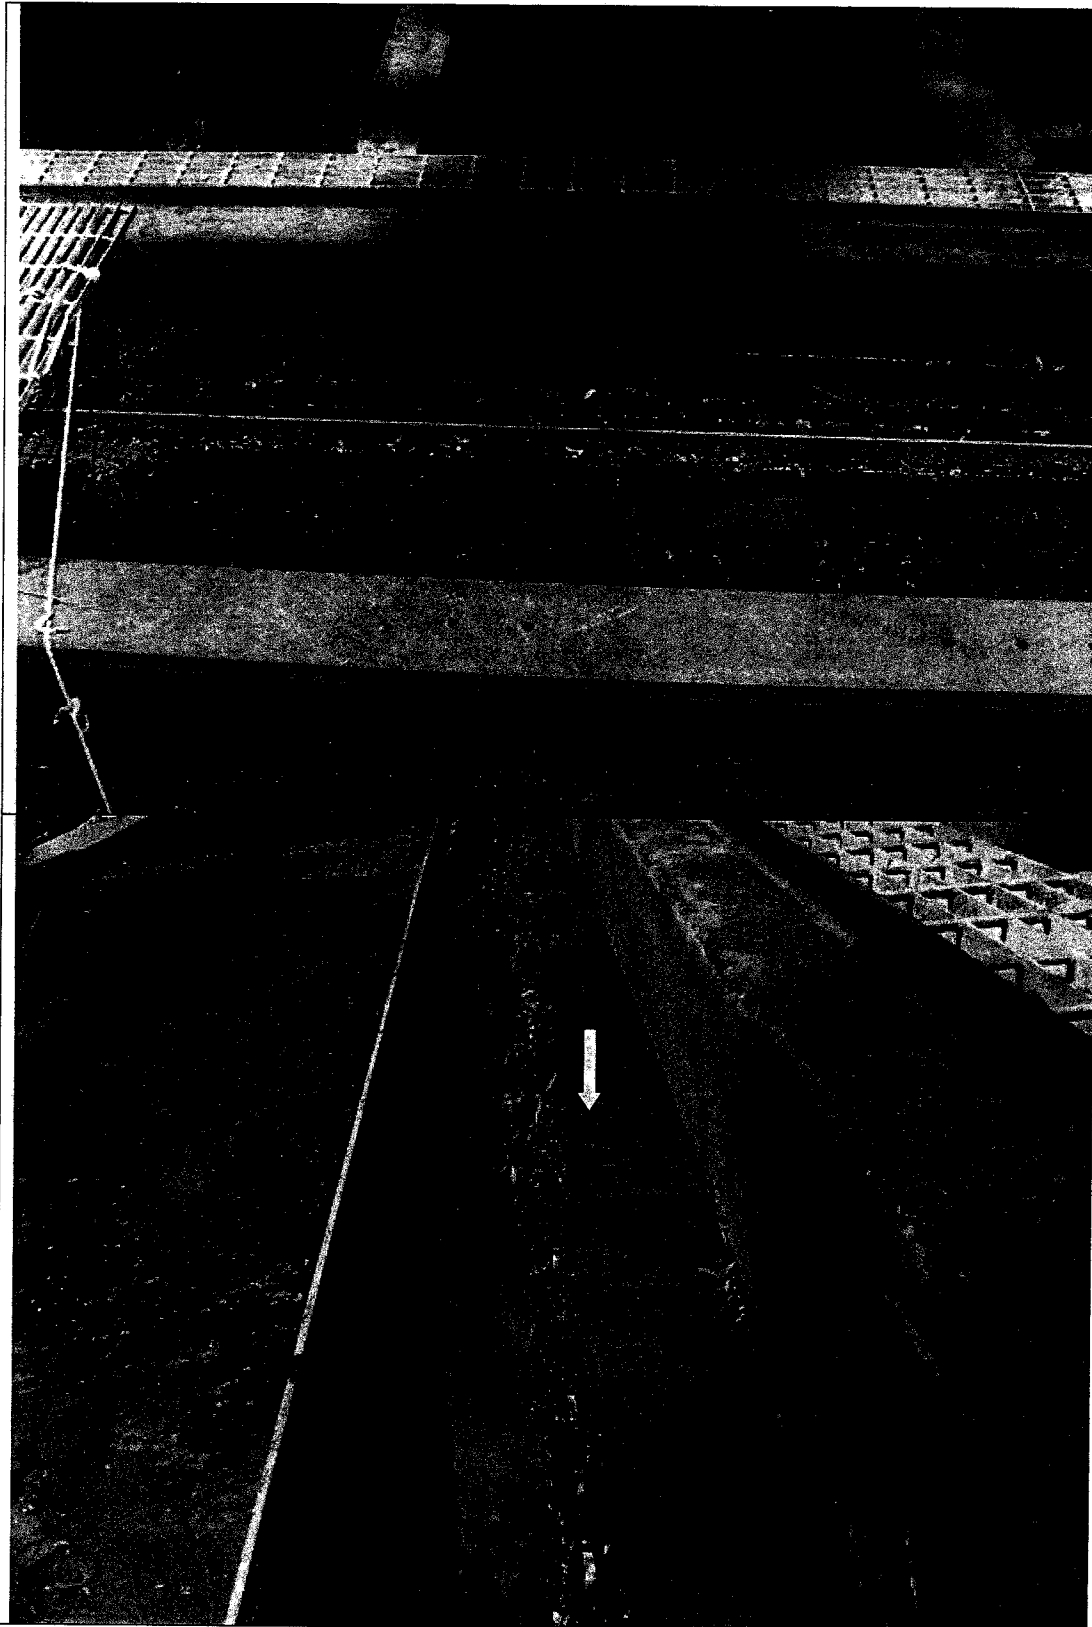
Clarifier and sawtooth weir. Note high amount of bulking sludge in clarifier and on sawtooth weir. You can also note the excessive sludge blanket just below the water surface. 9' sludge blanket with clarifier depth of 10'. Operational standards state that sludge blanket should be no more than 25% of the total clarifier depth.

Side view of clarifier and sawtooth weir. Note high amount of bulking sludge and sludge carryover to chlorine contact basin. Flow is toward the top of the picture

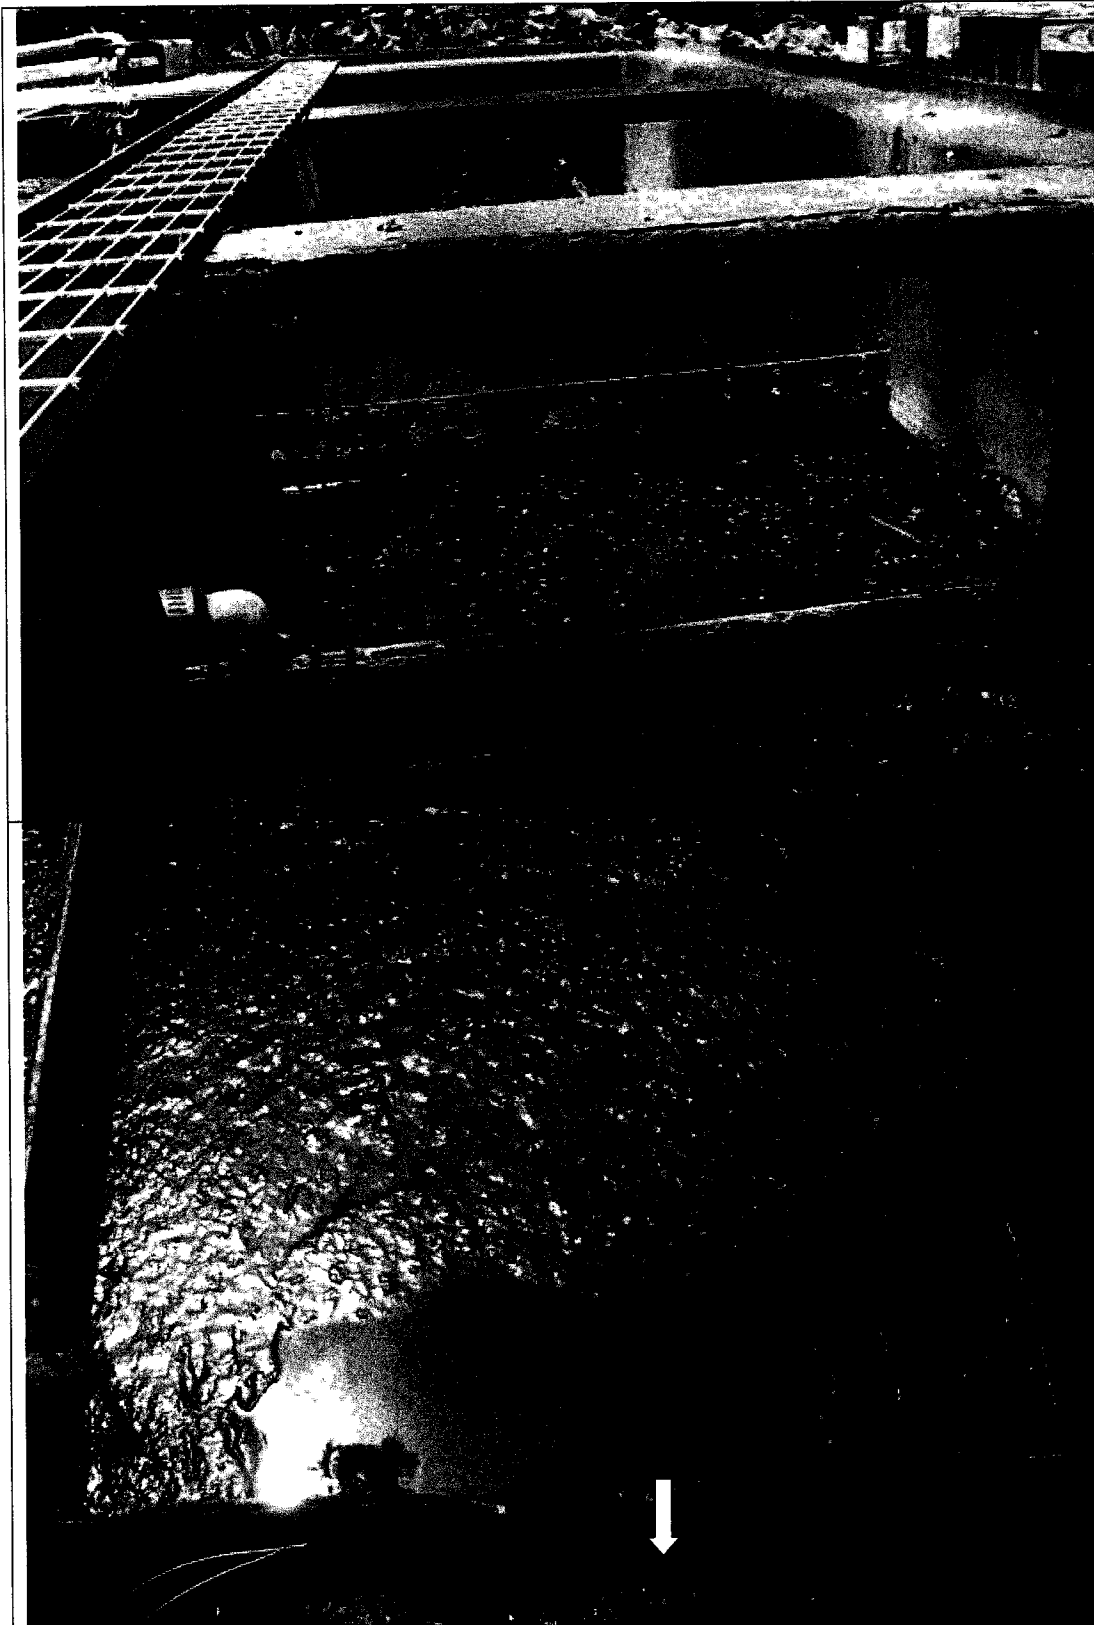
Chlorine contact basin.
Note there was no chlorine being added to effluent.
Note severe corrosion and tan color of the effluent.
Effluent should be clear at this point.

Final basin prior to discharge to Toledo Bend Reservoir. Note high amount of bulking sludge. Basin has 1.5 feet of sludge in 2 foot basin. No sludge should be present in the basin. Sludge is being discharged to Toledo Bend. Note samples were collected just below v-notch weir (arrow).

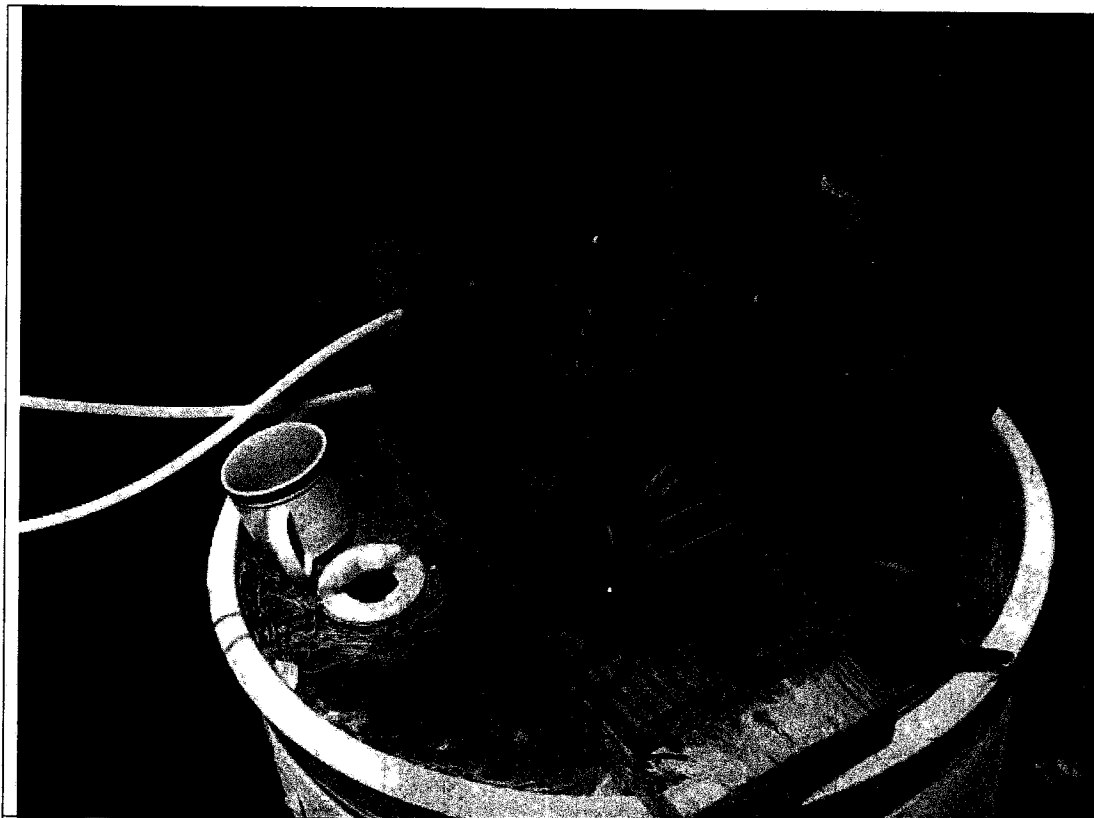
Chlorine pump on top of drum. Note chlorine pump was non functional.

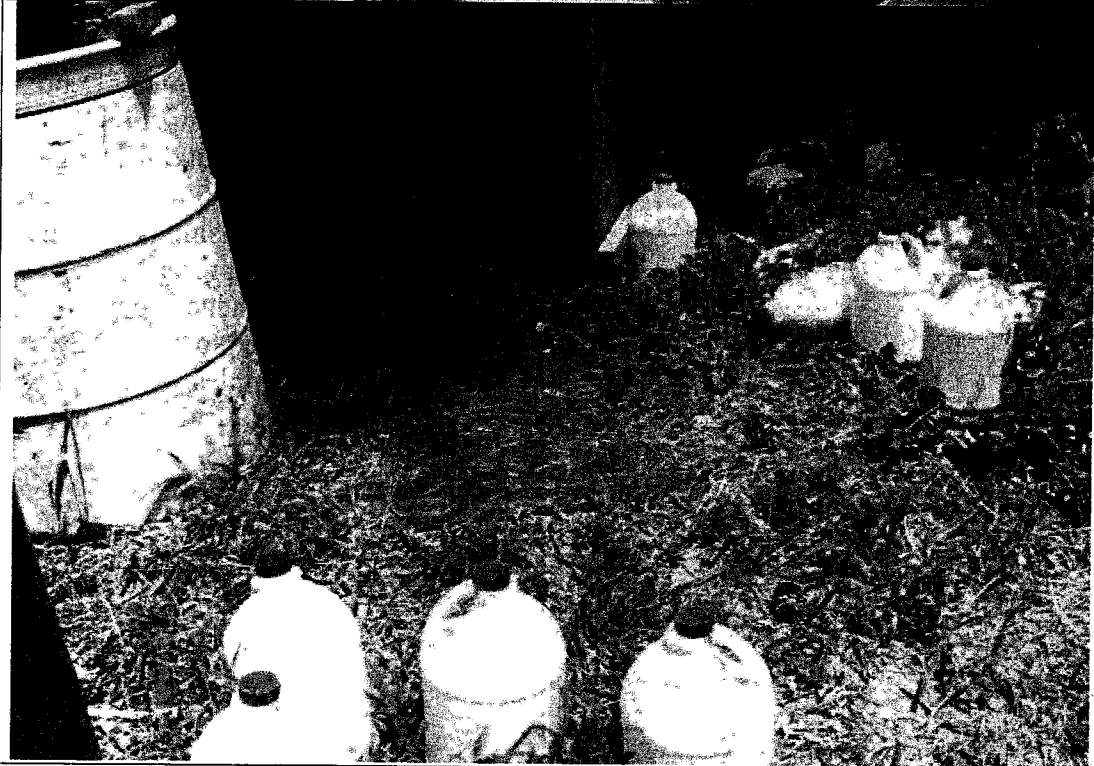
Bottles of Clorox around wastewater treatment plant.
