**SOAH DOCKET NO. 473-22-0414**  
**PUC DOCKET NO. 52205**

COMPLAINT OF CR PERMIAN	§	
PROCESSING, LLC F/K/A	§	BEFORE THE STATE OFFICE OF
CAPROCK PROCESSING, LLC	§	ADMINISTRATIVE HEARINGS
AGAINST ONCOR ELECTRIC	§	
DELIVERY COMPANY LLC	§

**DIRECT TESTIMONY**

**MATT WALL**

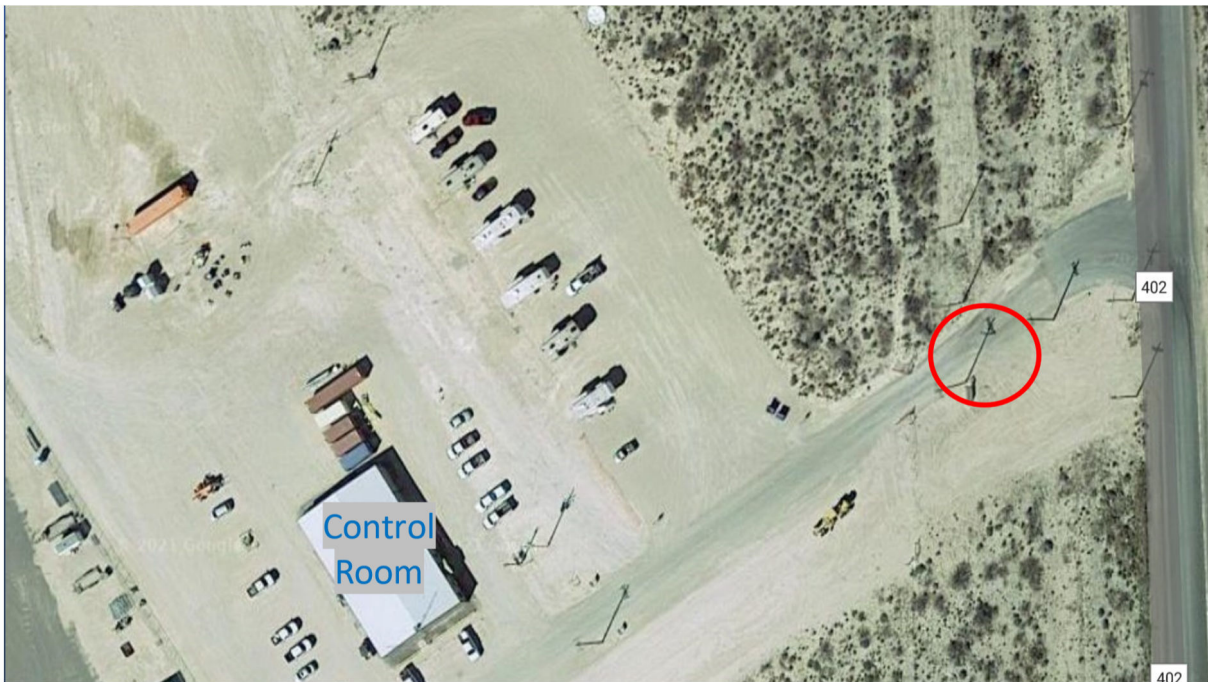
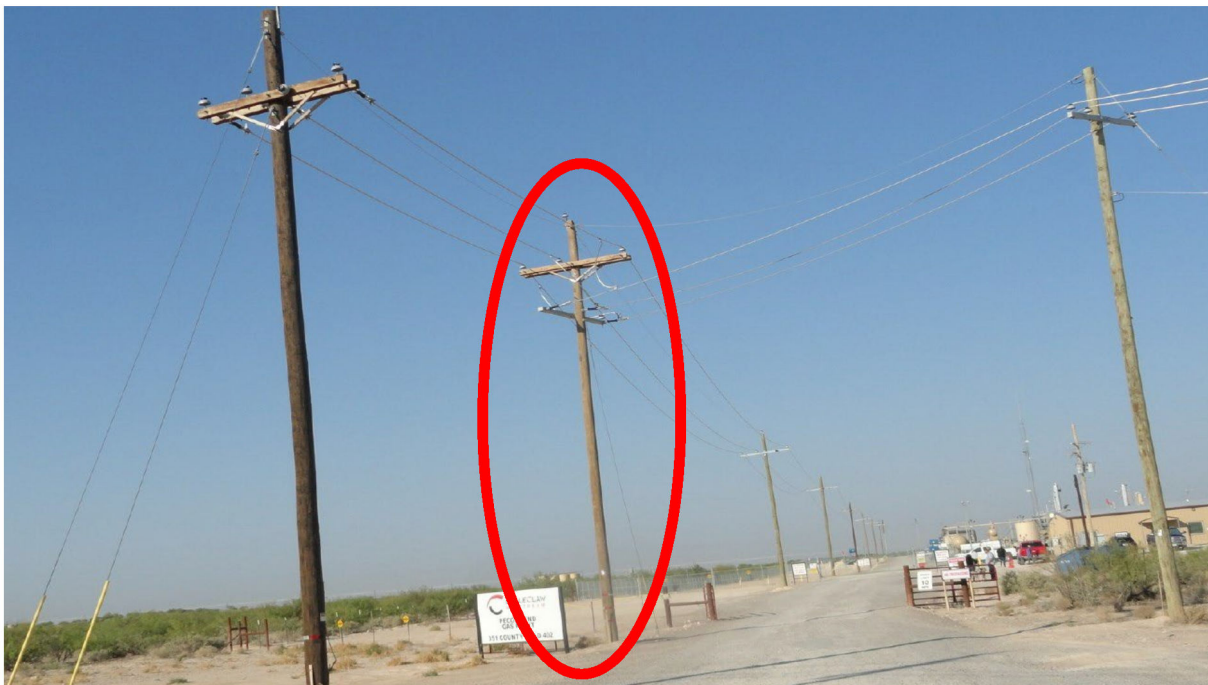
1                    **FIGURE 3: LOCATION OF WHERE JUMPER DETACHED (EX. 1 AT P. 5-6)**

6  
7           Pages 5 and 6 of Exhibit 1 are reflected in Figure 3 below. Page 5 is a zoomed-in image  
8           of the same map in Figure 1 above, with a red circle identifying the location of the  
9           utility pole where the jumper at issue disconnected. Page 6 is a picture of the utility  
10          poles at the entrance to the Plant taken by Caprock's expert, Morris Mach, in September  
11          2020, with a red circle identifying the pole near where the jumper at issue disconnected.

14 A. For reasons discussed by Dr. Dickens, Caprock claims its damages in this case were  
15 caused by an overvoltage event that originated on Oncor's side of the point of delivery,  
16 when a jumper installed by Primoris detached from Oncor's powerline on the night of  
17 June 4, 2019. The location of where the jumper detached is identified in Figure 3 above.

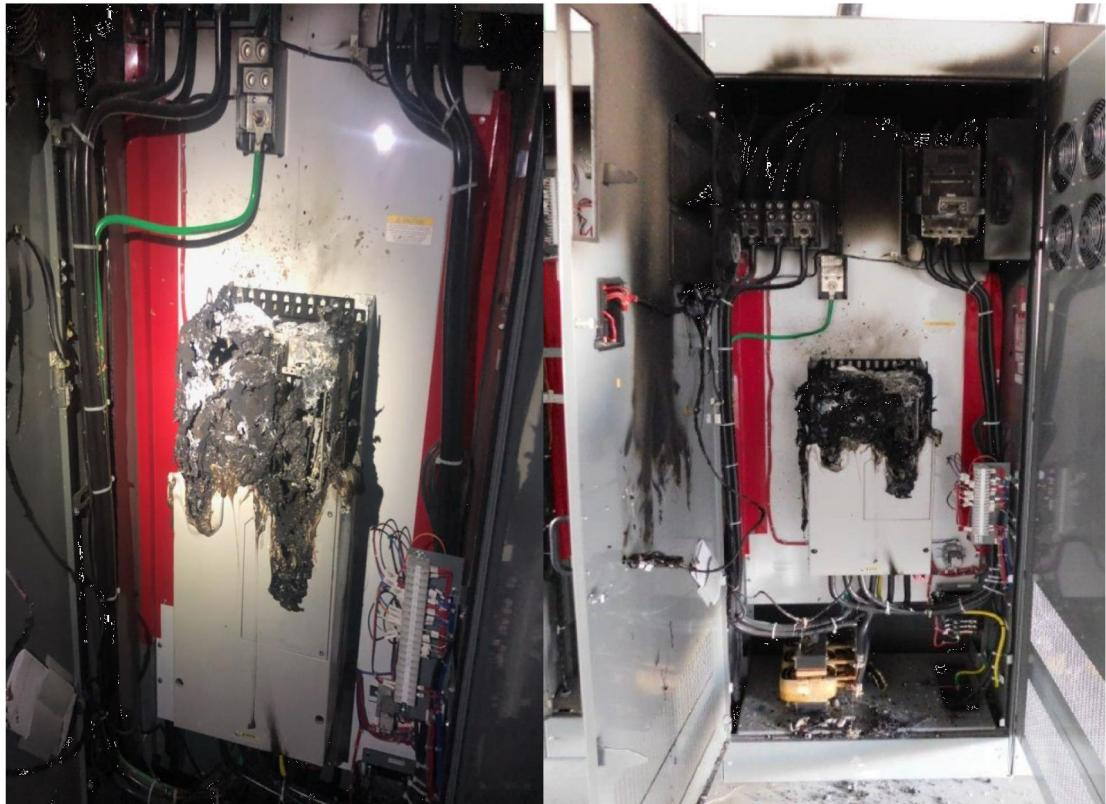
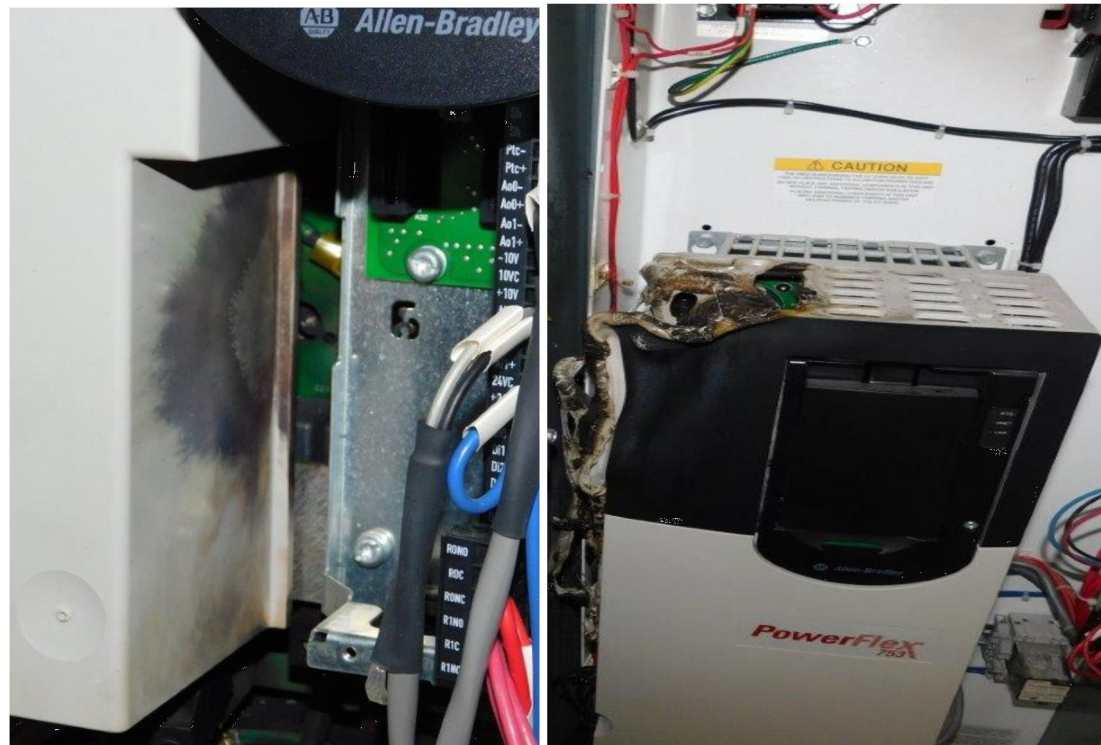
**Figure 4: Examples of Damaged Equipment (Ex. 5)**

17 A. Yes, the equipment and property I identified in my last answer sustained "physical  
18 damage" from the Incident. The equipment and property were essentially fried from  
19 the overvoltage event. See, for example, the pictures in Figure 4 above. Also, the  
20 equipment and property were not functional due to physical damage caused by the  
21 overvoltage.
