PWS\_2500019\_CP\_20211101\_Investigation  
**Texas Commission on Environmental Quality**  
**Investigation Report**

**Regulated Entity Name: BIG WOOD SPRINGS WATER SYSTEM**

<b>Investigation</b>	# 1781829	<b>Incident Numbers</b>	371717
<b>Investigator:</b>	KEVIN GLANTON	<b>Site Classification</b>	GW 51-250 CONNECTION
<b>Conducted:</b>	10/14/2021 -- 11/01/2021	<b>NAIC Code:</b>	221310
<b>Program(s):</b>	PUBLIC WATER SYSTEM/SUPPLY	<b>SIC Code:</b>	4941
<b>Investigation Type:</b>	Compliance Investigation	<b>Location:</b>	LOCATED 13 MI E OF QUITMAN ON FM 2088 IN WOOD CO
<b>Additional ID(s):</b>	2500019		
<b>Address:</b>	1604 PR 8692, WINNSBORO, TX , 75494	<b>Local Unit:</b>	REGION 05 - TYLER
		<b>Activity Type(s):</b>	PWSCMPL - PWS Complaint PWSRECON - PWS Recon- Reconnaissance investigation for surface water and groundwater facilities.

<b>Investigation #</b>	1782777	<b>Incident Numbers</b>	372339
<b>Investigator:</b>	KEVIN GLANTON	<b>Site Classification</b>	GW 51-250 CONNECTION
<b>Conducted:</b>	11/08/2021 -- 11/19/2021	<b>NAIC Code:</b>	221310
<b>Program(s):</b>	PUBLIC WATER SYSTEM/SUPPLY	<b>SIC Code:</b>	4941
<b>Investigation Type:</b>	Compliance Investigation	<b>Location:</b>	LO

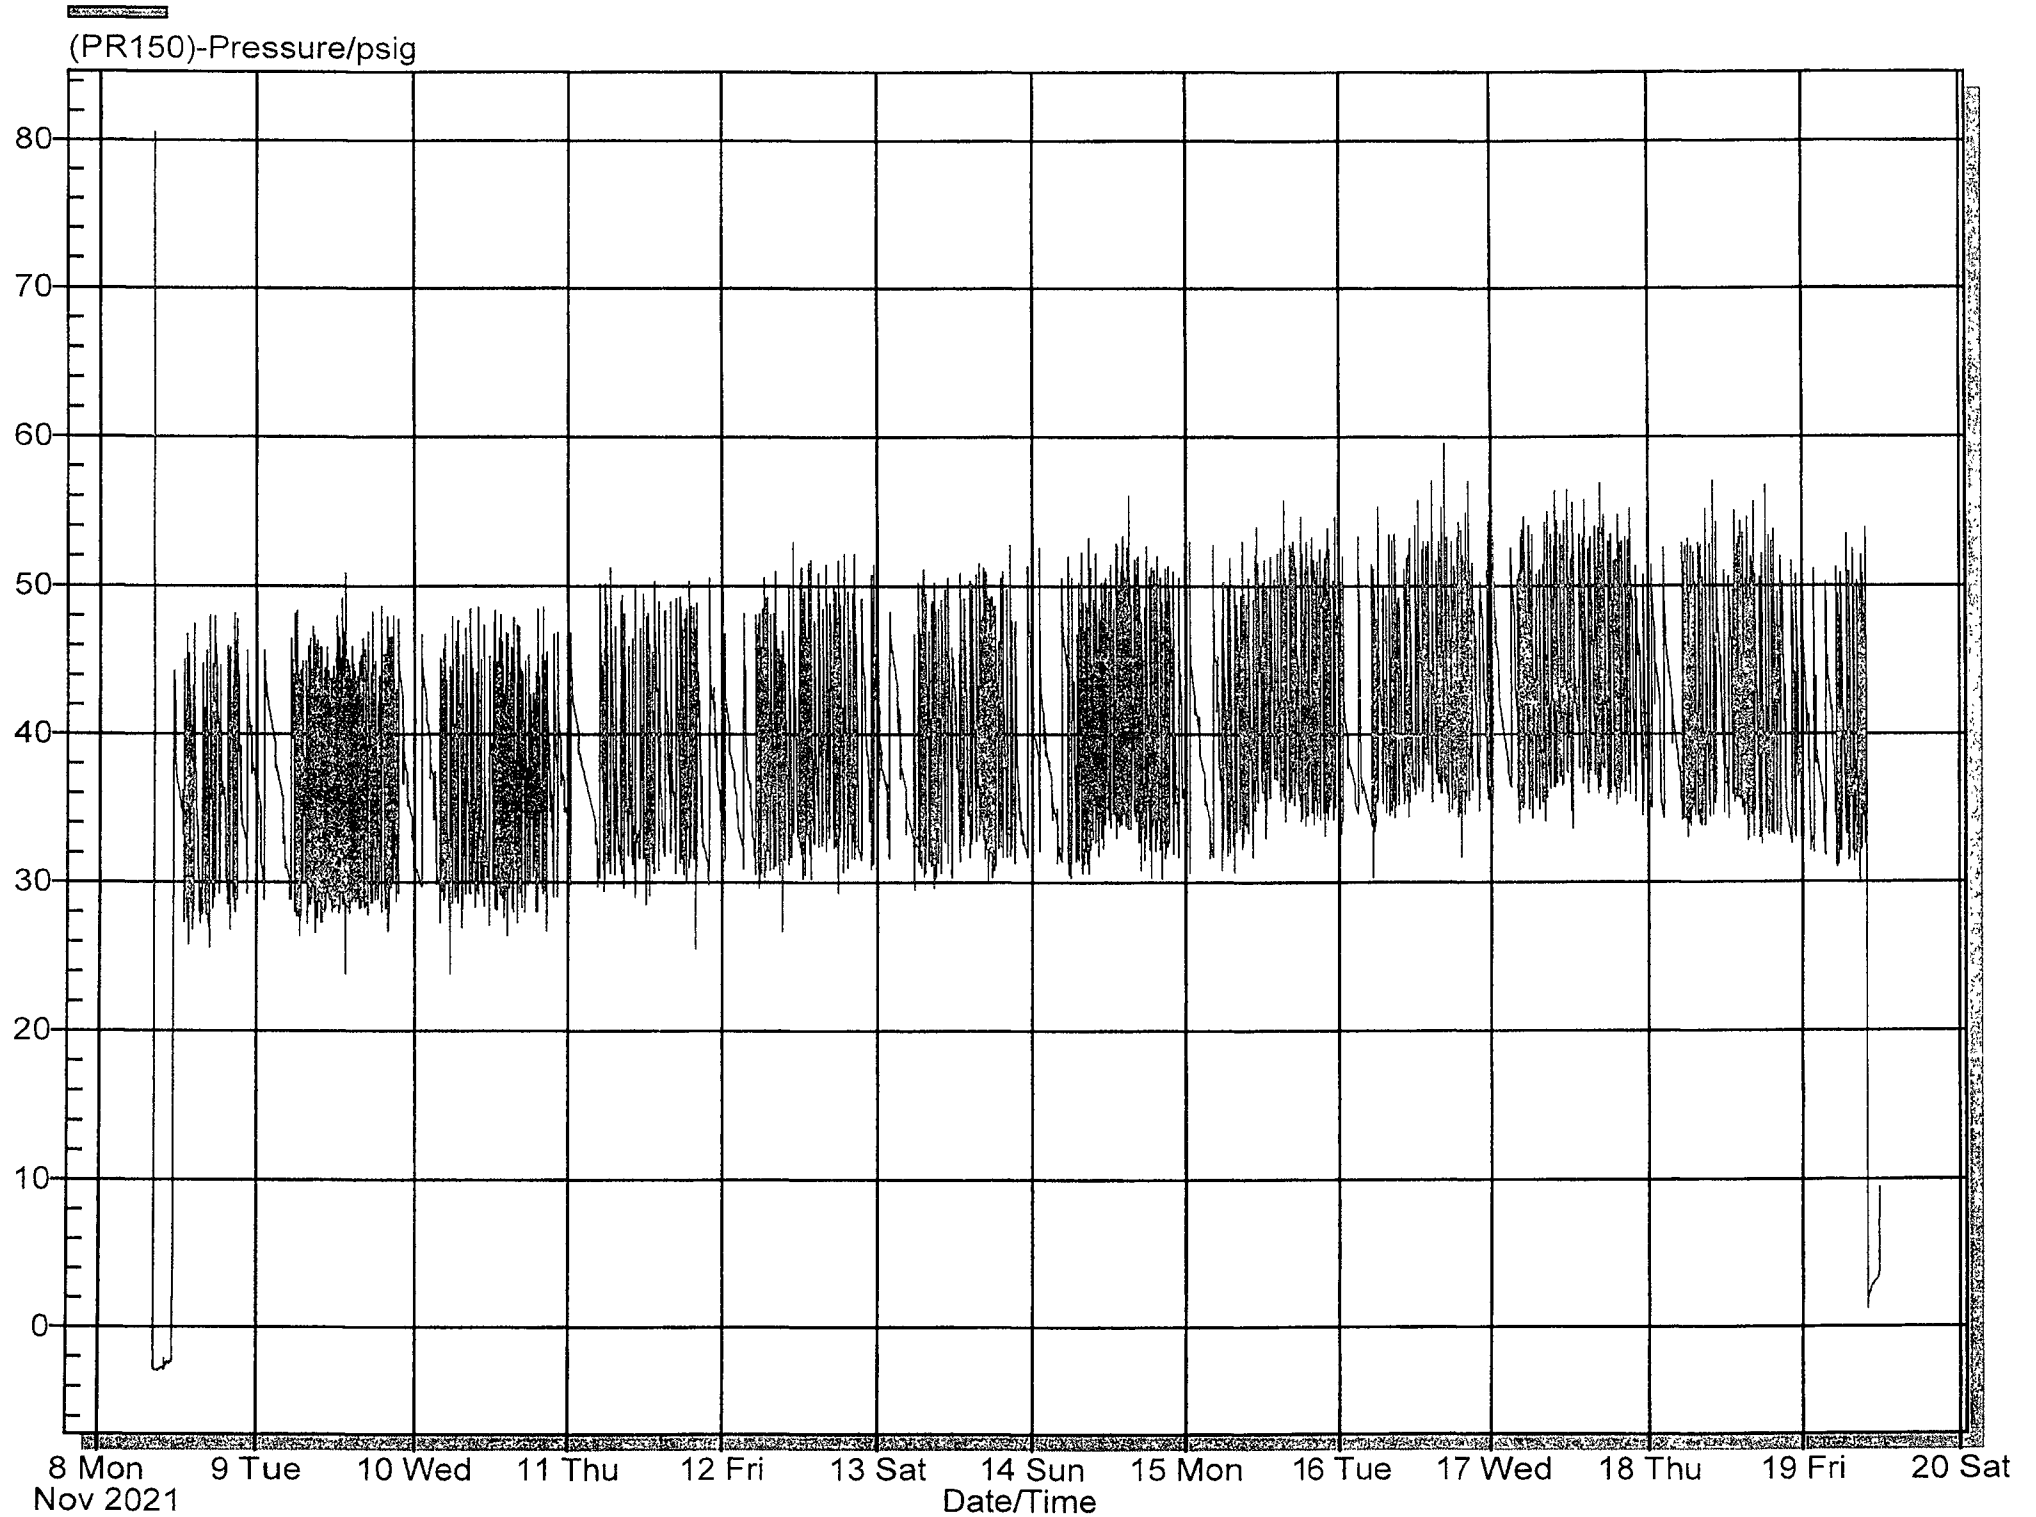
# Downloaded Data - Friday, November 19, 2021

The recorder on the flush valve on CR 3990 (at the end of the water main) showed pressure readings cycling between about 28 psi and 50 psi throughout each day that it was installed (during the latter part of the time the pressure cycled higher than the first few days—a graph is attached). The minimum normal operating pressure is 35 PSI. This has been noted as a violation.

During the investigation conducted between 11/08/2021 and 11/19/2021, the investigator installed a pressure recorder for recording pressure once every minute on a flush valve on CR 3990. A graph is attached that shows pressure readings cycling between about 28 psi and 43 psi throughout each day that it was installed (during the latter part of the time the pressure cycled higher than the first few days—a graph is attached).

**Recommended Corrective Action:** Please submit a compliance plan by 02/13/2022. The plan should include the proposed actions to be taken to correct the alleged violation and a schedule for the completion of the corrections. If this violation has already been corrected, please submit compliance documentation, photographs, purchase orders, results of analyses, etc. demonstrating what actions were taken.
