**ERCOT UPDATE CONCERNING
BRAUNIG UNIT 3 RELIABILITY MUST-RUN AGREEMENT**

PUC Project No. 55999, *Reports of the Electric Reliability Council of Texas*

CPS Energy Braunig Unit 3 – RMR Outage Update and Benefit Analysis

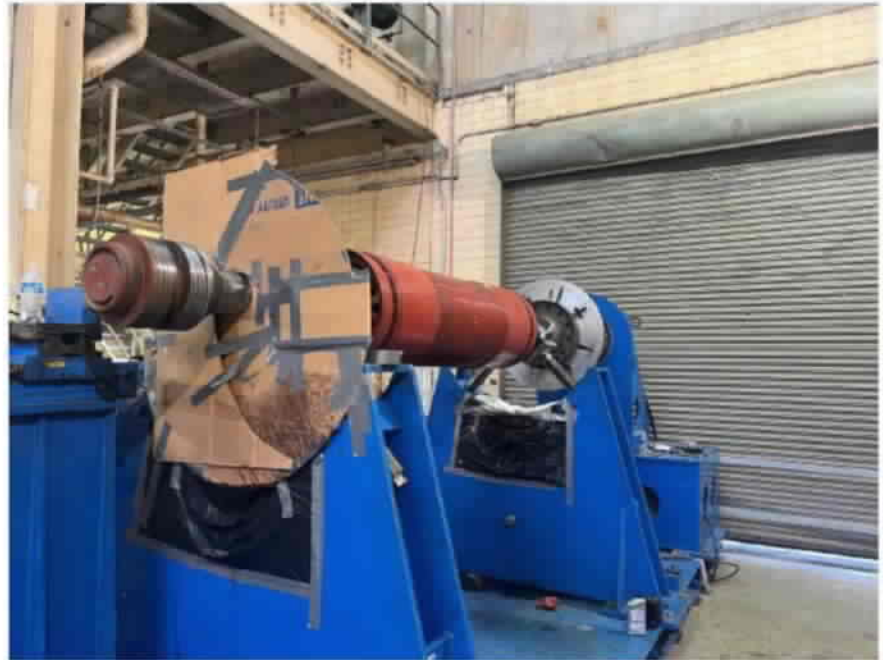
Generator Exciter Field on Lathe
For Ring Machining

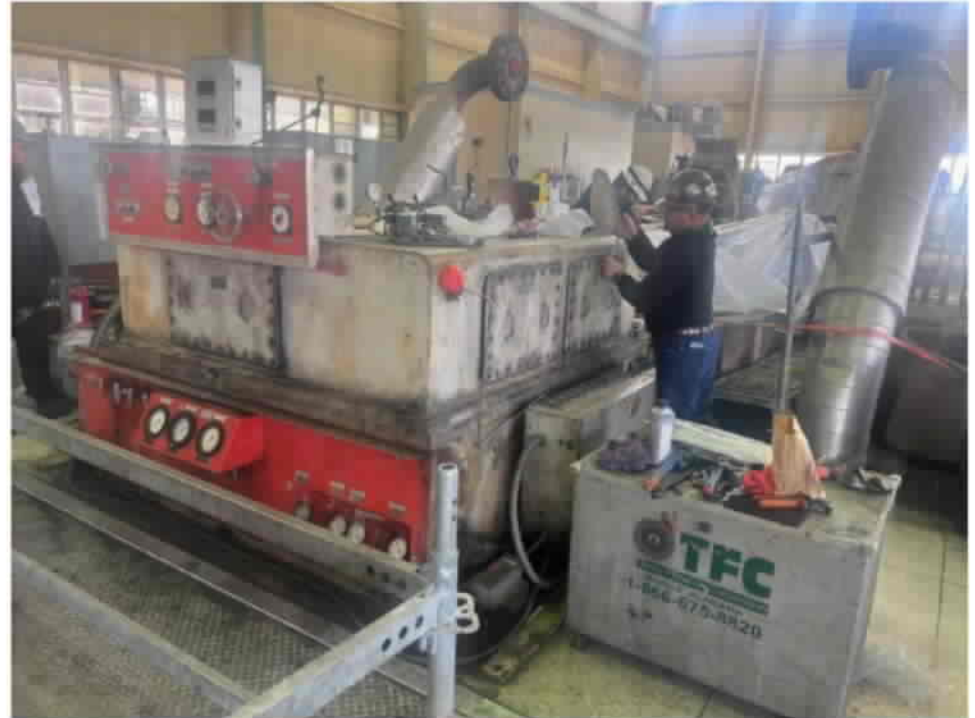
Turbine front standard covers installed for
lube oil flushing
