**NOTICE OF CORRECTION TO ERCOT UPDATE CONCERNING
BRAUNIG UNIT 3 RELIABILITY MUST-RUN AGREEMENT**

CPS Energy Braunig Unit 3 – RMR Outage Update and Benefit Analysis

April 24, 2025

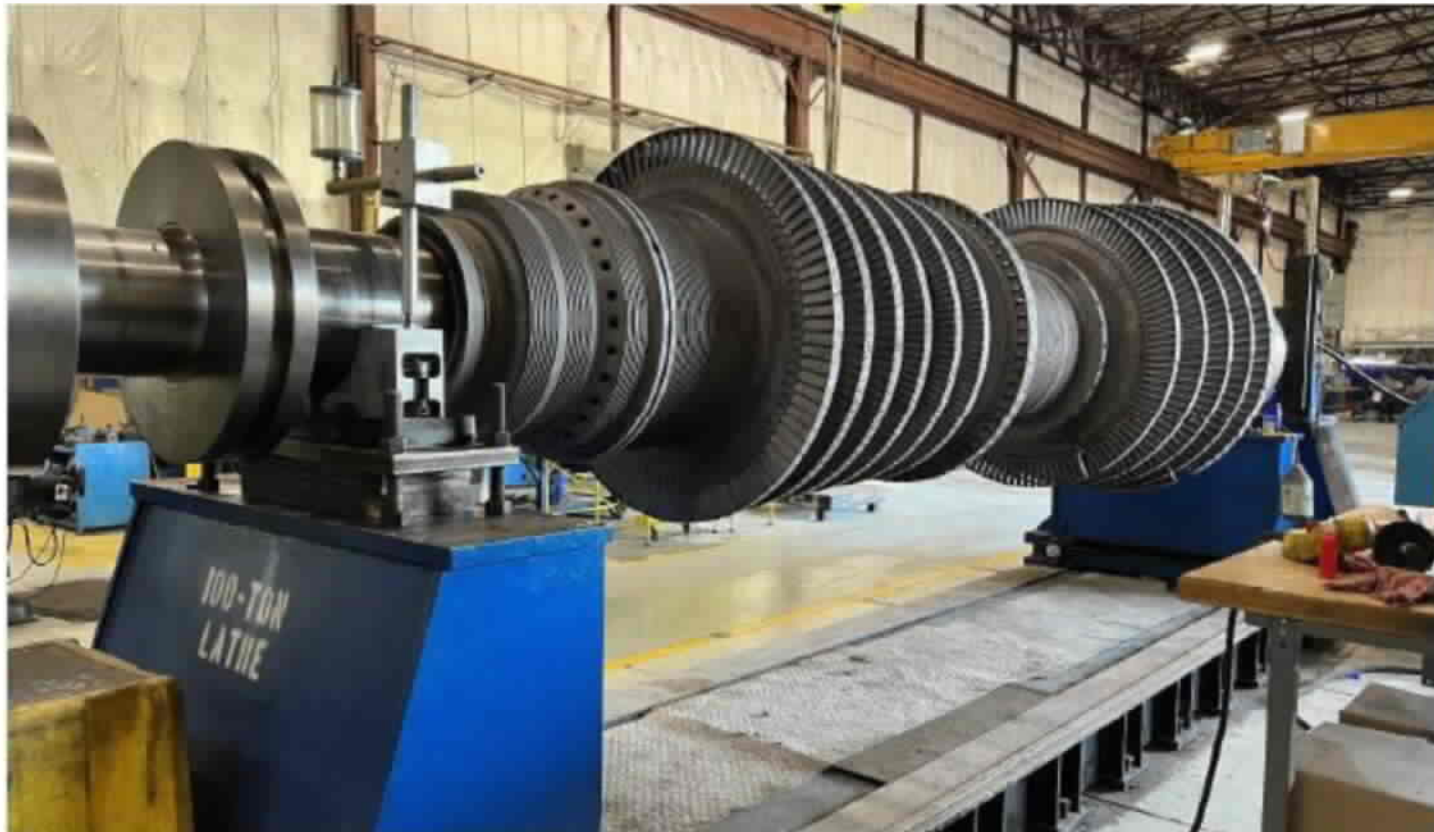
Steam Turbine High Pressure / Intermediate Pressure HP/IP Rotor
Shop Runout Inspection Completed
Internal Boresonic Inspections Complete

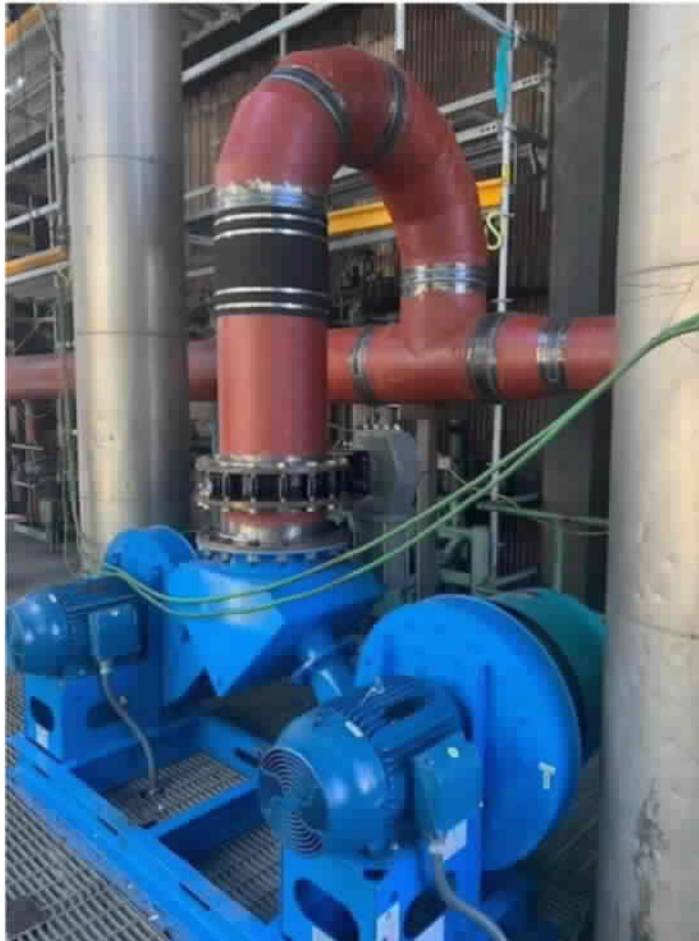
Ignitor Scanner Air Fans and Piping

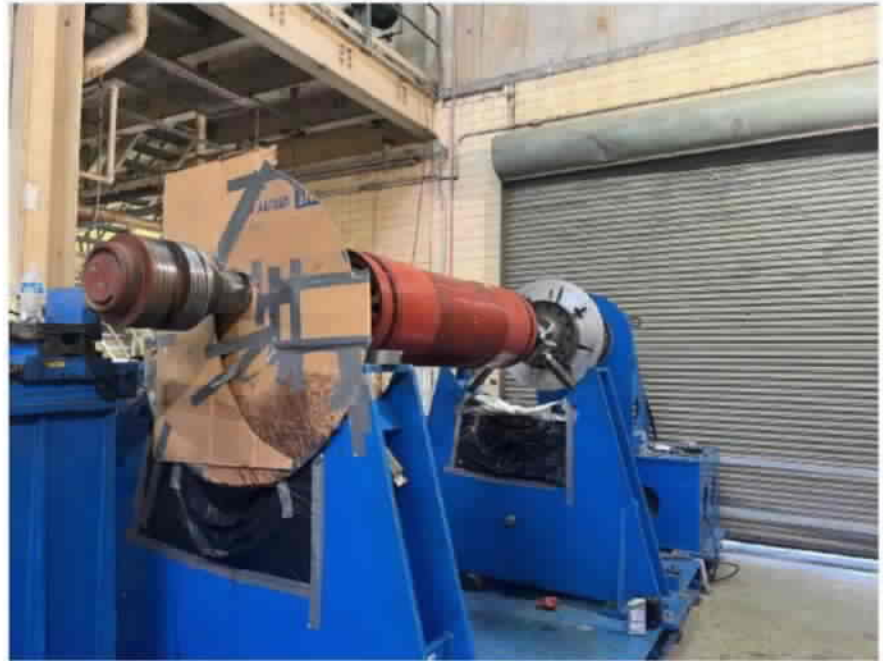
Generator Exciter Field on Lathe
For Ring Machining

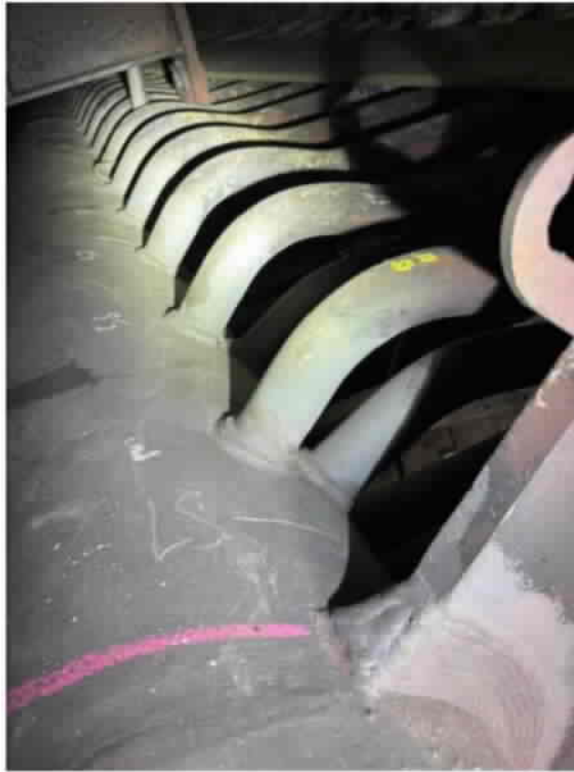
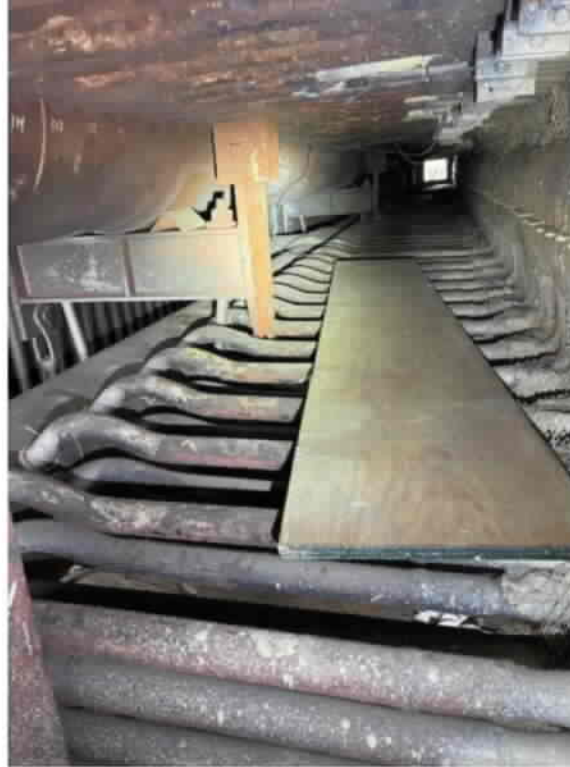
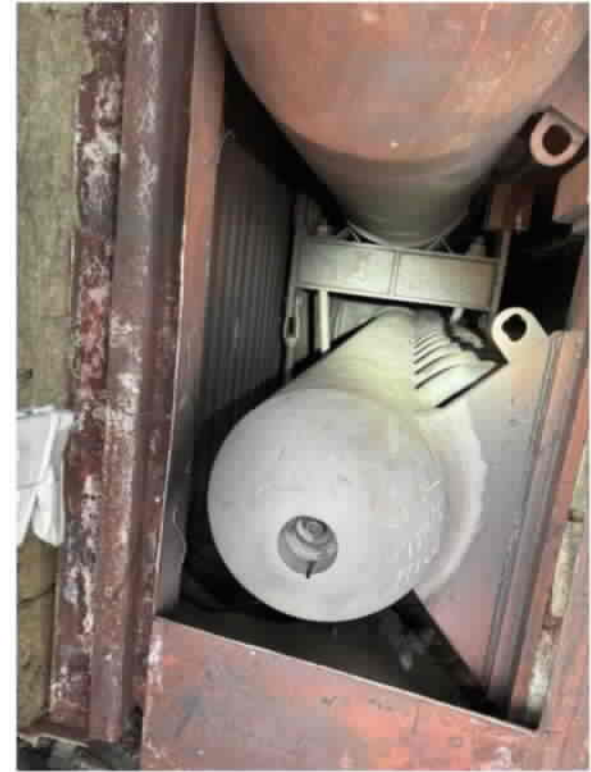
- CPS Energy has made good progress on the Braunig Unit 3 RMR outage
- ERCOT staff make weekly site visits and are in regular contact with CPS Energy staff to assure outage progress communication
- A significant repair is required to replace the No. 9 Superheater Header
- Braunig Unit 3 is likely not able to return to service for Summer 2025; however, Unit 3 continues to be a key part of assuring system reliability through Summer 2026

Three Views of the Number 9 Boiler Superheater Header with Superheater Piping Connections

- Continue to pursue the best schedule and cost-effective execution of the Braunig Unit 3 RMR outage.
- Complete outage activities that can appropriately be completed in coming months.
- Pursue expeditious fabrication of a new superheater header at a domestic shop.
- Once header is installed, complete outage work and test facility in preparation for potential RMR dispatch periods starting as early as practicable.

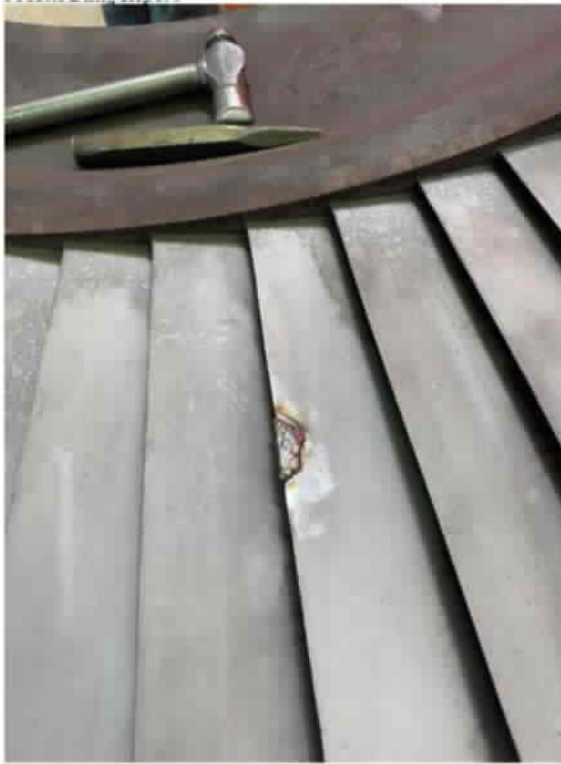
17th Stage Stationary
Blade Repair

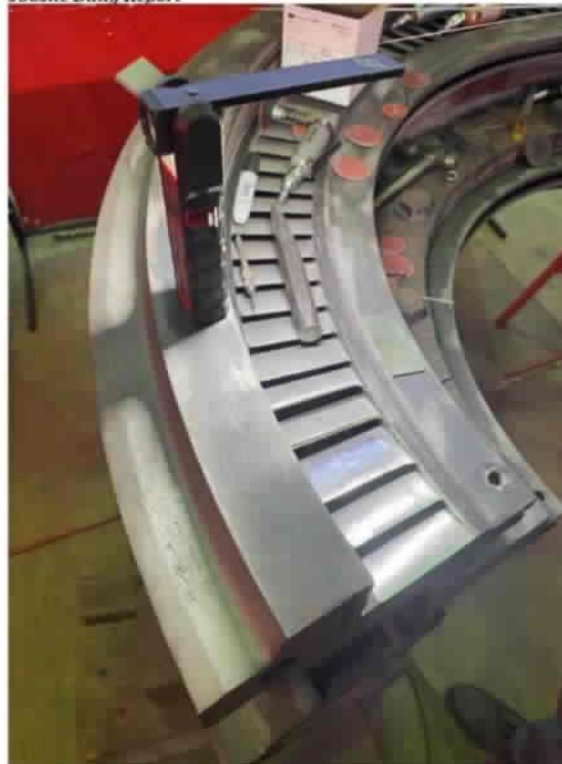
13th Stage Stationary
Blade Repair

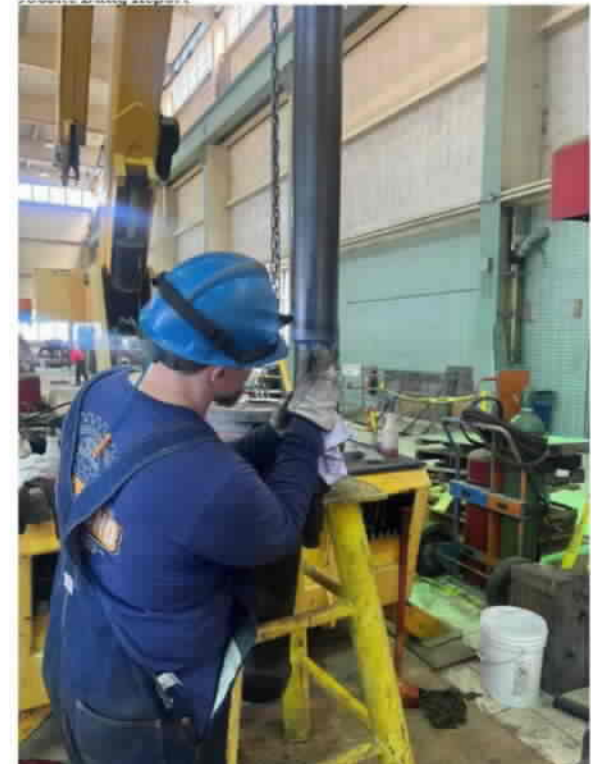
Lapping and Contact
Checking on Re-heat Seal
Valve Pressure Seats

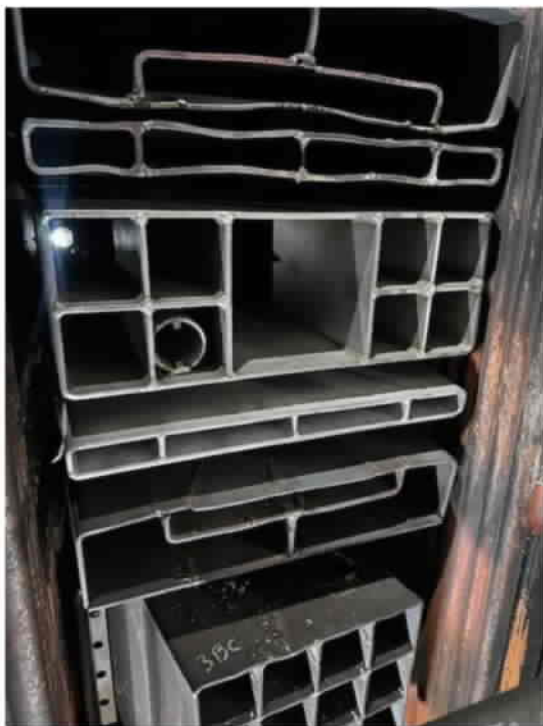
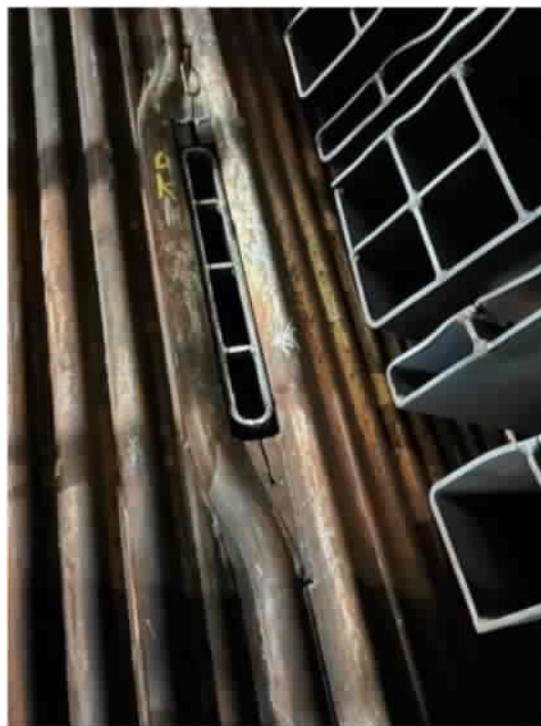
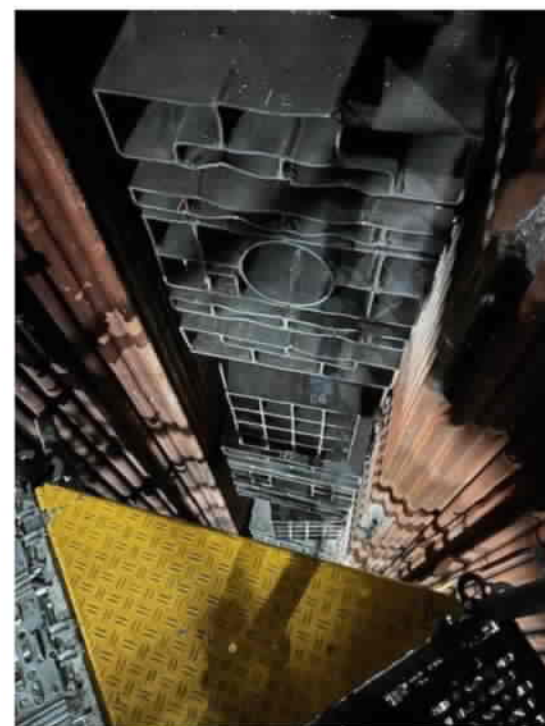
Natural Gas Burners on Boiler Corners

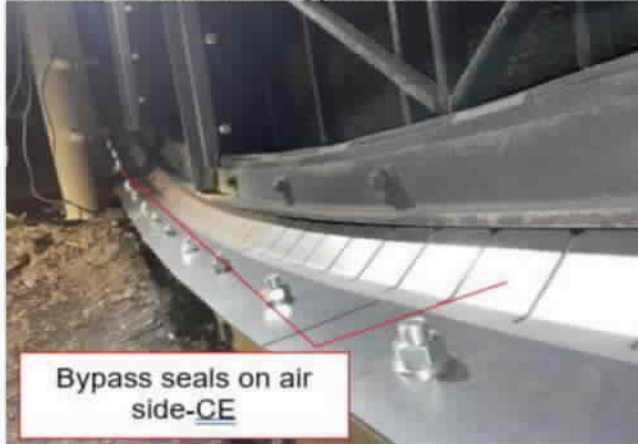
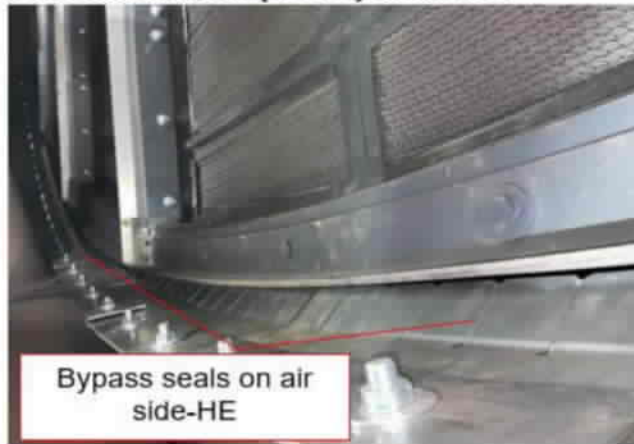
U3 APH Seal Replacement Project

- Continued to install the bypass seals on the air side of hot and cold ends, completed by lunch time.

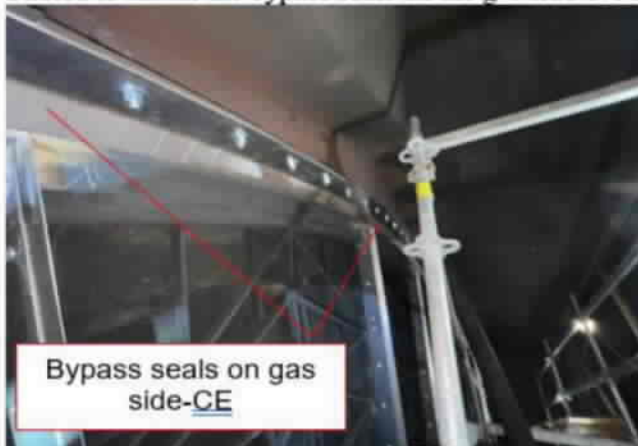
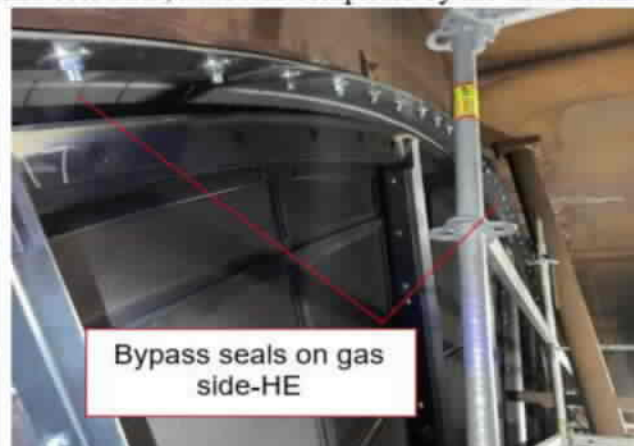
Air Preheater Seal Replacements

- Started to install the bypass seals on the gas side of hot and cold ends, 90% was completed by the end of shift.

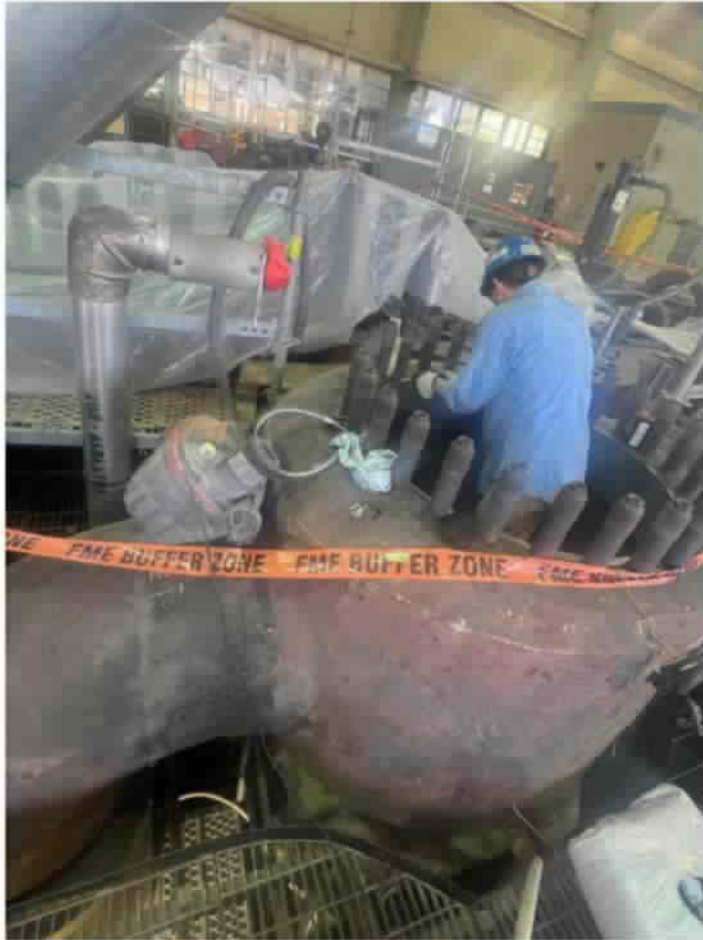
Cleaning Turbine Valve
Gasket Surfaces

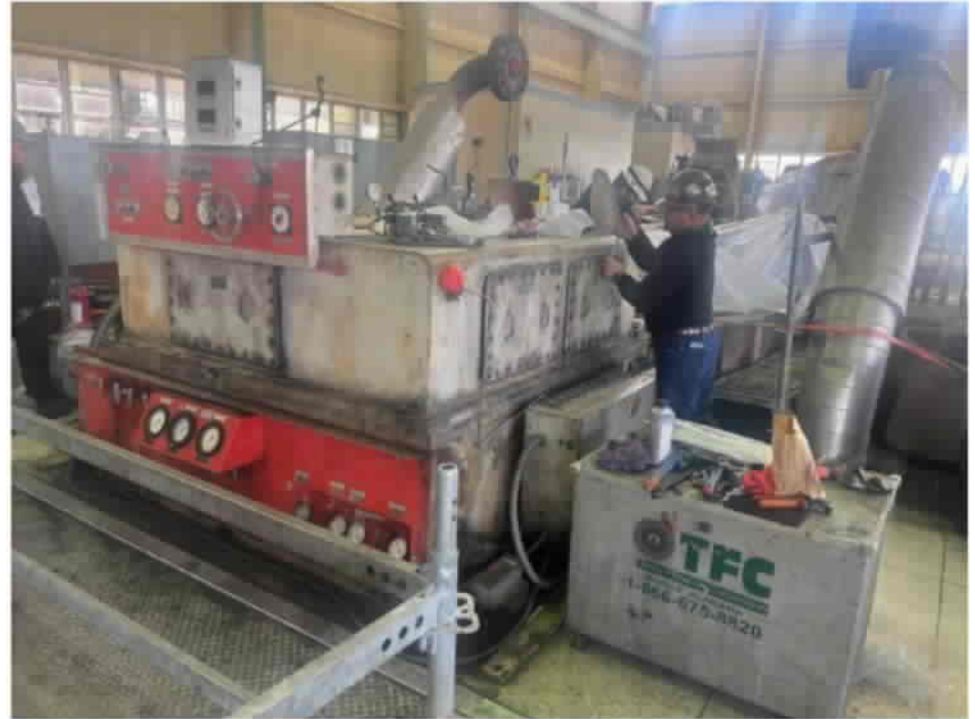
Turbine front standard covers installed for
lube oil flushing
