Filing Receipt

Control Number - 57579

Reliability Reporting Storm Report

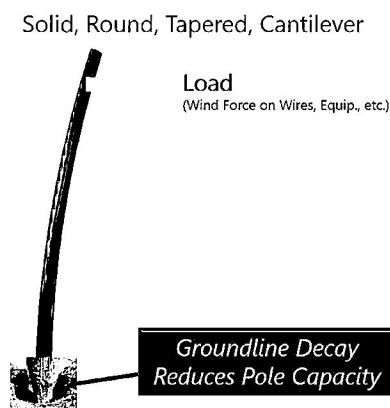
Figure 7. Decay occurs at the expected break point causing a reduction of the bending capacity.

Not only is the expected break point at groundline, this is where decay is also most likely to occur and weaken the pole (see Figure 9). External decay in the groundline zone causes a significant reduction of the pole's ultimate bending capacity.

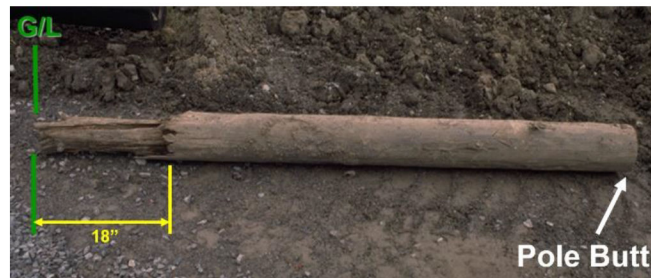
Figure 9. The section of a failed southern pine pole from the groundline and below.

Figure 9 shows how abruptly decay in southern pine poles ends at 18 inches below groundline due to a lack of oxygen to support decay.

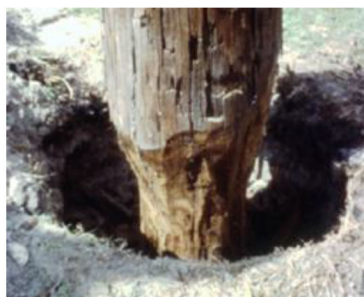
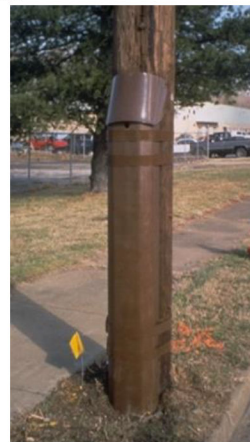
The next images show an example of more advanced shell rot which had been removed. The remaining sound wood was subsequently treated with preservative paste to prevent future decay. The bending strength was restored with the installation of a steel truss as shown on the right. Pole restoration can be completed much faster and for much less cost than pole replacement.

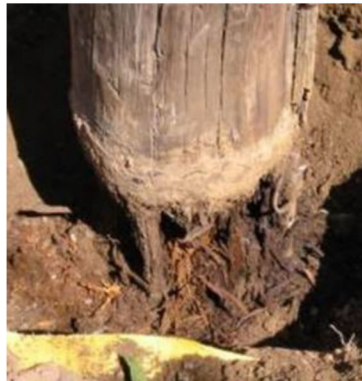
The decay process was so advanced for this pole that the only option was to replace it.

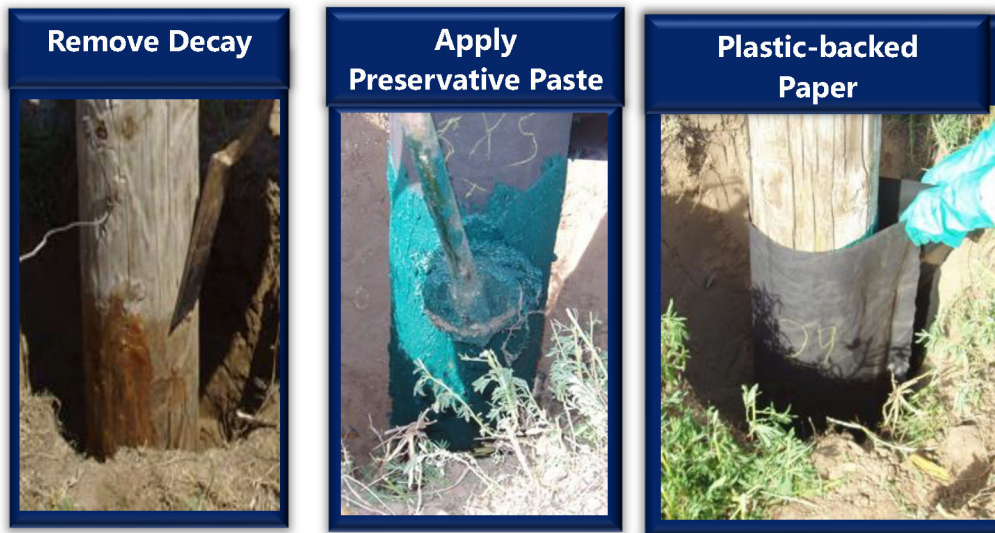
These photos show the removal of an early stage of shell rot and then the application of a preservative paste to the critical outer shell to control future decay. A plastic backed paper is then wrapped around the pole below groundline to help the preservative migrate into the pole by osmosis.

CenterPoint's practice of full excavation whenever possible and applying MP-500 external past is Best in Class.
