CENTERPOINT ENERGY HOUSTON ELECTRIC, LLC PUC DOCKET NO. 57579 SOAH DOCKET NO. 473-25-11558

HOUSTON COALITION OF CITIES REQUEST NO.: HCC-RFP01-05

FLOOD POTENTIAL STUDY

ADDICKS RESERVOIR DAM BREACH ANALYSIS

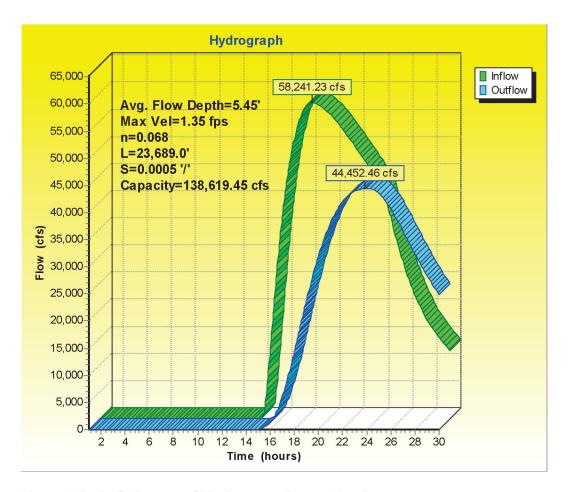
Figure 3. HydroCad output of Northern area (Tanner Road).

The downstream inundation from this dam breach analysis has several factors and different inundation levels. The northern most part of the analysis is around the intersection of Brittmoore and Tanner Road which is the location closest to where the assumed dam breach would be located and is the section of the analysis with the highest elevation. The HydroCad model simulates the damn breach and the parameters of the area around this intersection. The model results predict an average depth of 5.45° with the highest depth being 5.52° and the lowest depth being 4.32°; the highest depth was located closer to the roadways.

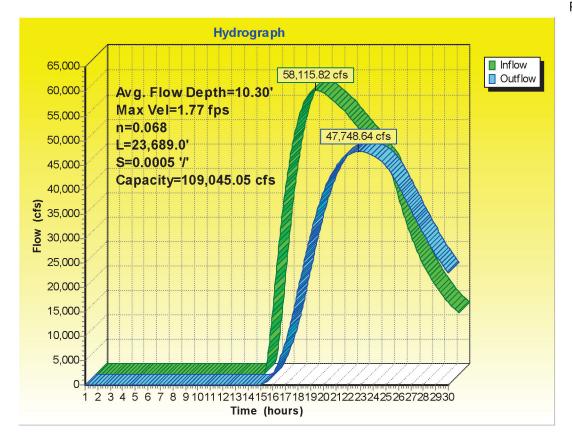
Figure 4. HydroCad output of the area by the A.O.C.

The middle/center of the analysis is around the CenterPoint AOC, Spring Branch Center, and Addicks Substation at the intersection of Brittmoore and Kempwood. This cross section had the largest depth of water of 10.5', where the land bottle necks into a narrowed location with the bounds of the water confined closer to the CenterPoint Facilities.

The average water depth near the A.O.C. is 10.3' at elevation 104.3'. The Beltway has overpasses and intersections at grade that allows water to flow east out of the model confines. The majority of the water will still flow south toward Buffalo Bayou. Exhibit 1 (attached 11x17) is an overhead plan view of these facilities with survey shots and elevations.

Model
CenterPoint A.O.C.	Elevations
100-Year Floodplain Elevation from Addicks	94.00'
Brittmoore Road at Gate	95.59'
Finish Floor Elevation in A.O.C.	98.61'
Projected Water Surface Elevation from Dam Breach and Uncontrolled Flow	104.3'

Based on this study, BHA recommends that the modeled water surface elevation plus three (3) feet of freeboard be used as the basis for the CenterPoint facility protection in the Addicks Reservoir study area. This results in the A.O.C. needing 8.7' flood doors added to the building, the Spring Branch Service Center needing 11.3' of protection, the Addicks Substation needing 10.3' of protection, and Brittmoore Substation needing 10.4' of protection.

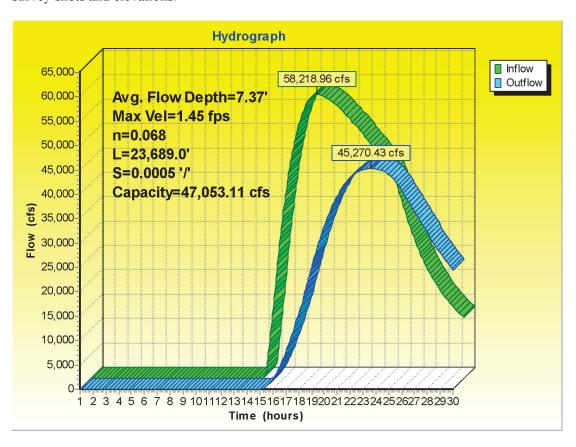
Figure 5. HydroCad output of the Brittmoore Substation.

The southern analysis point is located around the intersection of Brittmoore and Mayfield Road; at the Brittmoore Substation. This is the last section where an analysis took place. Due to the wide area, the low elevation and many outlets for water, this area should see a lower water elevation with an average of 4.52' predicted. The substation could actually see more than seven feet of water inside the yard and the road area and toward Beltway 8 and Interstate 10 have a low lying intersection that would see water closer to ten feet based on the model. Exhibit 2 (attached 11x17) is an overhead plan view of the Brittmoore Substation with survey shots and elevations.

CenterPoint Brittmoore Substation	Model Elevations
Brittmoore Road at Substation	88.06'
Finish Floor Elevation Control Bldg	91.05'
Projected Water Surface Elevation from Dam Breach and Uncontrolled Flow	96.37°

The Addicks Reservoir has survived all of the major storms to hit the Galveston/Houston area since 1938, when it was built. Hurricane Harvey was the latest test to the dam embankment that contains the water that is captured. In our opinion it would take almost a combination of several storms to breach the dam embankment, but that isn't to say that the embankment will never break. This analysis took the flooding and rainfall of Hurricane Harvey and added some additional rain. Based on the model storm, dam break model and the USACE recommended uncontrolled release amount of 40,000cfs anywhere from 7' to 10' of water in the Brittmoore road area is possible. This model also predicts the average of water will be one to four (4) feet of water in the Addicks Substation control room, 3.2 feet of water in the Spring Branch Service Center, and one to 6.6 feet inside the A.O.C. As the analysis went further south from the breach, the water is an average of eight to nine feet of water in the Brittmoore road area. This will cause five to six feet of water in the Brittmoore Substation.
