- provides an overview of the Company's transmission and substation facilities;
- describes the Transmission Operations, Substation Operations, and RTO groups;
- discusses the preparation measures taken by the Company prior to Hurricane Beryl landfall;
- discusses the damage caused by Hurricane Beryl and Winter Storm Enzo to the Company's transmission and substation facilities; and
- supports the reasonableness and necessity of transmission and substation costs incurred in support of the restoration efforts associated with Hurricane Beryl and Winter Storm Enzo.

11 A. My testimony describes and discusses the incurred transmission and transmission-
 12 related substation restoration costs due to damage caused by Hurricane Beryl and
 13 Winter Storm Enzo that occurred in July of 2024 and January of 2025, respectively.
 14 In this context, I describe CenterPoint Houston’s transmission system, generally
 15 comprised of transmission and transmission-related substation facilities, and
 16 CenterPoint Houston’s Transmission and Substation Operations organization. I
 17 then describe my organization’s pre-storm preparations, how Hurricane Beryl and
 18 Winter Storm Enzo impacted CenterPoi

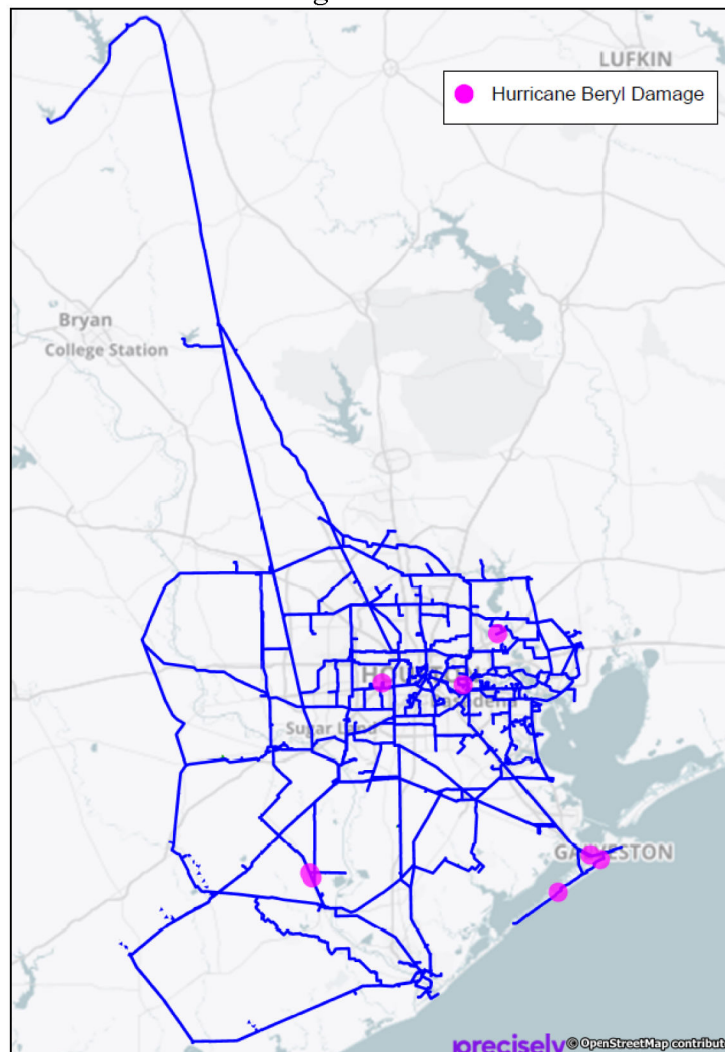
Figure DM-3

In addition, several other transmission structures sustained damage from Hurricane Beryl (e.g., bent lattice steel, broken insulator, damaged conductor/fiber, and damaged obstruction lighting) caused by wind and flying debris that still necessitated repair, replacement, and restoration work. The map below (Figure DM-3) shows where most of the damage to transmission structures occurred due to Hurricane Beryl in the context of the Company's transmission system as a whole.

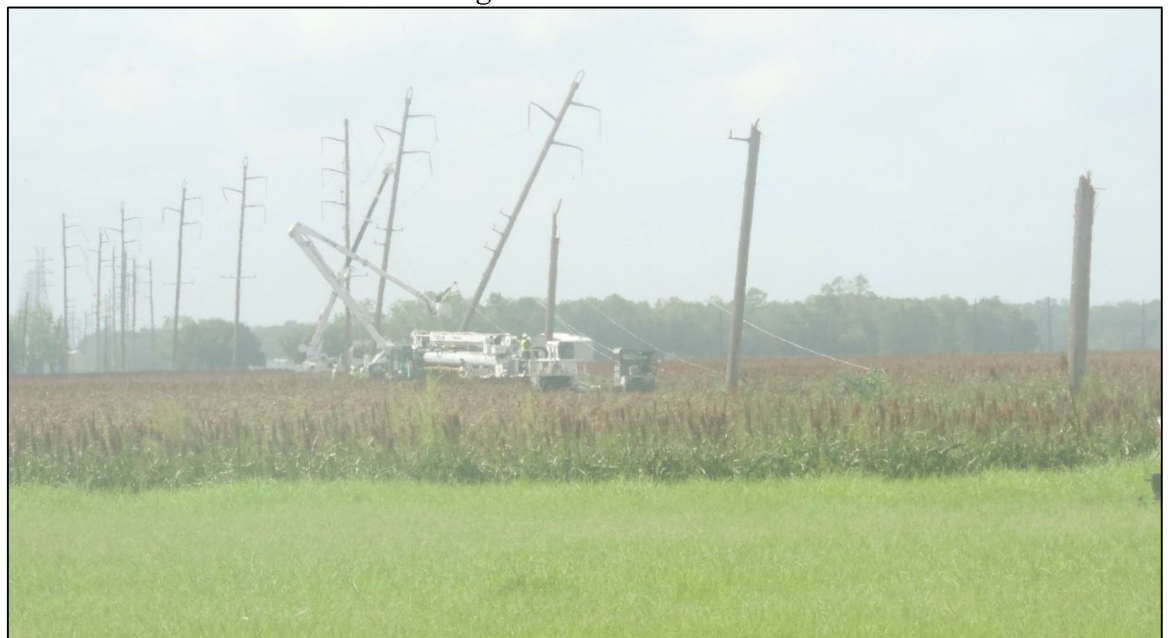
Figure DM-11

And, the pictures below (Figure DM-11 and Figure DM-12) are of the line of 14
