Subject: **Project No. ~~32128~~** Infrastructure Reliability, Emergency Management, and
Homeland Security Matters

Attached for filing are ten (10) copies of the Entergy Gulf States presentation made
by Joseph F. Domino, President and CEO of Entergy TX, at the Public Meeting in
Beaumont, Texas on February 22, 2006.

Hurricane Rita Impact & Recovery

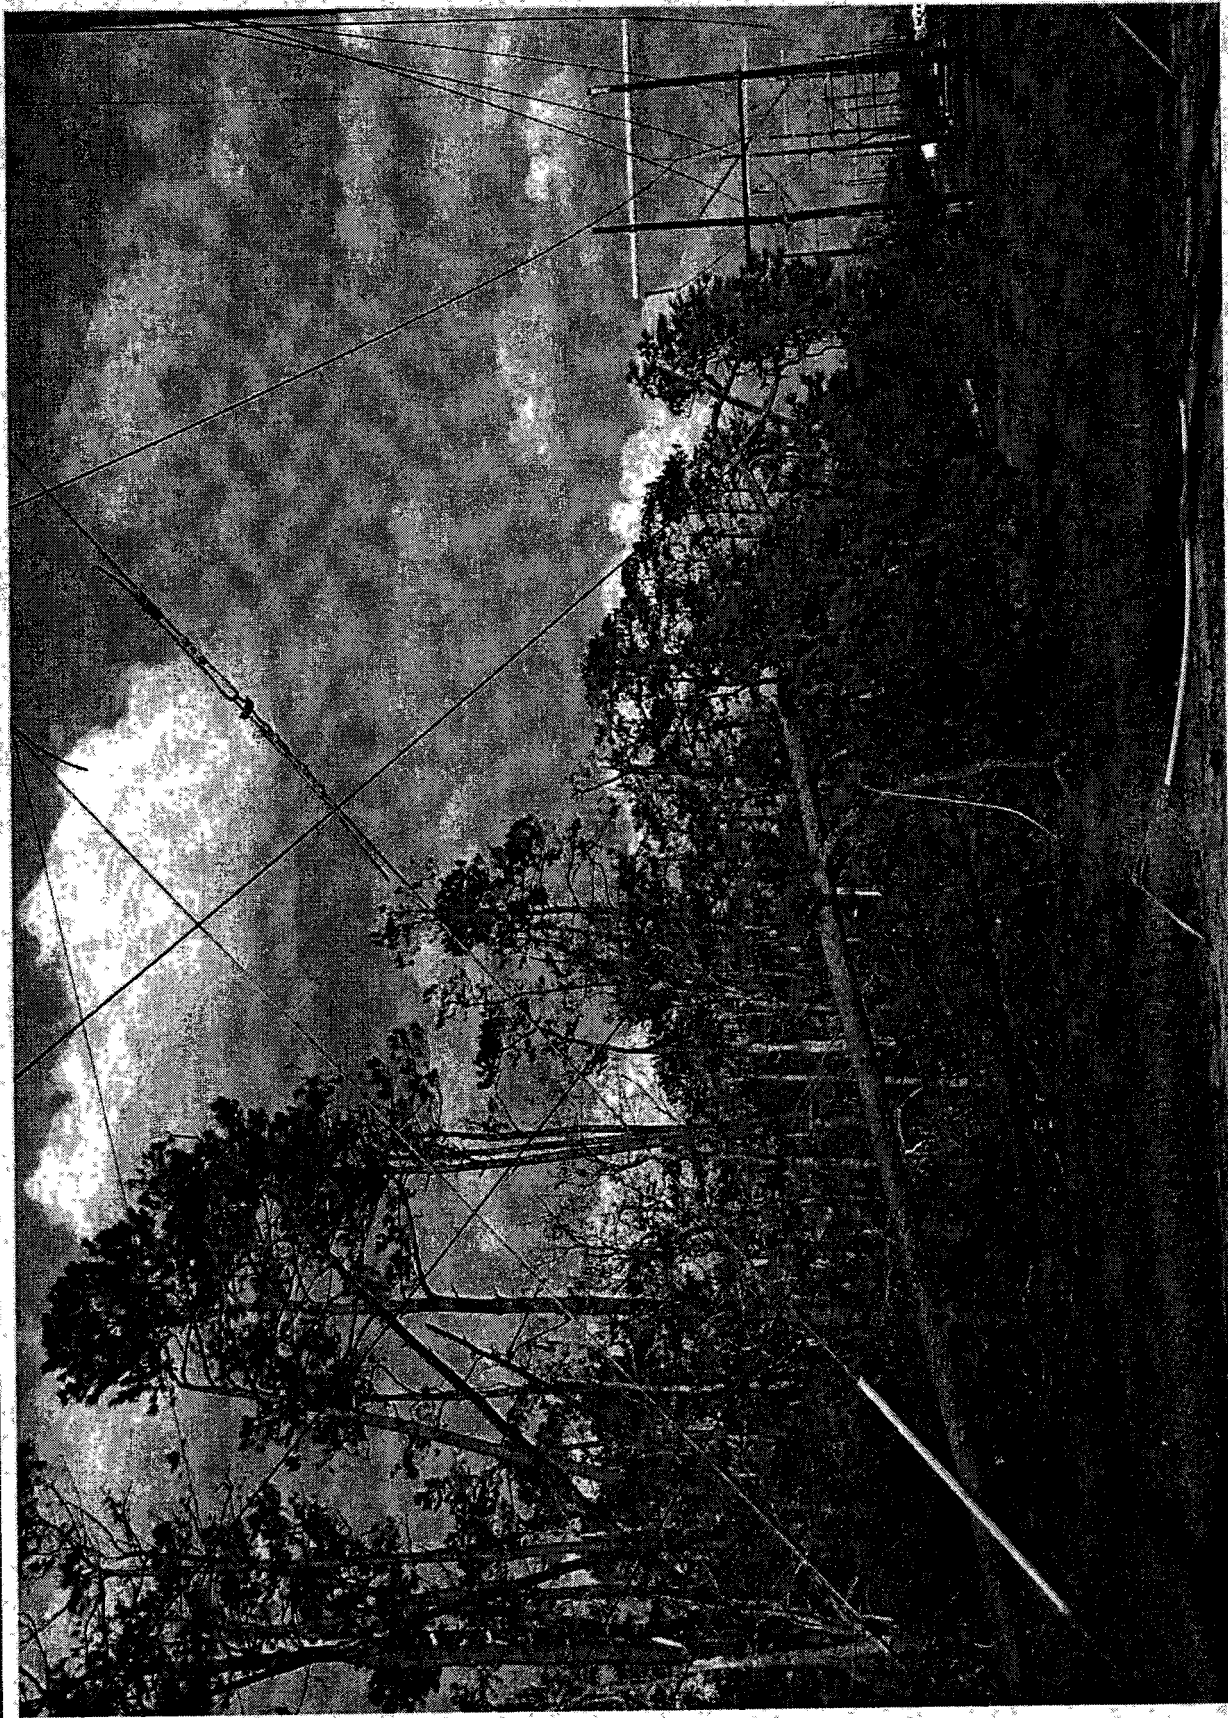
Off ROW Trees Causing Damage

- **Severe Infrastructure Damage Caused By Wind and Trees**
 - ◆ Coastal Areas experienced moderate wind damage
 - ◆ Further inland, severe damage due to falling trees due primarily to the heavy pine tree density

- ◆ Pine trees located as far away as 100 feet from power lines caused damage
 - ◆ Downed trees caused accessibility problems not only at work sites but roadways were blocked in the entire area

- Remove damaged or danger trees from outside the right of way
- Remove hanging limbs over power lines
- Environmental clean up from transformer damaged as needed
- Right of Way clean up as needed
- Patrols of distribution lines with all damages and temporary repairs corrected
- Conducted post-storm evaluation
