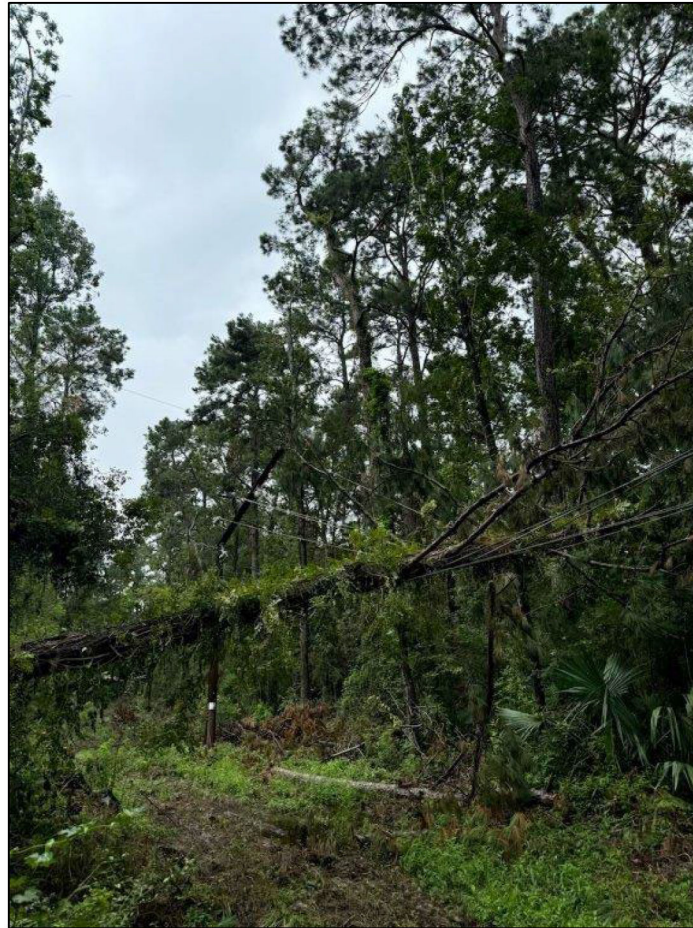
Figure RP-5
Tree outside of easement causing outage

Shows the damage caused by a tree outside the easement falling onto power lines during Hurricane Beryl. The tree contacting the power lines would create an outage and restoration would require repairing multiple poles, wires, and connections to the insulators. Note the distance of the fallen tree from the electrical equipment; this tree was well outside the easement and would not have been trimmed by CenterPoint Houston because of the distance from the electrical infrastructure, yet it managed to cause outages and damage equipment.

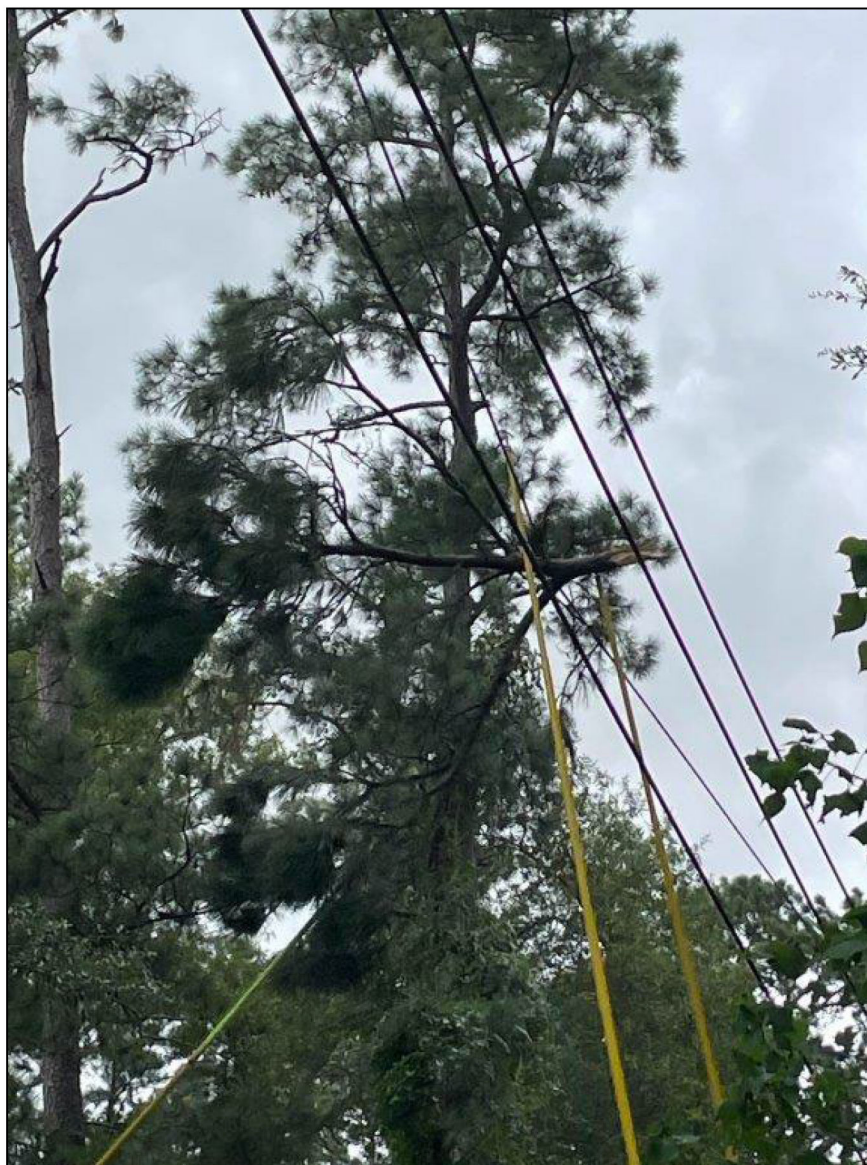
Figure RP-6
Treetop falling into power lines

Treetop entwined with electrical cables, which would cause outages. It appears the top of the tree snapped during Hurricane Beryl and flew into the power lines. It is common during high winds for debris to be blown into power lines causing outages.

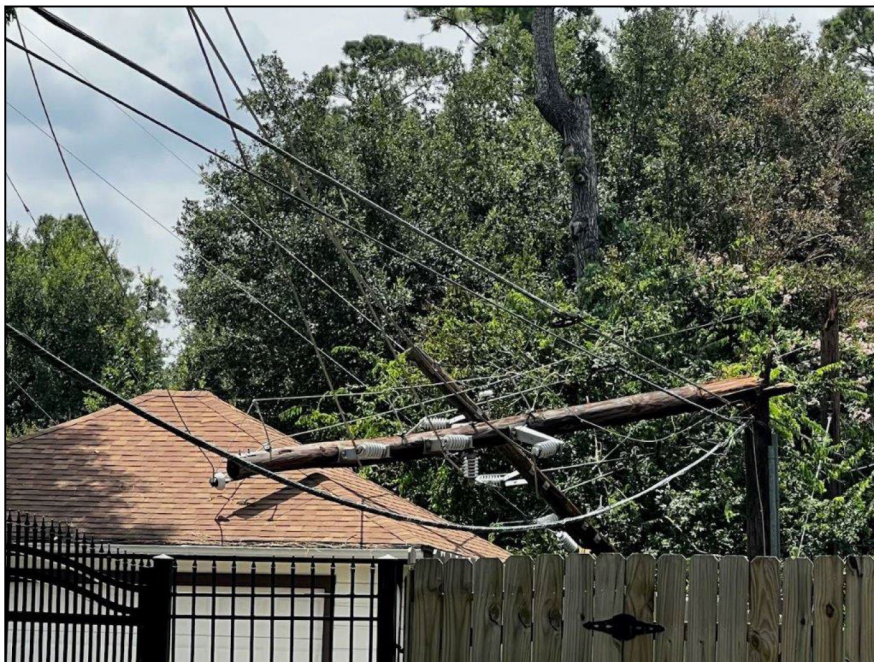
Figure RP-7
Broken poles from tree falling

Two broken poles that were damaged from falling tree sections that are now being supported by the garage roof. This damage is typical during wind events such as hurricanes.

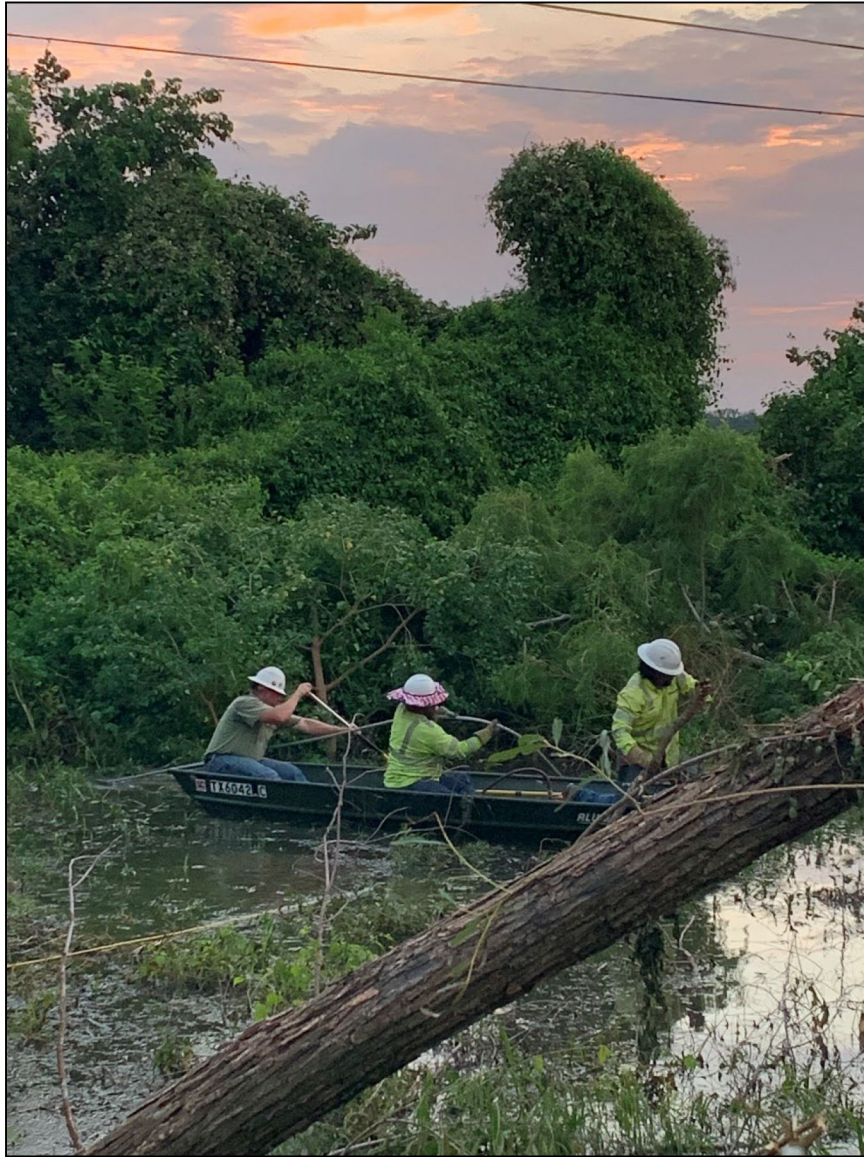
Figure RP-8
Fallen conductor in water

A crew in a boat working to collect the fallen conductor in a flooded area. The crew will then reconnect it to the existing overhead equipment to restore service. Getting access to poles and wires is a challenge during events that have flooding and significant damage.

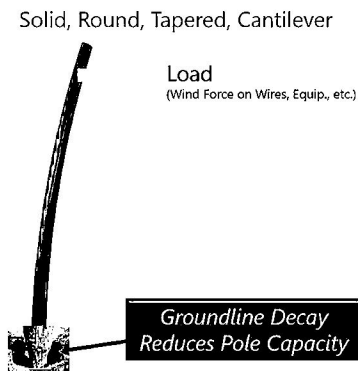
Not only is the expected break point at groundline, this is where decay is also most likely to occur and weaken the pole (see Figure 9). External decay in the groundline zone causes a significant reduction of the pole's ultimate bending capacity.

Figure 7. Decay occurs at the expected break point causing a reduction of the bending capacity.

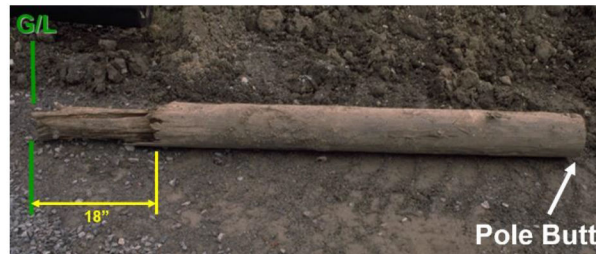
Figure 9 shows how abruptly decay in southern pine poles ends at 18 inches below groundline due to a lack of oxygen to support decay.

Figure 9. The section of a failed southern pine pole from the groundline and below.

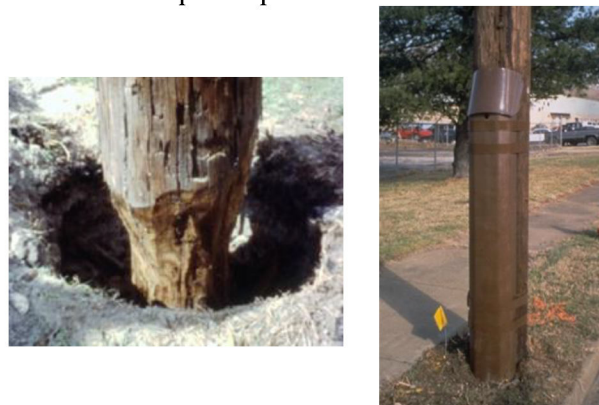
The next images show an example of more advanced shell rot which had been removed. The remaining sound wood was subsequently treated with preservative paste to prevent future decay. The bending strength was restored with the installation of a steel truss as shown on the right. Pole restoration can be completed much faster and for much less cost than pole replacement.

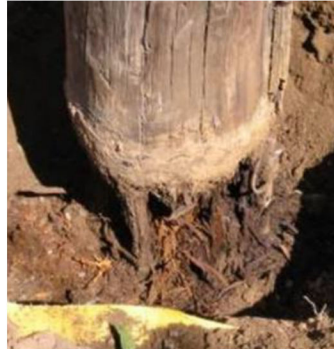
The decay process was so advanced for this pole that the only option was to replace it.
