**RE:** Project No. 38578, Energy Efficiency Implementation Project  
Under SUBST.R.25.181 (q)

## PERFORMANCE REPORT

**Heat Recovery System  
Model: Eco-Aqua TM**

### REPORT OF TEST

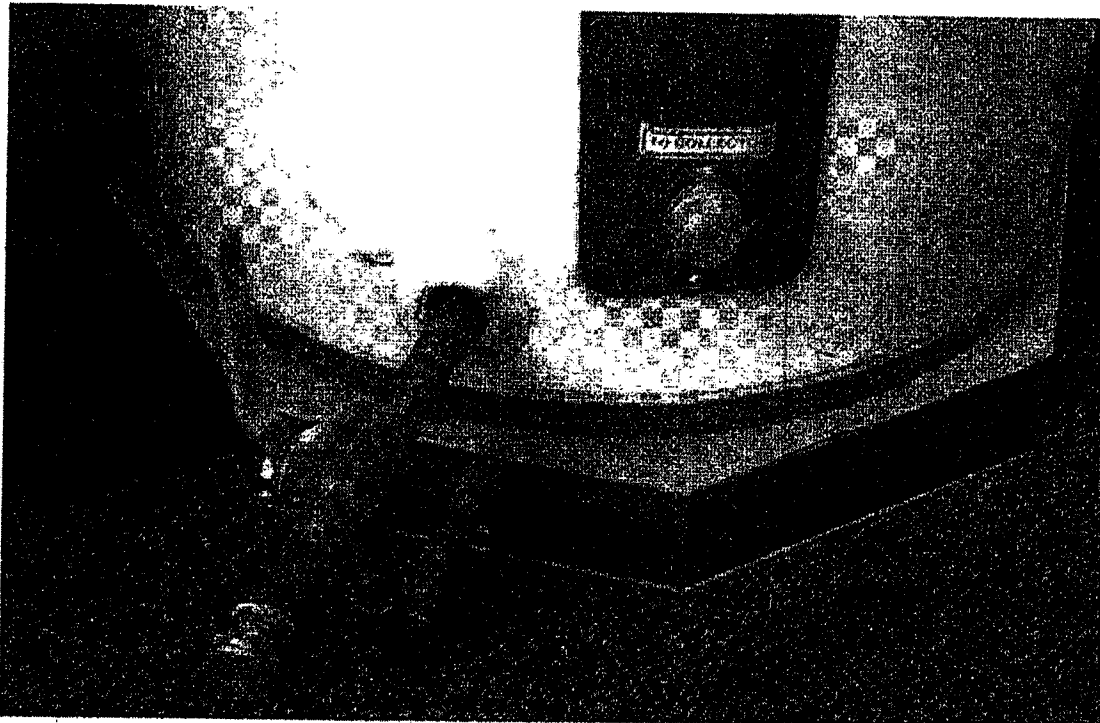
Photograph 1  
Eco-Aqua TM

- 2.1 The test system on which temperature measurements were taken was installed at Metalloy Industries, Inc, 13101 Rachael Blvd, Alachua, FL, 32615
- 2.2 The test system was attached, via seamless copper tubing of various trade sizes, to the condensing unit of a 3-ton Carrier Heat Pump and a Rheem Solaride Water Heater. Apollo tempering and flush valves were also used
- 2.3 The outlet of the heat pump's compressor (discharge) was rerouted and connected to the refrigerant inlet of the Eco-Aqua TM. The refrigerant outlet of the Eco-Aqua TM was then routed back to the heat pump and connected to the inlet of the condensing coil.

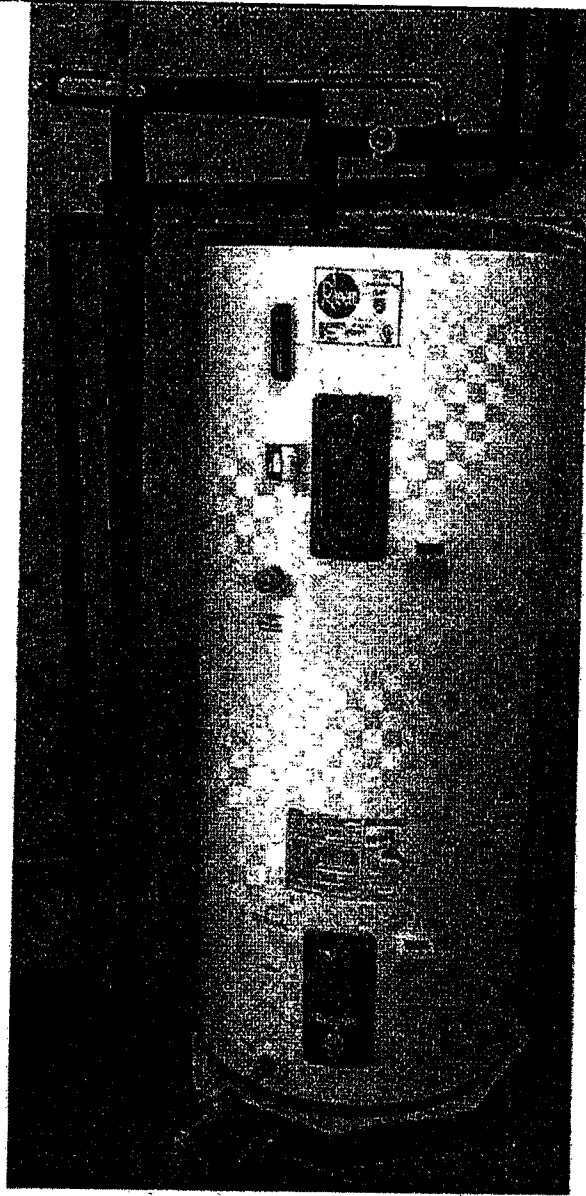
**Photograph 2**  
**Installed Test System**

- 2.4 Cold, city water was supplied to the top of the water heater where it was routed, via tubing, to the bottom of the tank. The cold water exited the bottom of the tank and was connected to the water inlet of the Eco-Aqua TM. The water outlet of the Eco-Aqua TM was routed back to the top of the tank via a heat riser. Hot water was then piped to two (2) sink faucets (Right and Left) located at a distance of approximately sixty (60) feet from the tank.
- 2.5 The hot water source of the Right Sink Faucet was connected to the Eco-Aqua TM.
- 2.6 The hot water source of the Left Sink Faucet was not connected to the Eco-Aqua TM. It was connected to a separate electric hot water heater without any modifications.

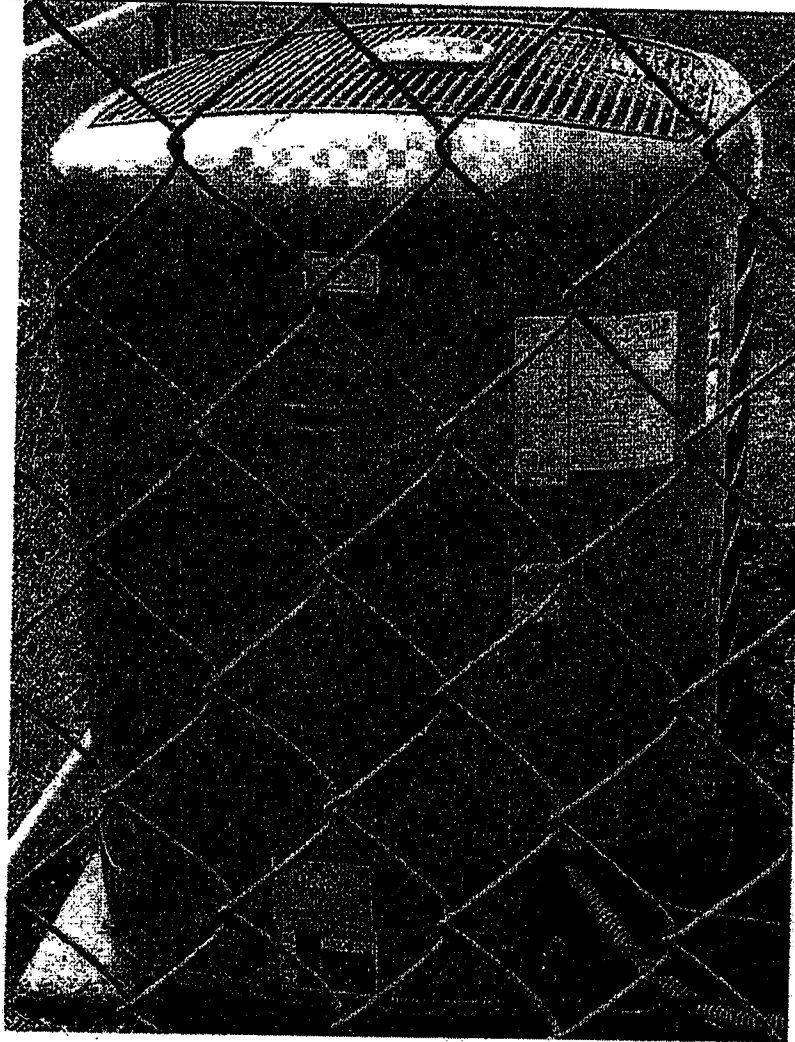
**Photograph 3**  
**Condensing Unit of 3-ton Carrier Heat Pump**
