Re: Notice of Violation for Public Water Supply Comprehensive Compliance Investigation at:
New Forest Estates Water System, Kountze (Hardin County), Texas
Regulated Entity No.: 102686474, PWS ID No.: 1000062; Investigation No.: 1887664

New Forest Estates Water System

Regulated Entity: New Forest Estates Water System

PWS ID: 1000062

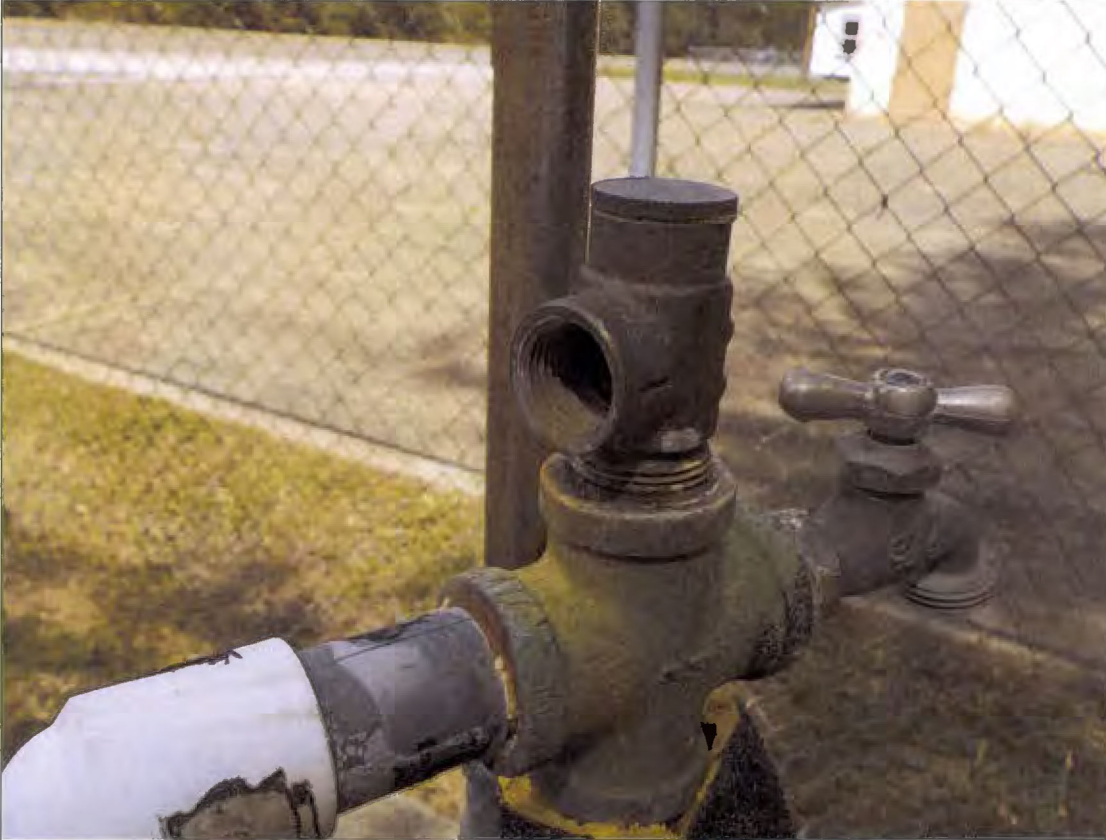
During the investigation, it was noted that the water system did not provide 16-mesh, corrosion-resistant screening material on the openings from the two air release devices on Well No. 1.

Photograph documenting one of the two air release devices on Well No. 1 that did not have their openings covered with 16-mesh corrosion-resistant screening material.

Recommended Corrective Action: Cover all openings to the atmosphere with 16-mesh or finer, corrosion-resistant screening material or an acceptable equivalent.

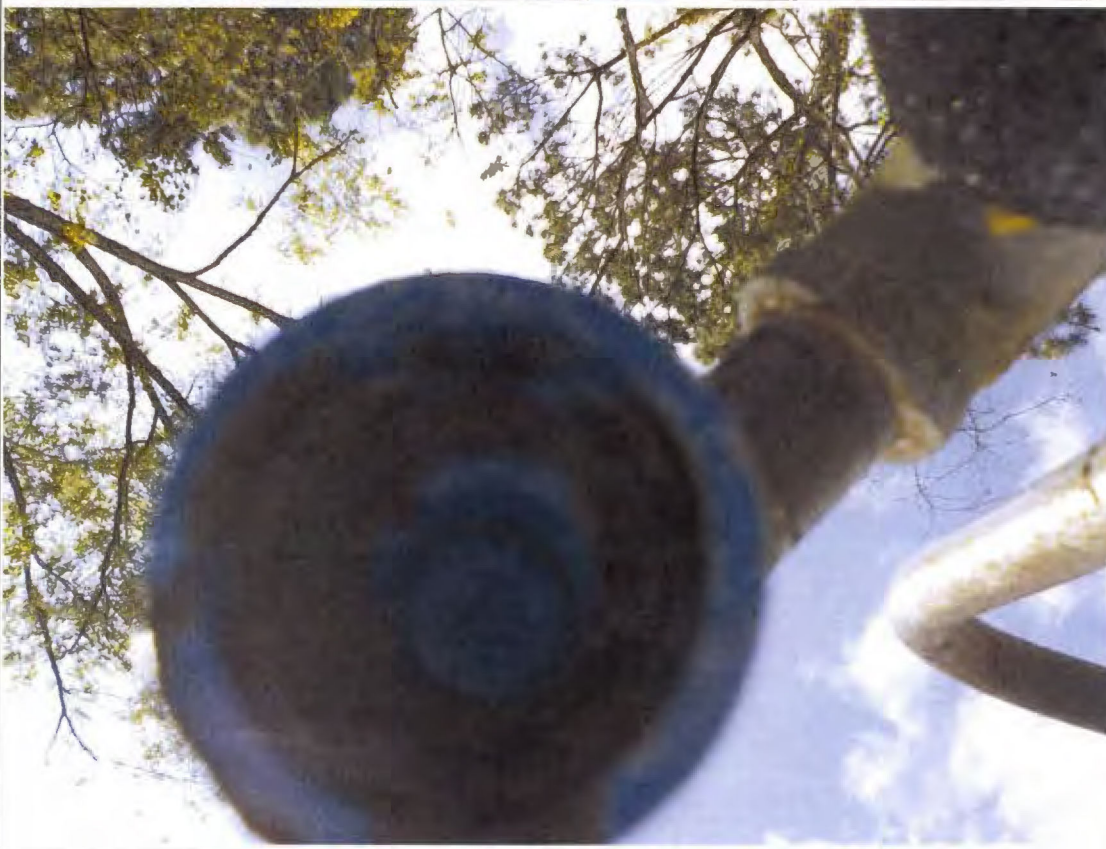
Photograph documenting the second air release device on Well No. 1 that did not have its opening covered with 16-mesh corrosion-resistant screening material.

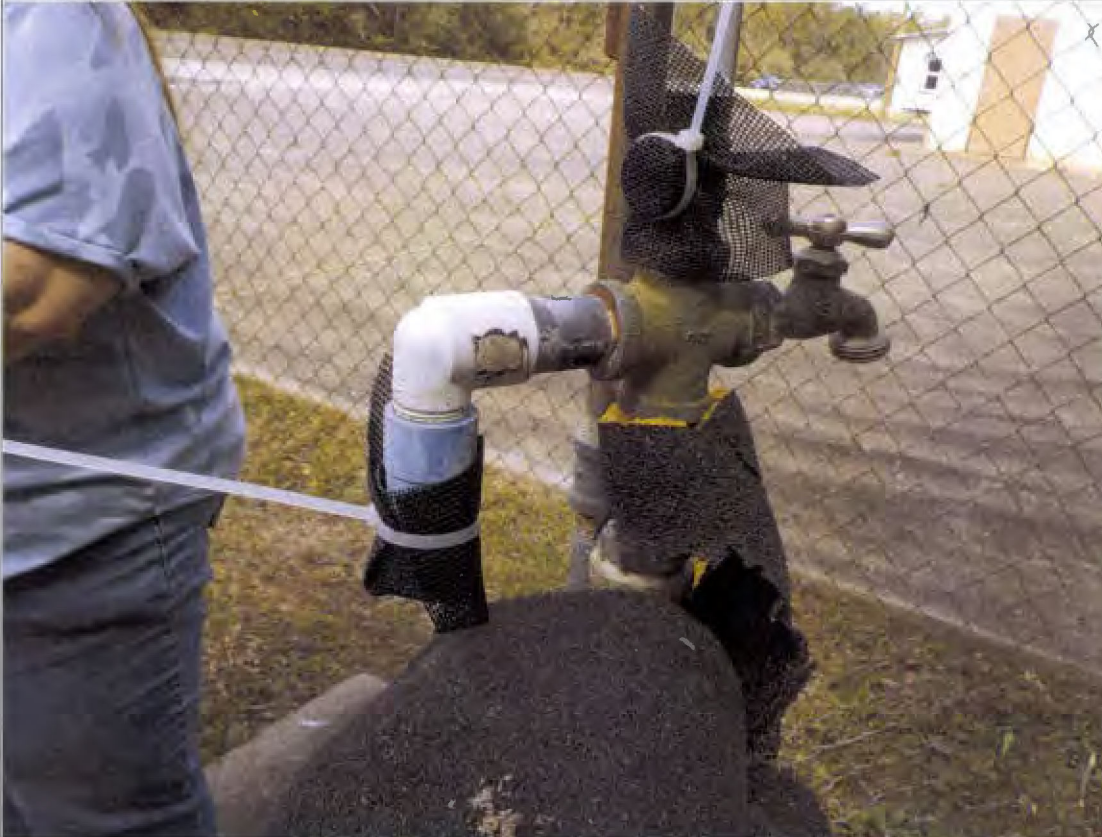
Photograph documenting the two air releases on Well No. 1 after the water system covered their openings with 16-mesh corrosion-resistant screening material.

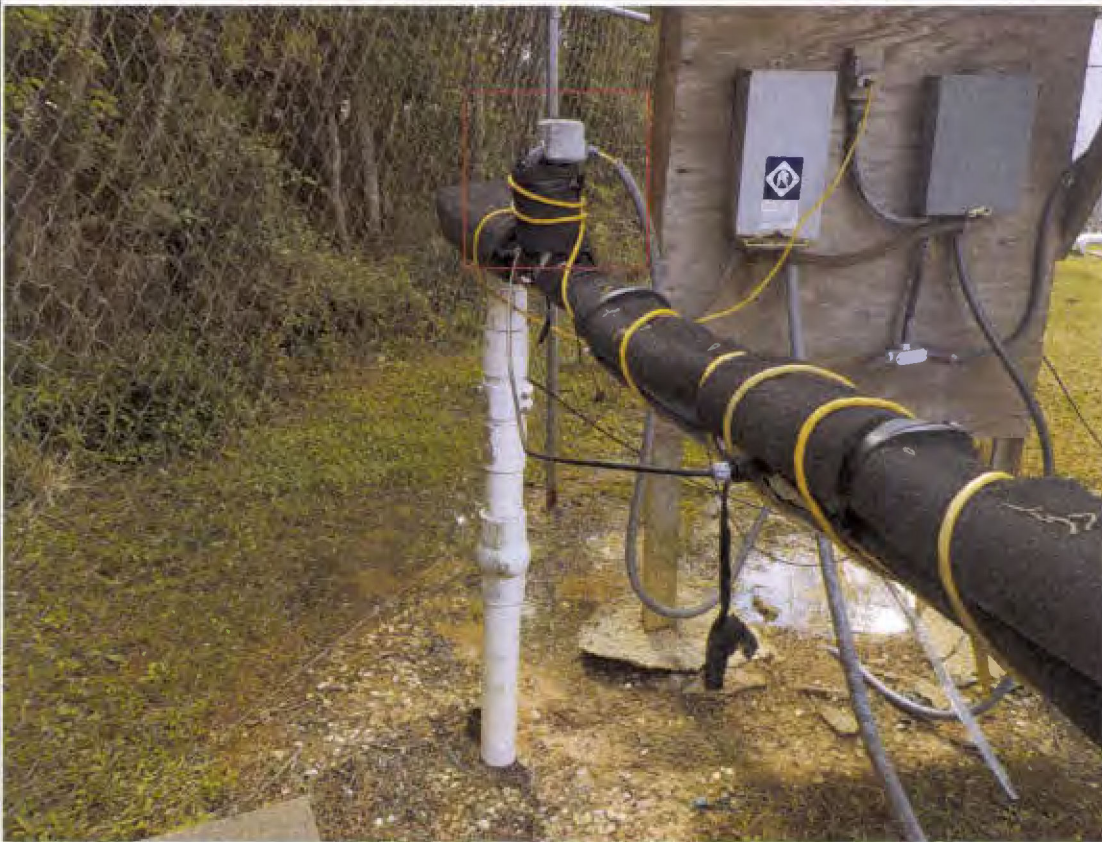
During the investigation, it was noted that the conduit tubing covering the wiring for Well No. 1's pressure switch was detached from the pressure switch's housing. Because of this, the pressure switch's electrical wiring was exposed. The water system stated that the water system plans to have an electrician come to the water treatment plant to ensure that all water system electrical wiring is properly installed. On April 10, 2023, the water system submitted a copy of a work order showing that one had been created to repair or replace the exposed wires that were noted at the water treatment plant.

Photograph documenting the wiring for Well No. 1's pressure switch, which was detached from the pressure switch's housing. Because of this, the pressure switch's electrical wiring was exposed.

Recommended Corrective Action: Repair or replace conduit tubing covering the wiring for Well No. 1's pressure switch so it is securely attached to the pressure switch's housing. Submit photographic documentation of the repaired conduit tubing to the Beaumont Regional Office.

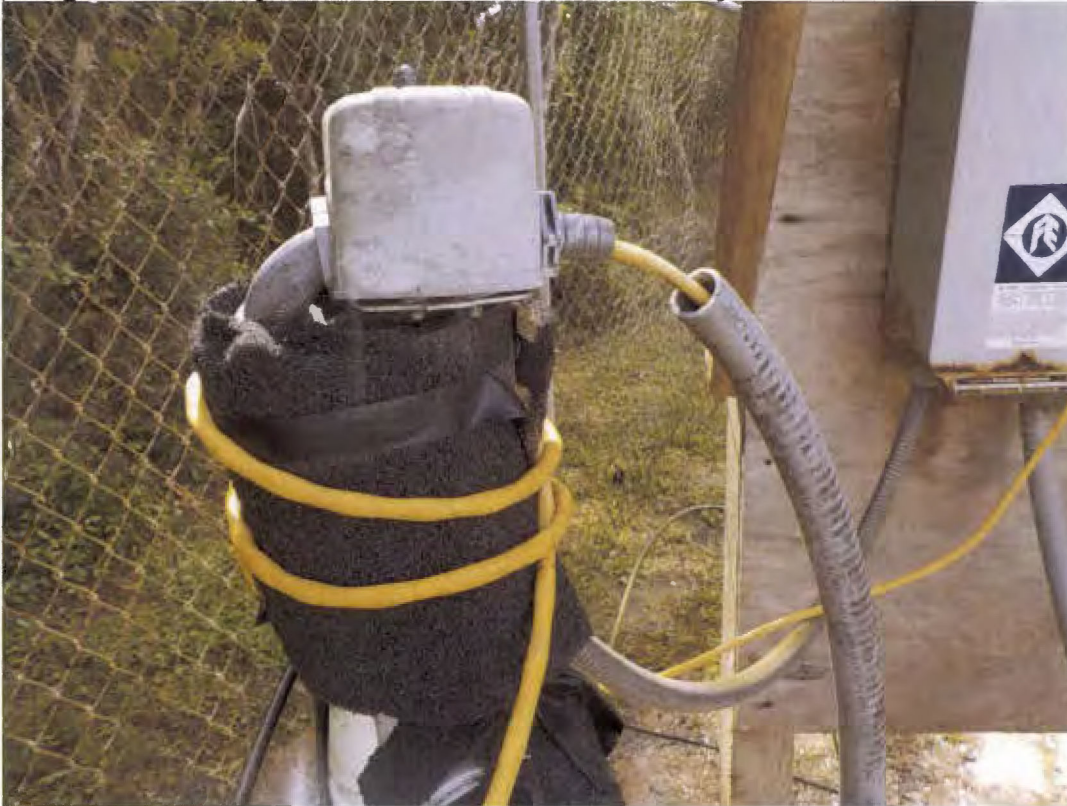
Photograph documenting a closer view of the wiring for Well No. 1's pressure switch, which was detached from the pressure switch's housing. Because of this, the pressure switch's electrical wiring was exposed.

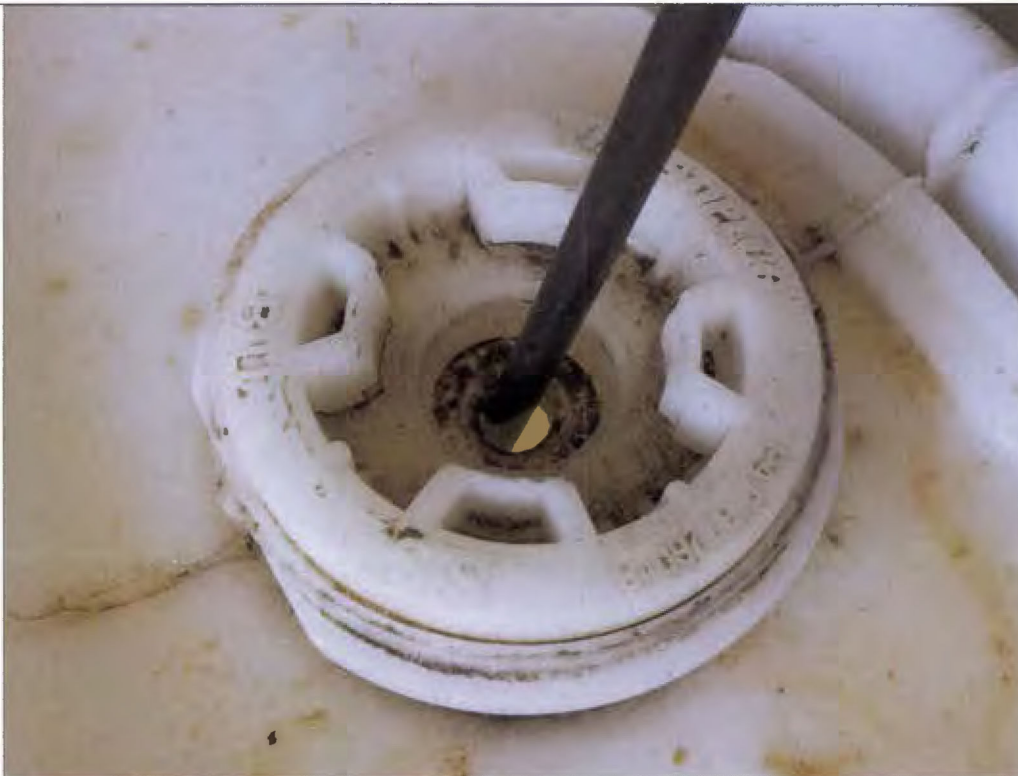
During the investigation, it was noted that there was a gap in the top of the Azone 15 sodium hypochlorite solution container between its cap and the chemical injection line. On April 10, 2023, the water system submitted a copy of a work order showing that one had been created to install grommets on the chemical barrels maintained at the water treatment plant to seal the openings to the atmosphere.

Photograph documenting the gap in the top of the Azone 15 sodium hypochlorite solution container between its cap and the chemical injection line.

Recommended Corrective Action: Seal the gap in the top of the Azone 15 sodium hypochlorite solution container between its cap and the chemical injection line. Submit photographic documentation to the Beaumont Regional Office.

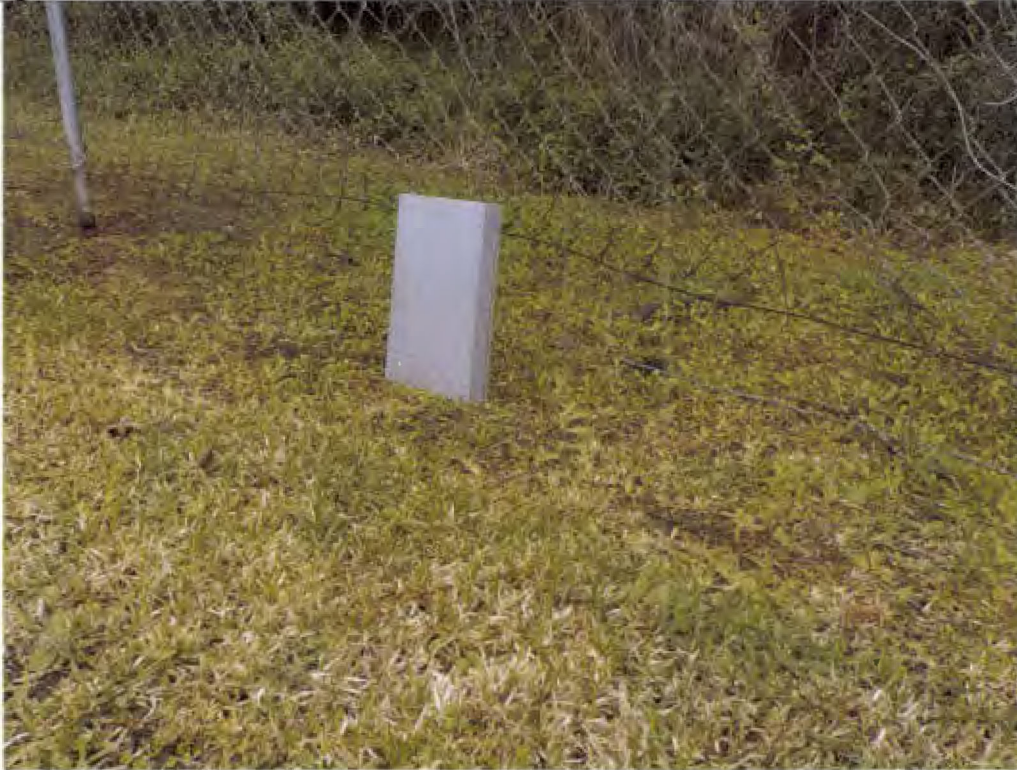
During the investigation, it was noted that the middle strand of barbed wire along the top of the back-left section of the fence was broken and that the three strands of barbed wire along the top of the back side of the fence was loose and tangled. It was also noted the following sections of the fence either had a large gap under the fence or were loose enough that the bottom could be pulled upward and potentially allow entry into the water treatment plant: the left-back side, the middle-back to right-back side, the back-right side, and the front-middle to front-right side. Please note that there was one strand of barbed wire blocking the gaps under the back side of the fence, two strands of barbed wire blocking the gaps under the left side of the fence, and no strands of barbed wire under the front-middle to front-right side of the fence. The water system stated that they are currently planning to repair the intruder resistant fence at the water treatment plant. On April 10, 2023, the water system submitted a copy of a work order showing that one had been created to repair the fence at the water treatment plant.

Photograph documenting the large gap under the middle-back to right-back side of the water treatment plant's fence that were loose enough that the bottom could be pulled upward and potentially allow entry into the water treatment plant. Please note that there was one strand of barbed wire blocking the gaps under the back side of the fence.

Recommended Corrective Action: Repair all fence issues noted above. Submit photographic documentation of each repaired issue to the Beaumont Regional Office.

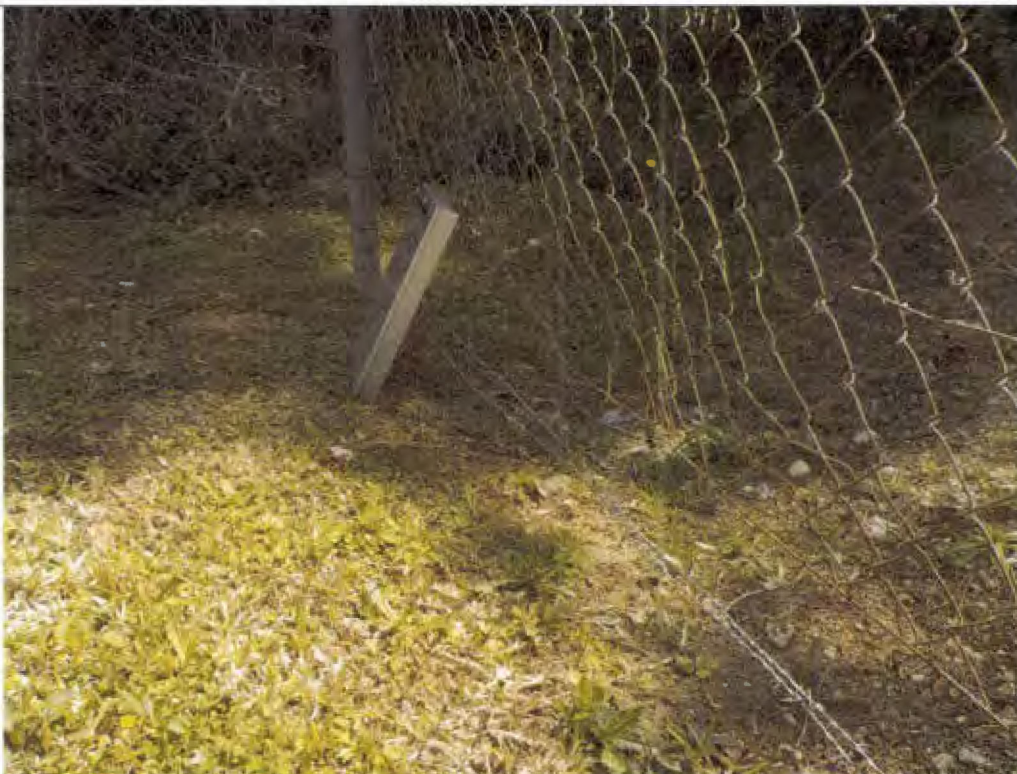
Photograph documenting the large gap under the back-right side of the water treatment plant's fence that were loose enough that the bottom could be pulled upward and potentially allow entry into the water treatment plant. Please note that there were two strands of barbed wire blocking the gaps under the left side of the fence.

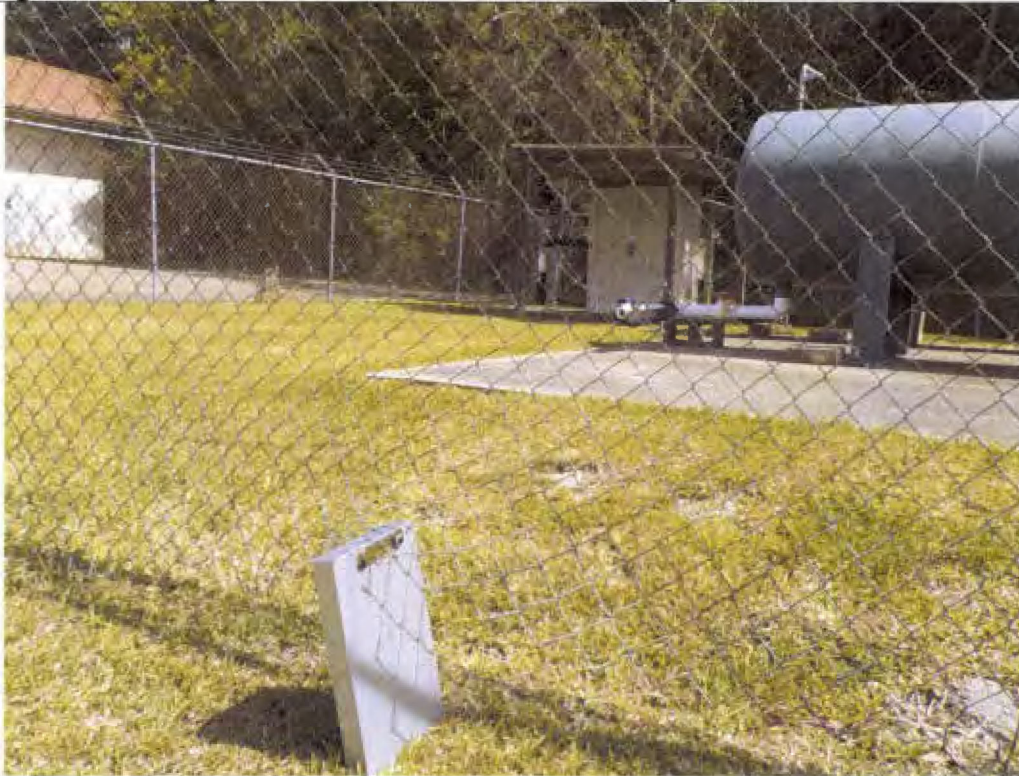
Photograph documenting the large gap under the front-middle to front-right side of the water treatment plant's fence that were loose enough that the bottom could be pulled upward and potentially allow entry into the water treatment plant. Please note that there were no strands of barbed wire under the front-middle to front-right side of the fence.

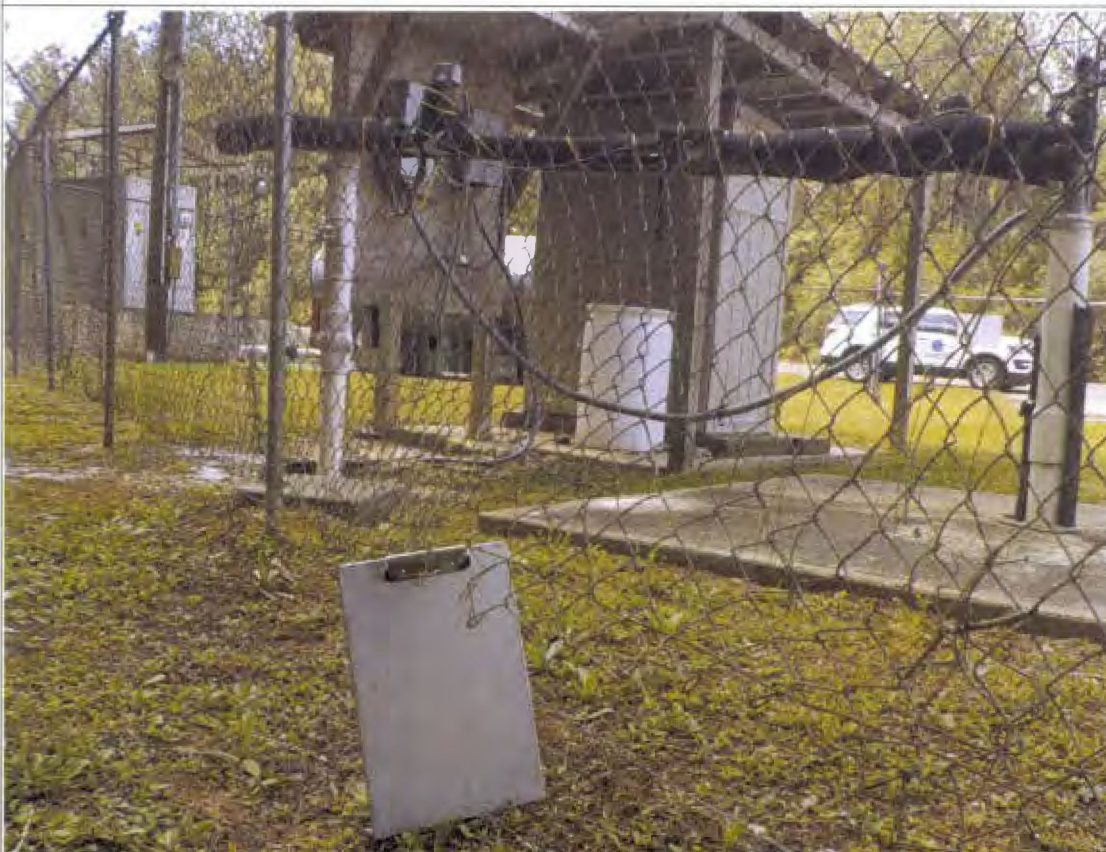
Photograph documenting the large gap under the left-back side of the water treatment plant's fence that were loose enough that the bottom could be pulled upward and potentially allow entry into the water treatment plant. Please note that there was one strand of barbed wire blocking the gaps under the back side of the fence.

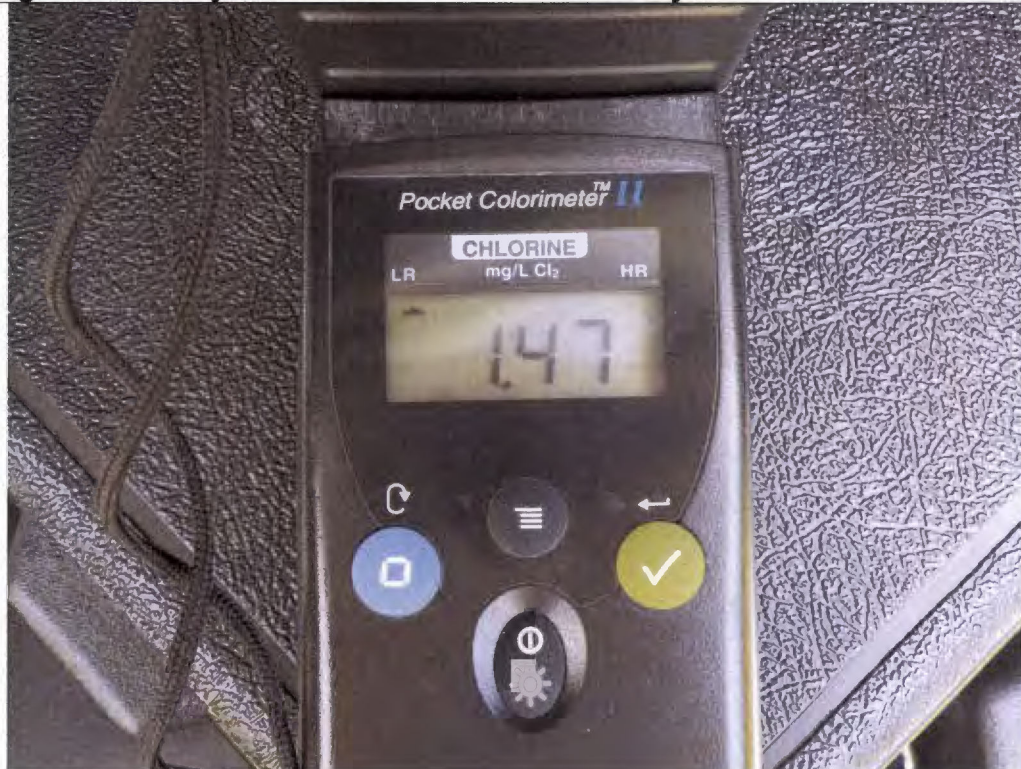
Photograph documenting the free chlorine residual that was documented at 3565 New Forest after flushing for approximately three minutes.

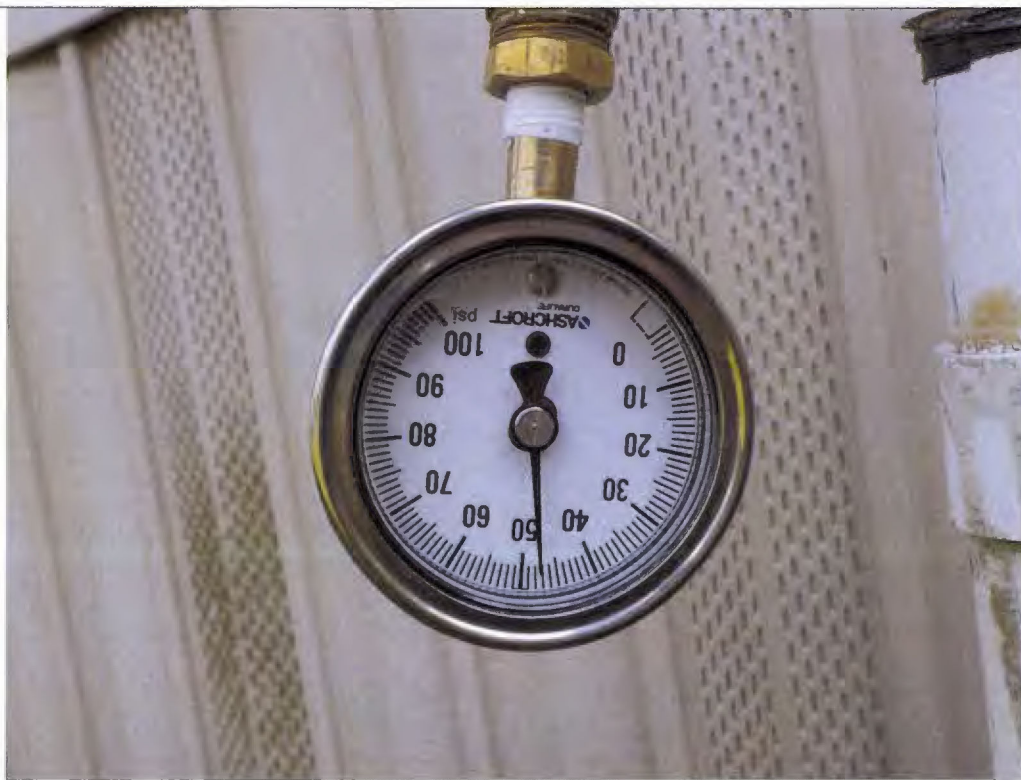
Photograph documenting the pressure reading that was documented at 3565 New Forest.
