Texas Commission on Environmental Quality

Dairyland Heights Water System

PWS ID No. 1000065

Investigation No. 1887692

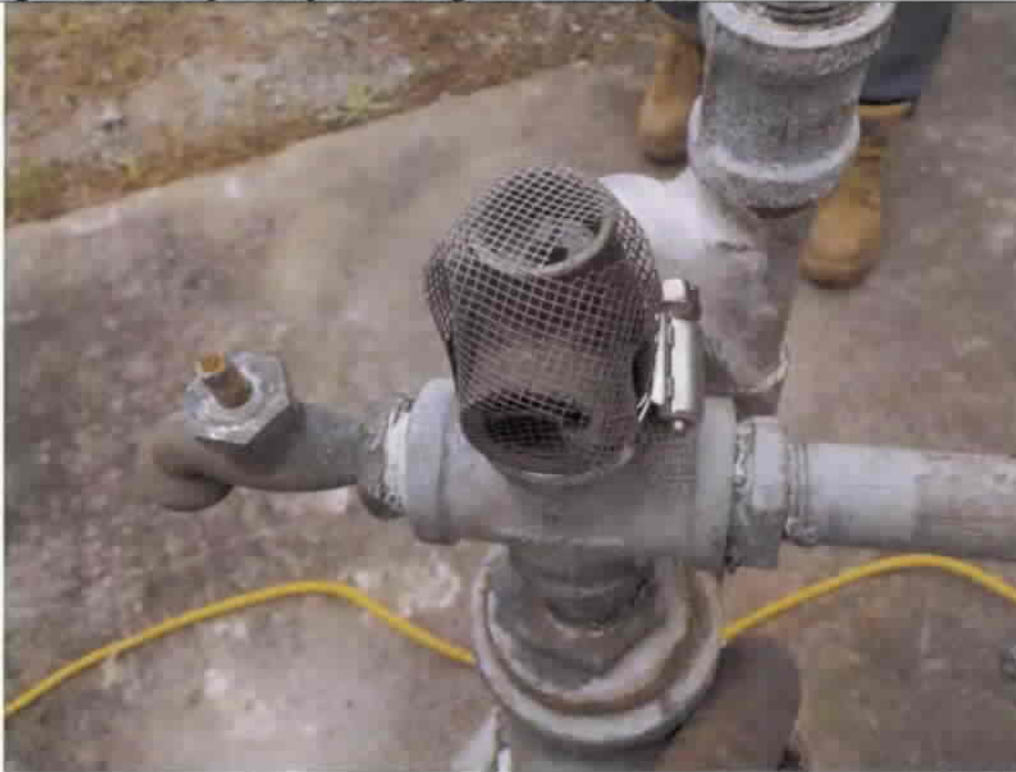
Photograph documenting one of the holes in the 16-mesh screening material attached to the air release device for Well No. 1.

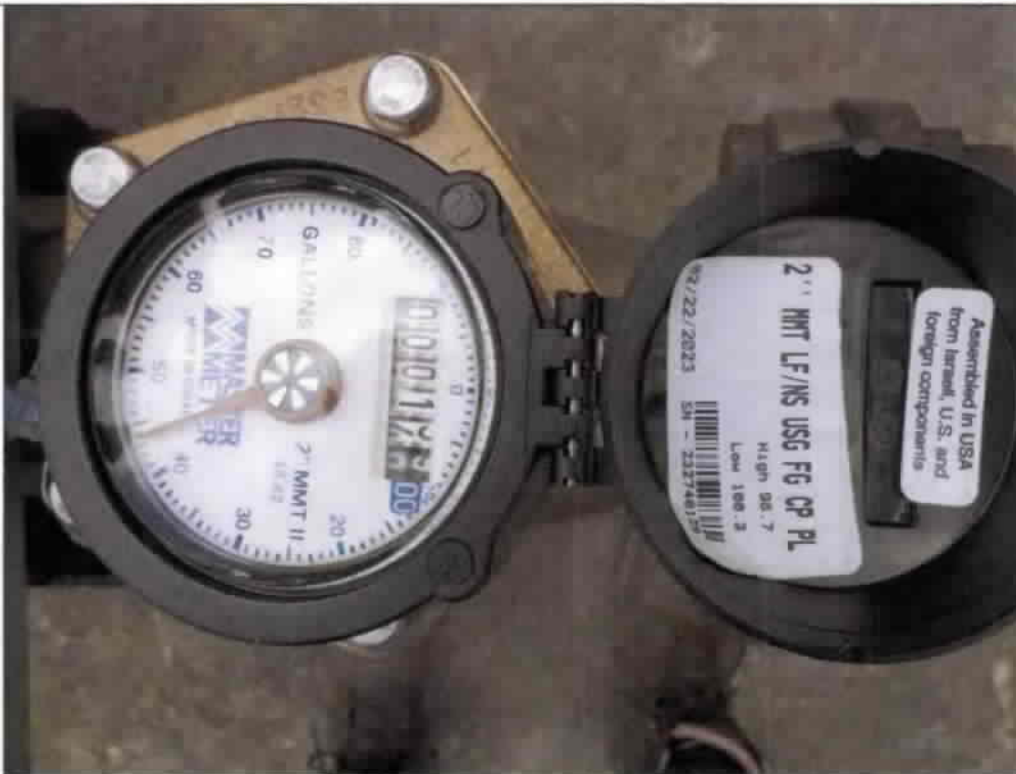
Photograph documenting the recently replaced well meter for Well No. 1.

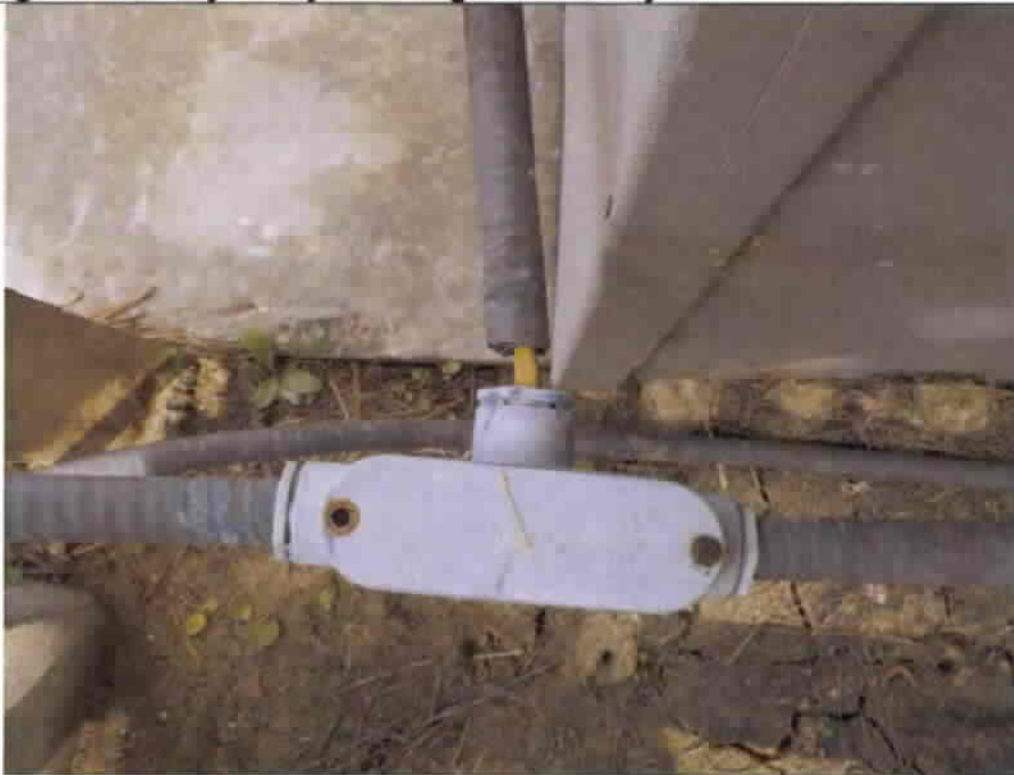
Photograph documenting the conduit tubing covering the electrical wiring for the chemical storage room, which was disconnected at the top of the electrical box located behind the chemical container housing.

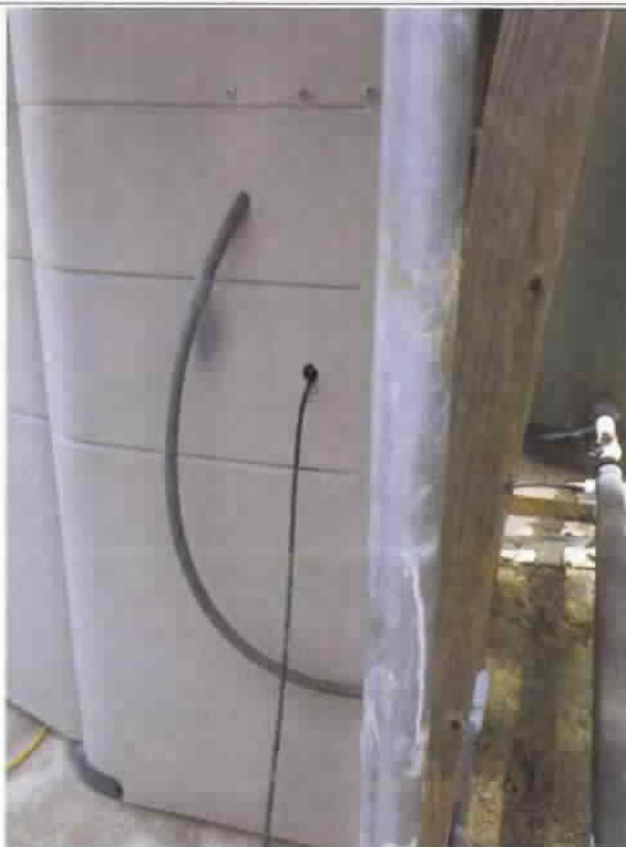
Photograph documenting the conduit tubing covering the electrical wiring for the chemical storage room, which was disconnected at the top of the electrical box located behind the chemical container housing.

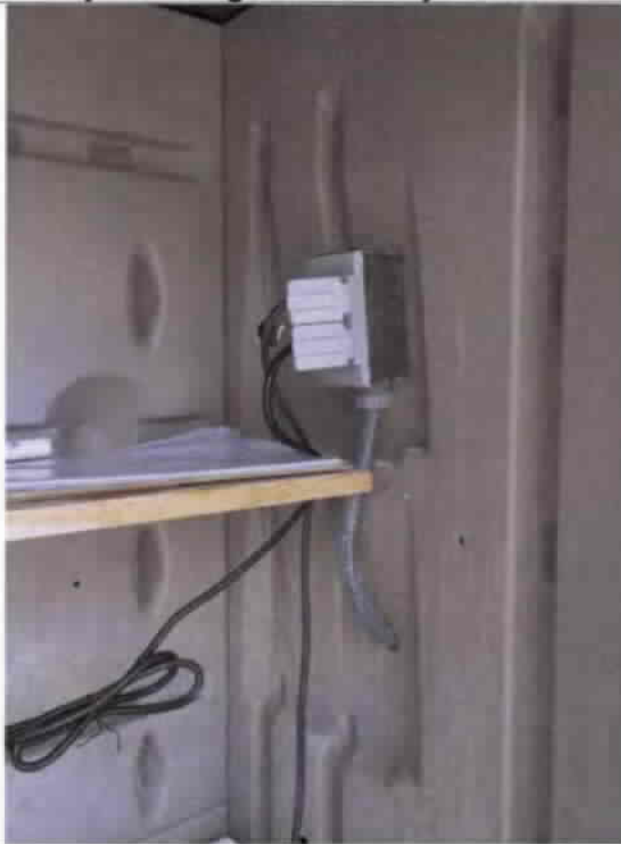
Photograph documenting the conduit tubing covering the electrical wiring for the chemical storage room, which was disconnected at the top of the electrical box located behind the chemical container housing.

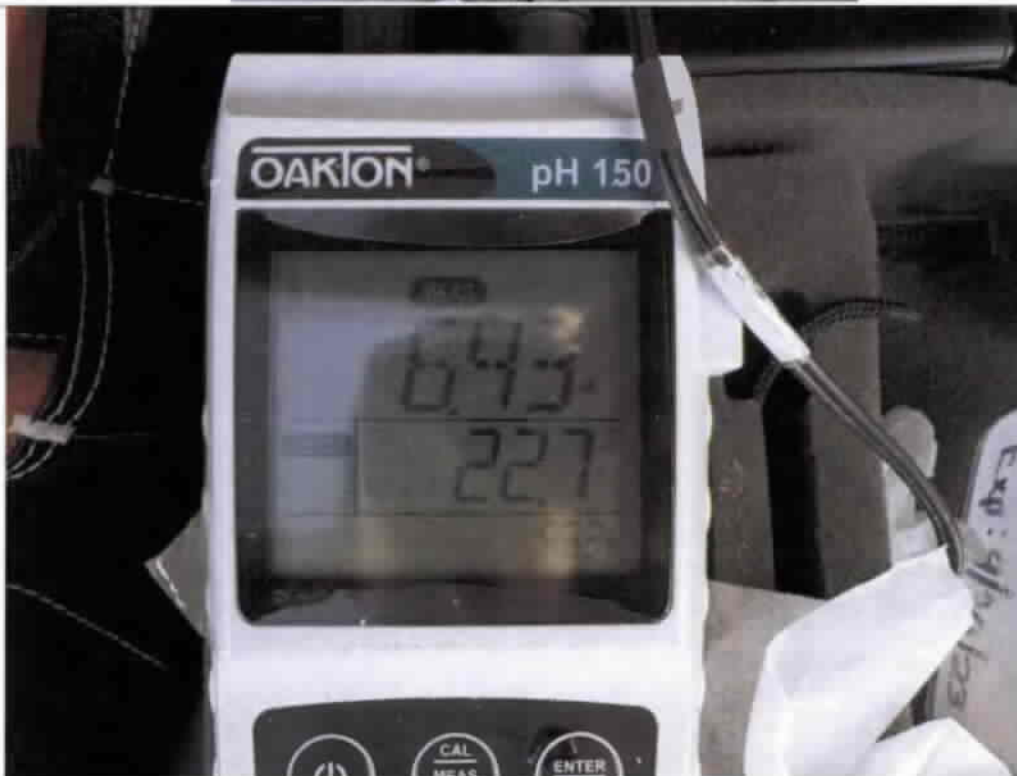
14	PV	290.118(b) (Potential Violation)	Failure by Blue Topaz Utilities – Dairyland Heights Water System to to comply with the Secondary Constituent Level of 7.0 s.u. for pH. Still need to speak with the TCEQ Water Supply Division regarding the low pH that was documented at EP001.
15	RR	Records Request	Submit the following documentation to the Beaumont Regional Office within 14 days from today: the 2022 tank evaluations conducted by Blue Topaz Utilities prior to the purchase of the water system and the customer complaint records for Amanda Russ, Ashley Viator, and Gina Lee, who were noted to have also reported issues with the water in Dairyland Heights according to the December 23, 2022 customer complaint record for 2159 Whitehead Road. Please note that this documentation was not available for review during the investigation.

Photograph documenting the pH that was documented at Entry Point No. 1.

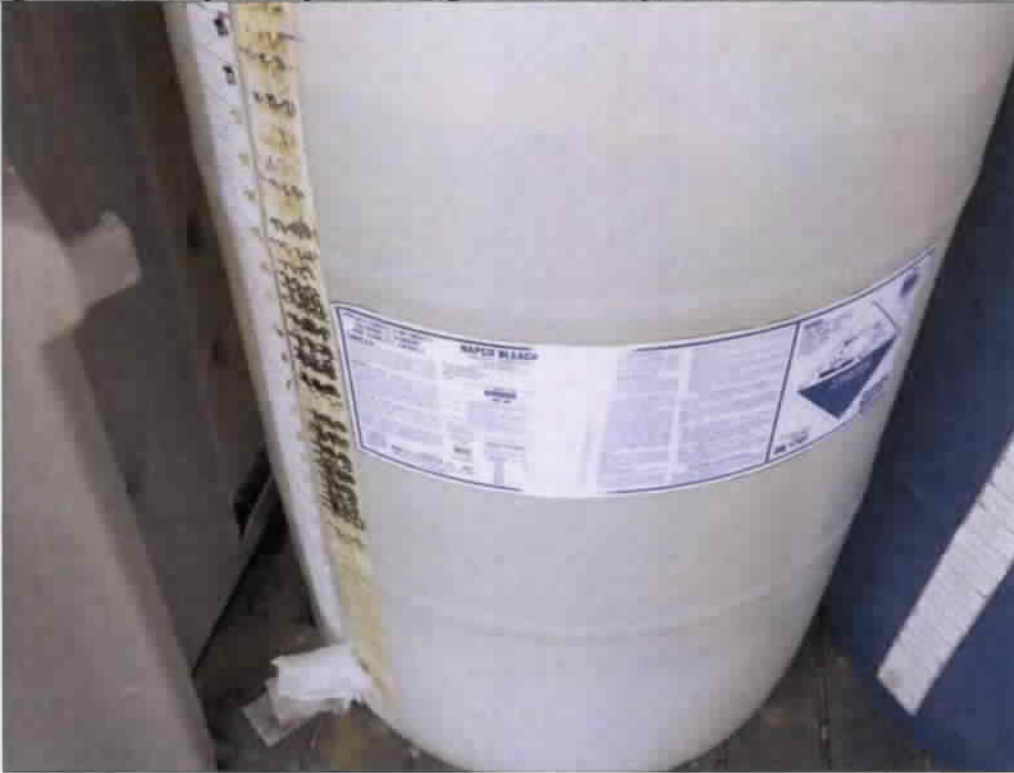
Photograph documenting the sodium hypochlorite storage container.

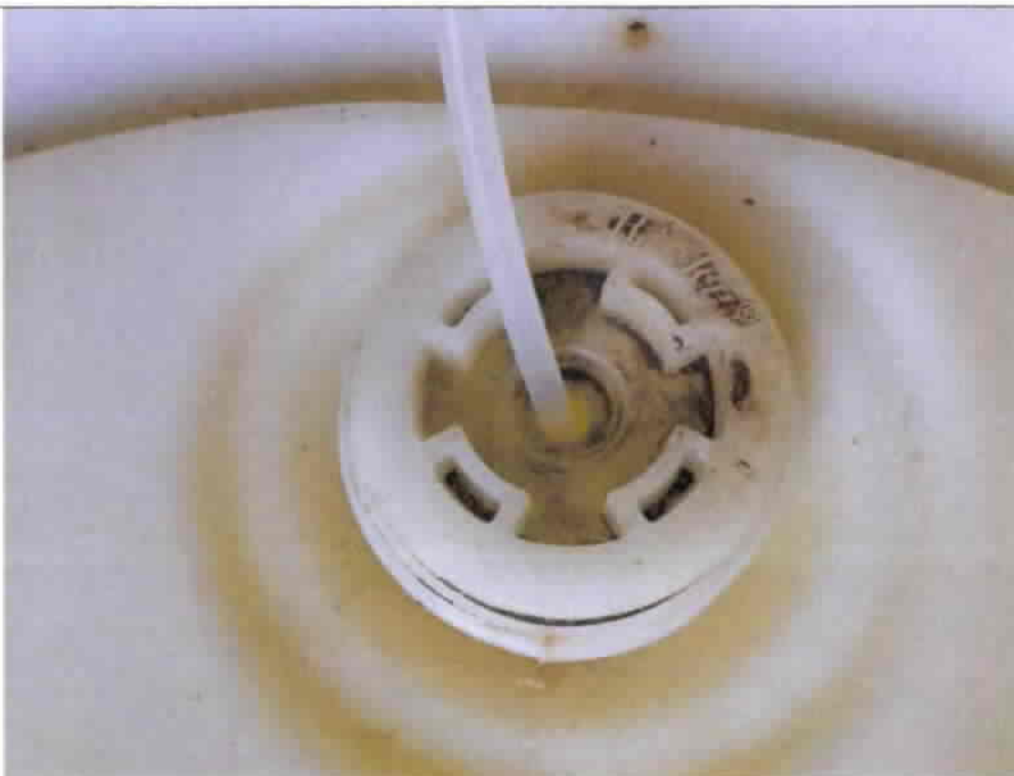
11	AV	290.42(e)(5) (Outstanding)	Failure by Blue Topaz Utilities – Dairyland Heights Water System to completely cover the top of the hypochlorination solution to prevent the entrance of dust, insects, and other contaminants. During the investigation, it was noted that there was a gap in the top of the sodium hypochlorite solution container between its cap and the chemical injection line.

Photograph documenting the gap in the top of the sodium hypochlorite solution container between its cap and the chemical injection line.

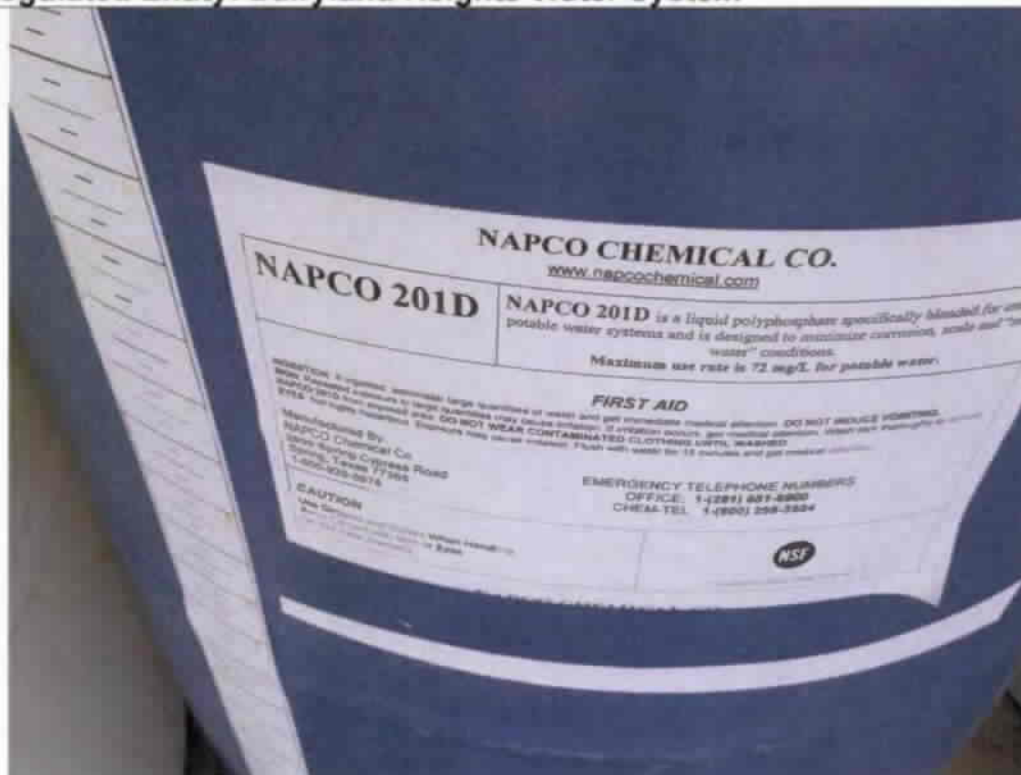
Photograph documenting secondary containment for the NAPCO 201D storage container.

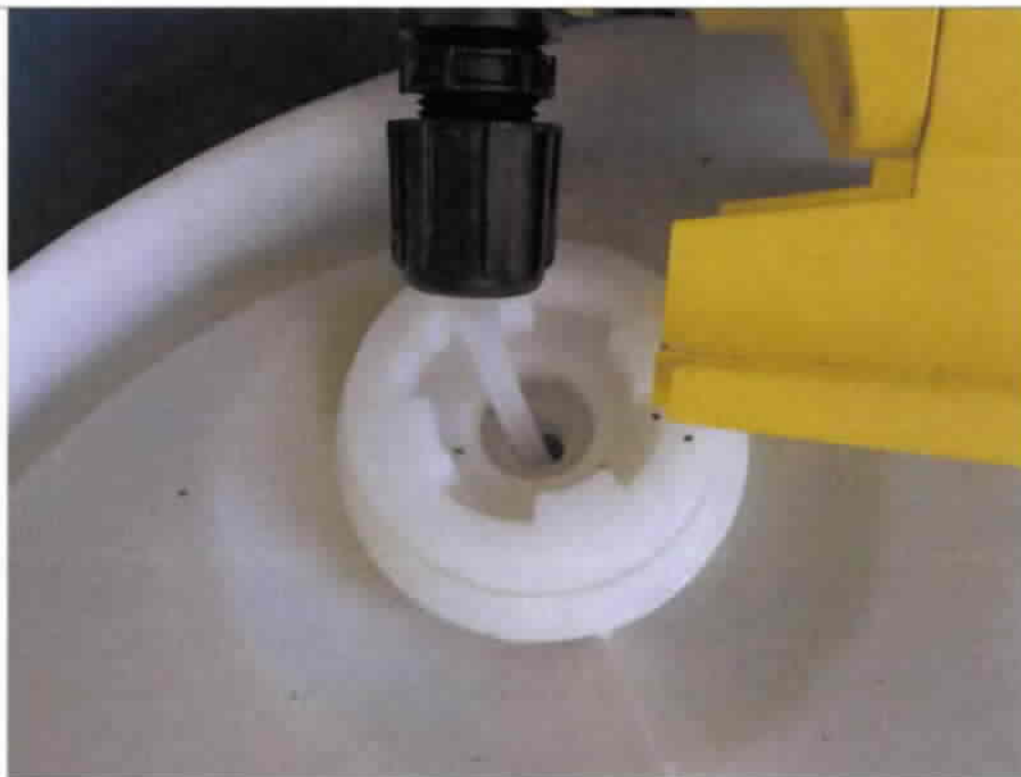
During the investigation, it was noted that there was a gap in the top of the NAPCO 201D solution container between its cap and the chemical injection line. It is suggested that the water system seals the noted gap to ensure that dust, insects, and other contaminants do not contaminate the water system's supply of NAPCO 201D. On April 19, 2023, the water system submitted photographic documentation showing that the water system had obtained new caps for the chemical storage tanks at the water treatment plant, and the water system stated that the hole in this cap was reduced in size to fit the chemical injection line tubing. Please note, however, that no photographic documentation was provided to show that the new cap had been installed on the NAPCO 201D storage container.

Photograph documenting the gap in the top of the NAPCO 201D storage container between its cap and the chemical injection line.

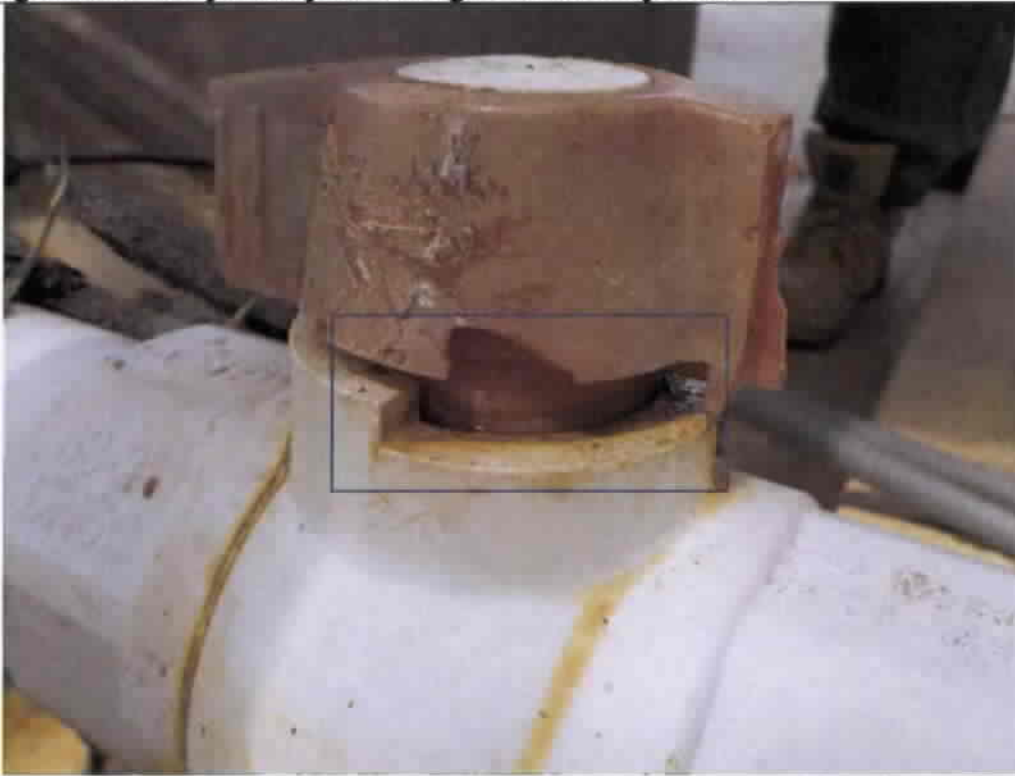
Photograph documenting the leak in the crease of the gate valve located near Pressure Tank No. 1 between the pressure tank and Well No. 1.

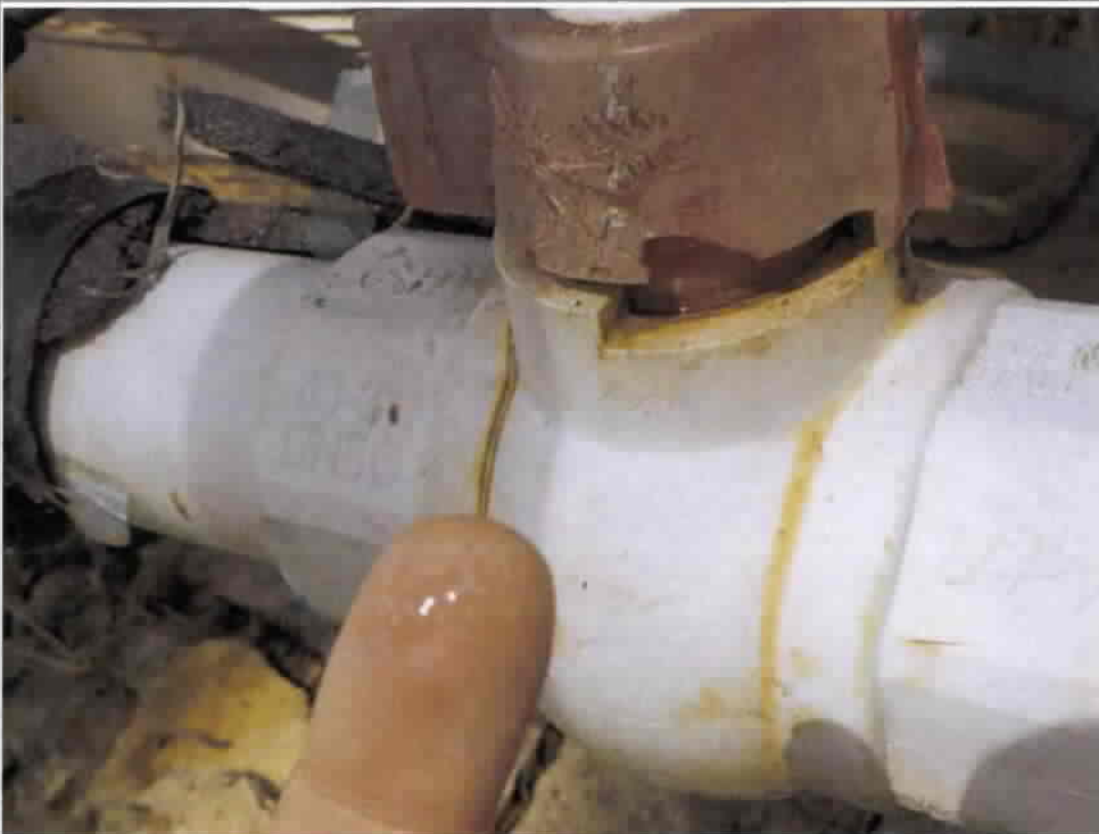
Photograph documenting the leak in the crease of the gate valve located near Pressure Tank No. 1 between the pressure tank and Well No. 1.

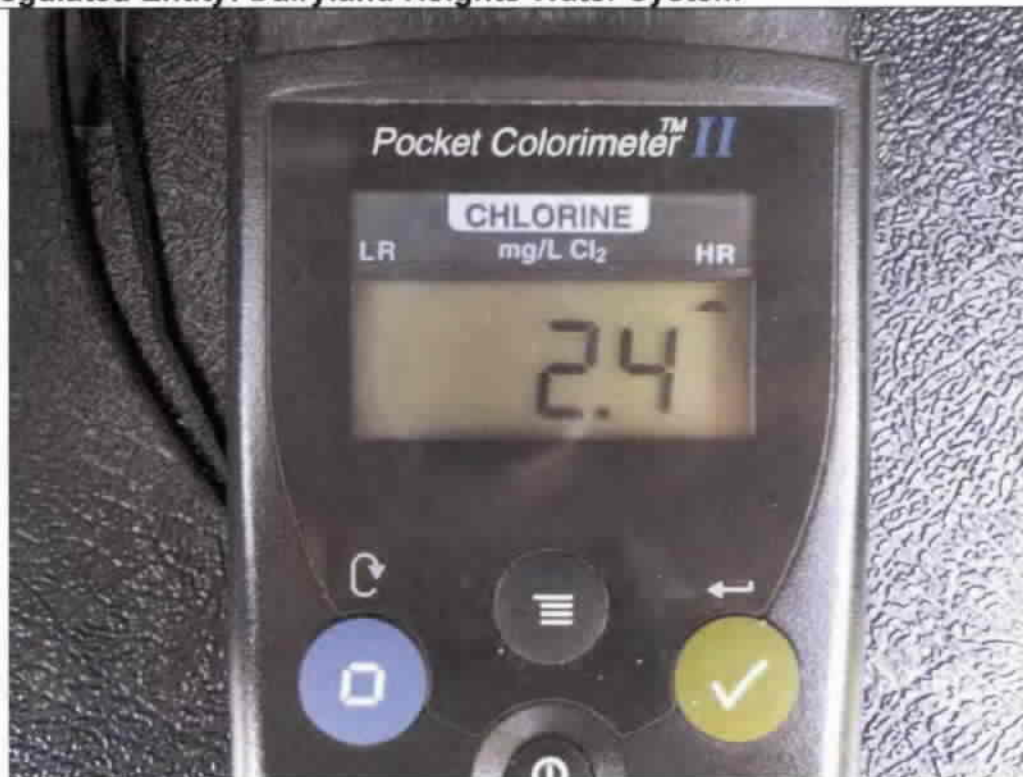
Photograph documenting the free chlorine residual that was noted at 2124 Whitehead after flushing for approximately three minutes.

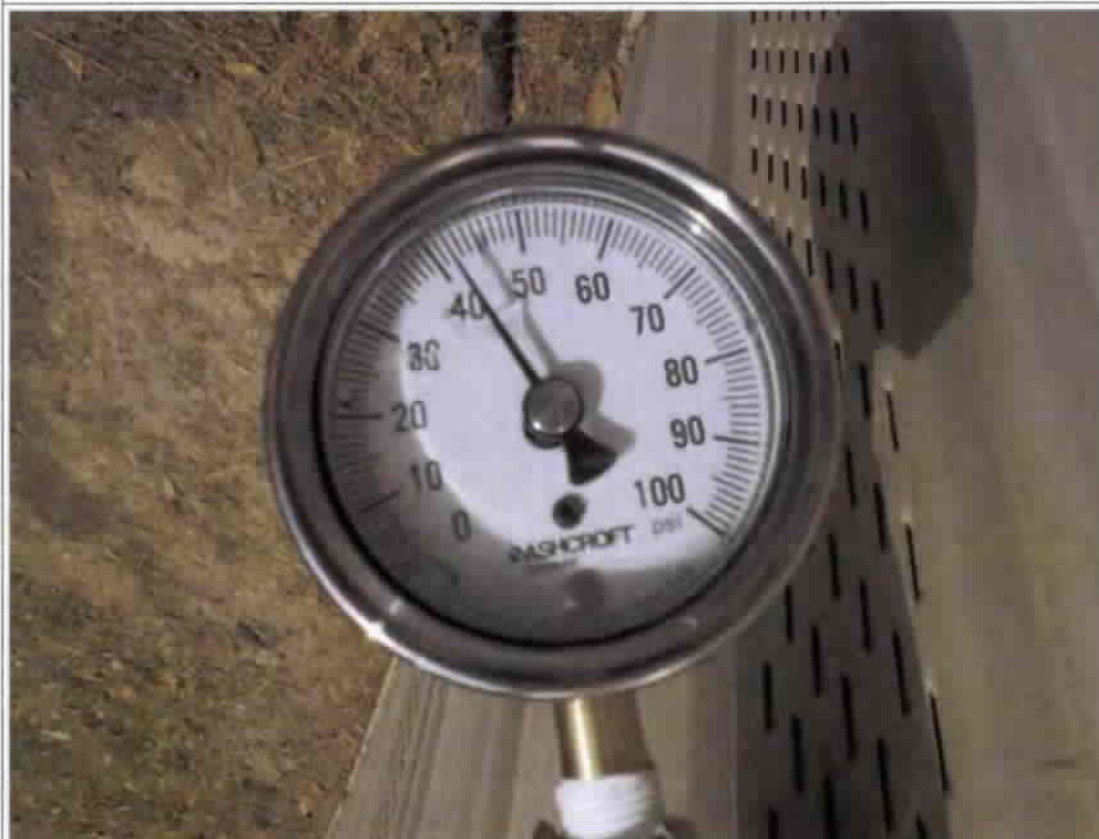
Photograph documenting the pressure reading that was documented at 2124 Whitehead.

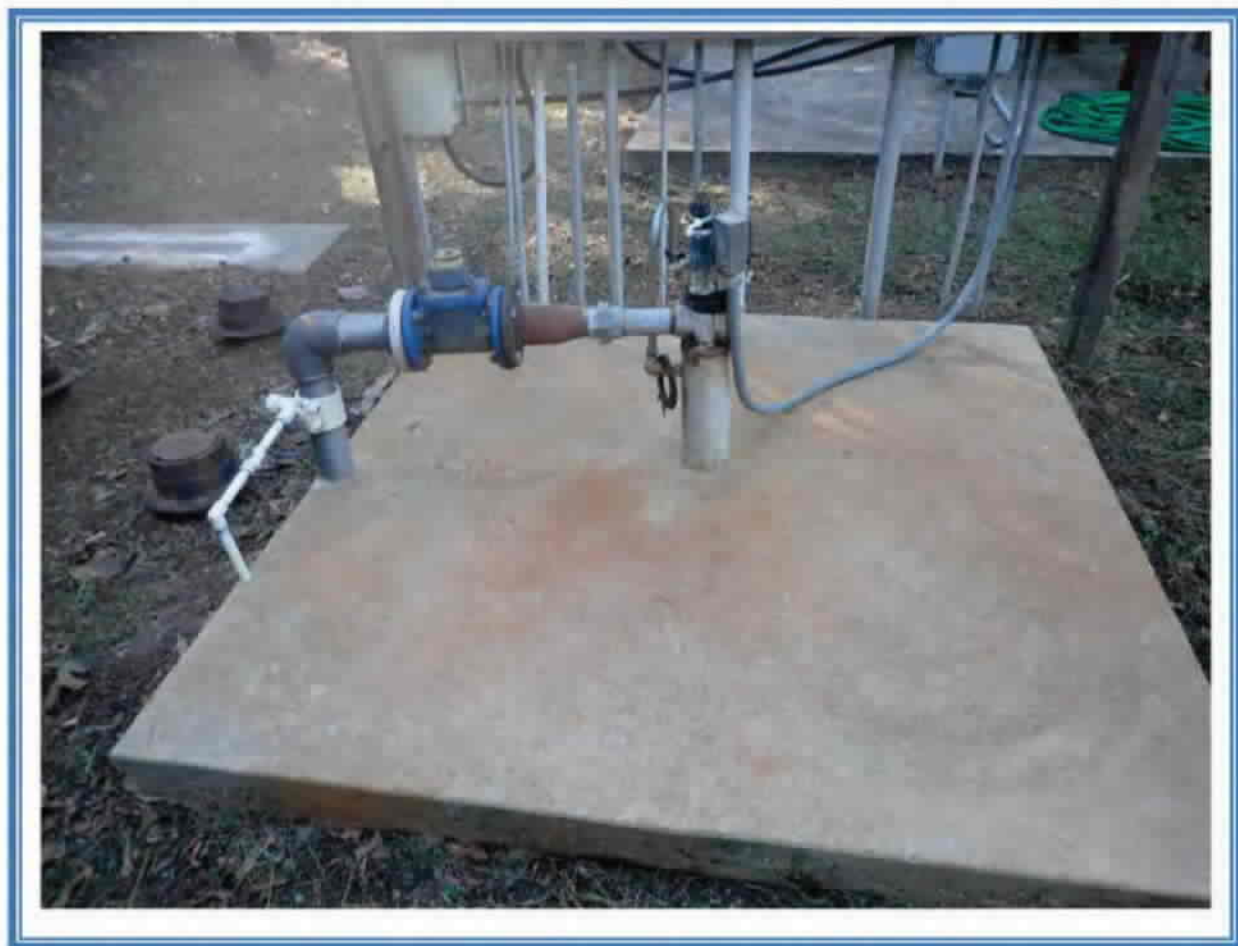
PHOTOGRAPH #1

Description: This photograph taken by Razja Legington, shows the general area of Well 1, Source ID No. G1460153A. (Angle no. 1)

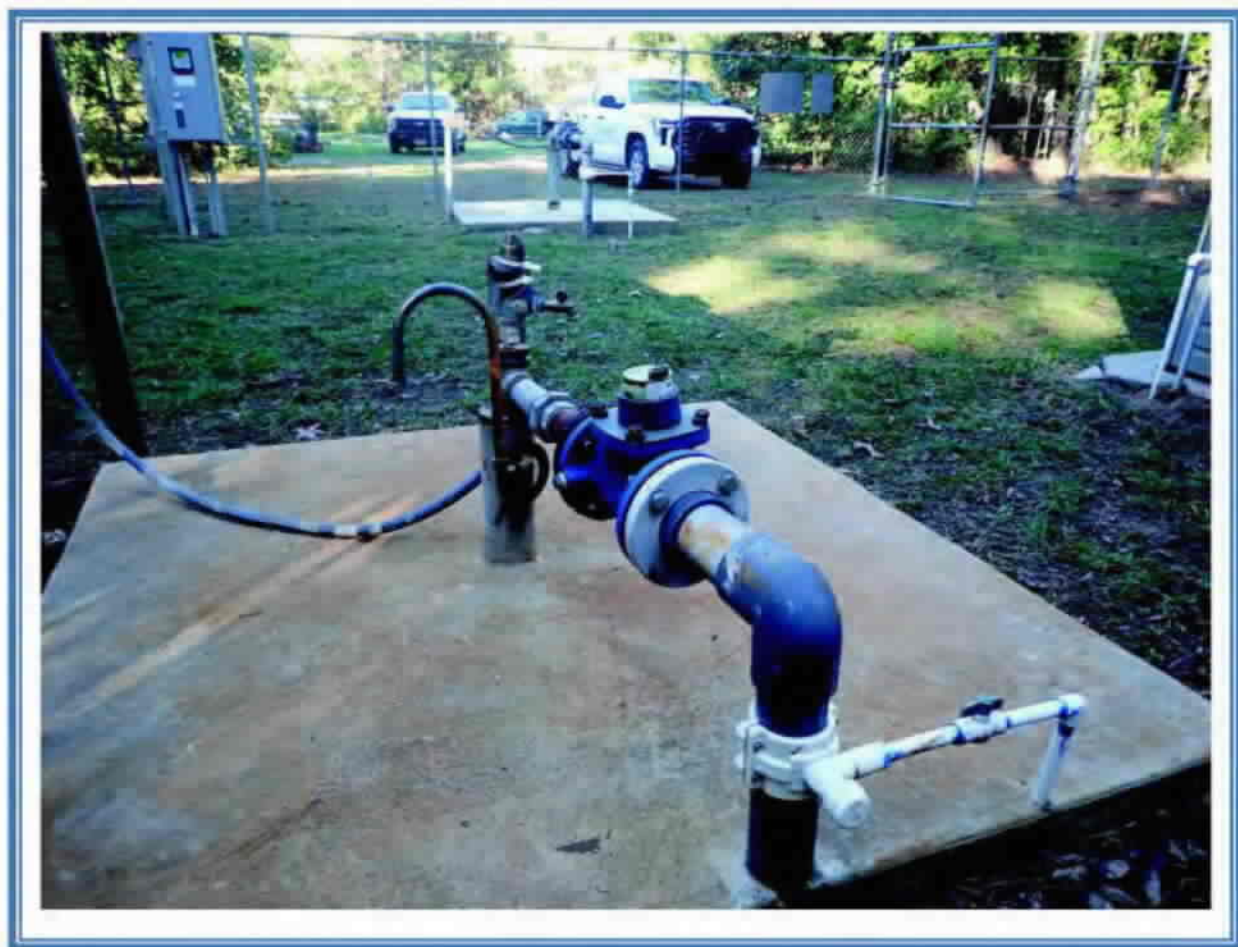
PHOTOGRAPH #2

Description: This photograph taken by Razja Legington, shows the general area of Well 1, Source ID No. G1460153A. (Angle no. 2)

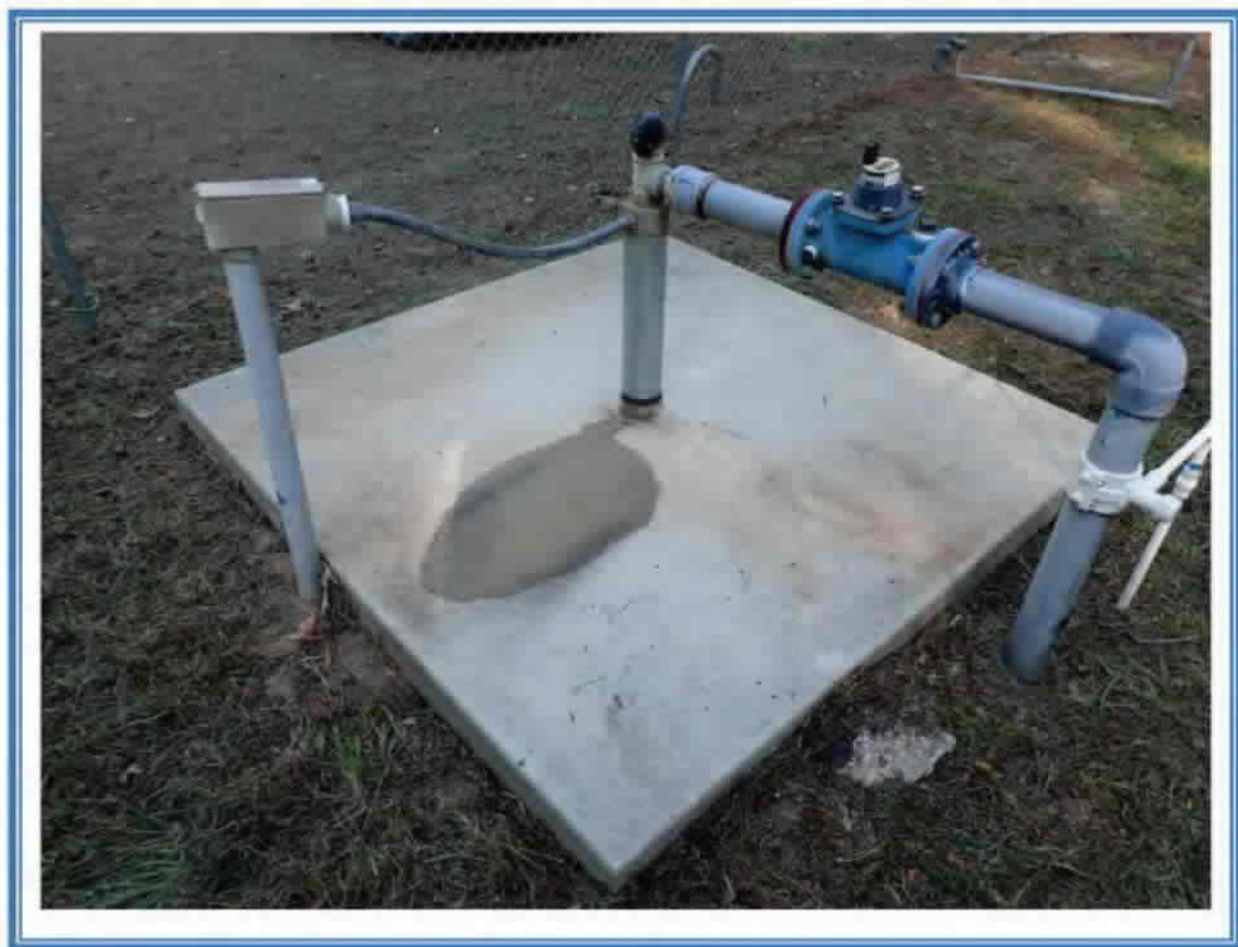
PHOTOGRAPH #3

Description: This photograph taken by Razja Legington, shows the general area of Well 1, Source ID No. G1460153B. (Angle no. 1)

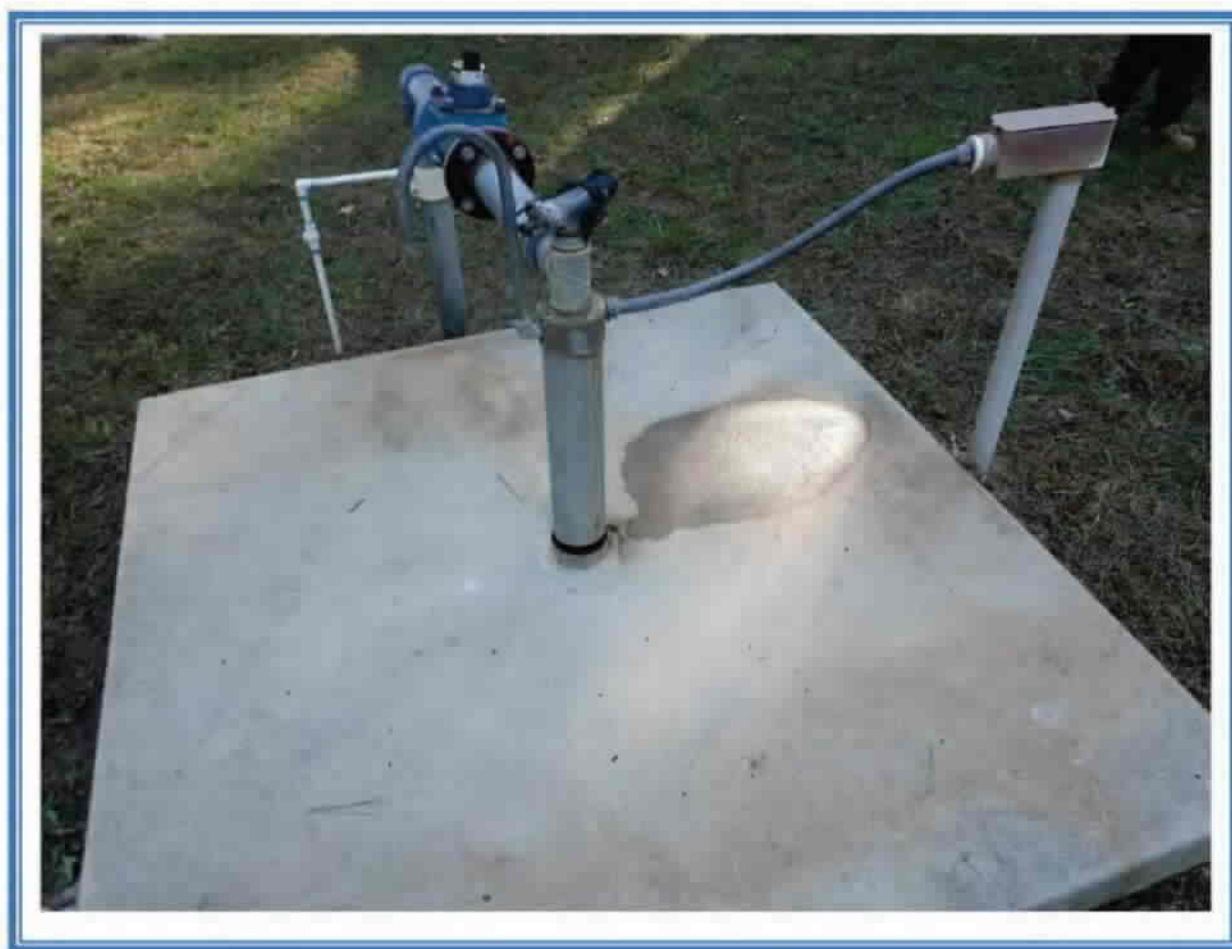
PHOTOGRAPH #4

Description: This photograph taken by Razja Legington, shows the general area of Well 1, Source ID No. G1460153B. (Angle no. 2)

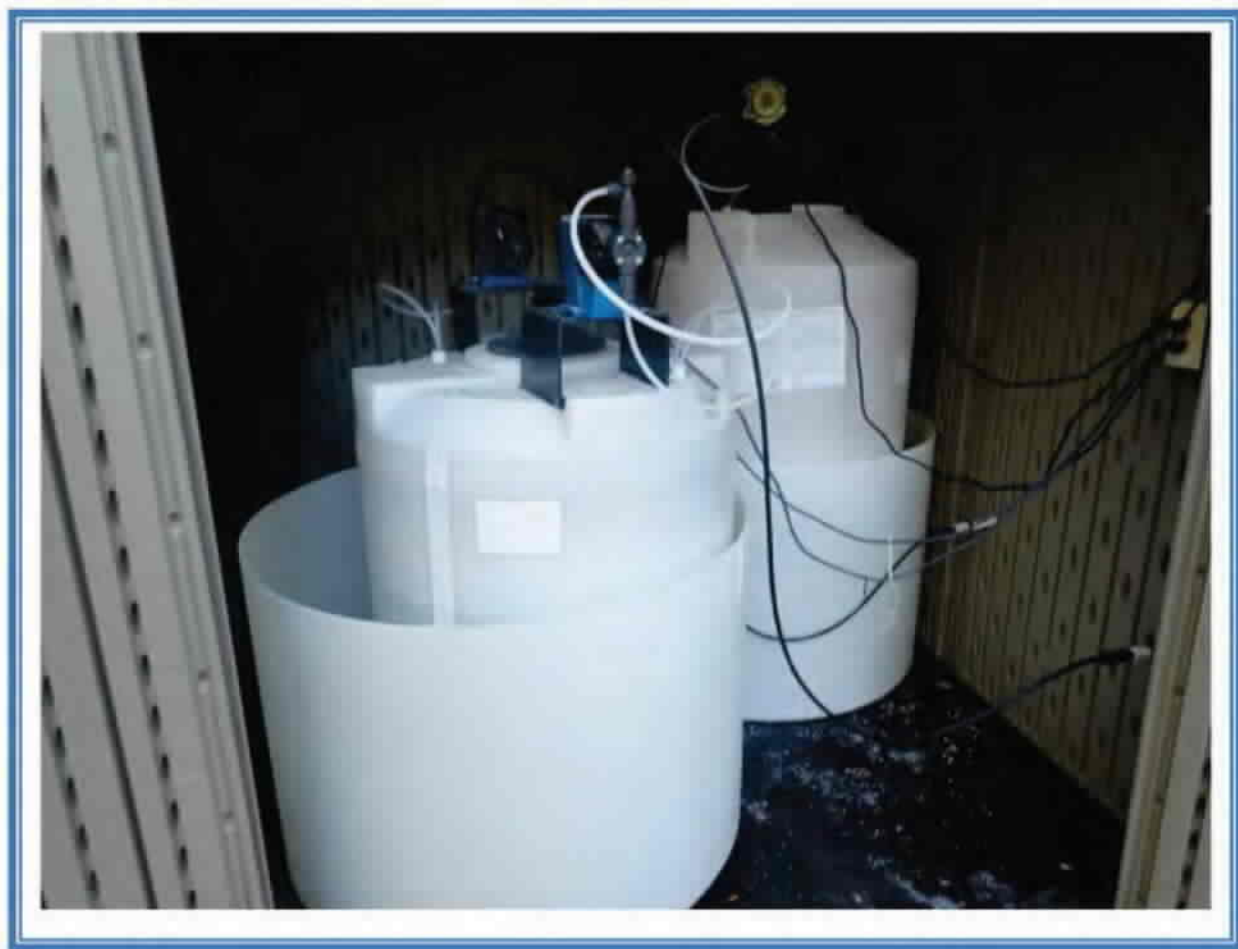
PHOTOGRAPH #5

Description: This photograph, taken by Investigator Razja Legington, shows the interior of the hypochlorination and Polyphosphate treatment facility. Both had secondary containment at the time of the investigation.

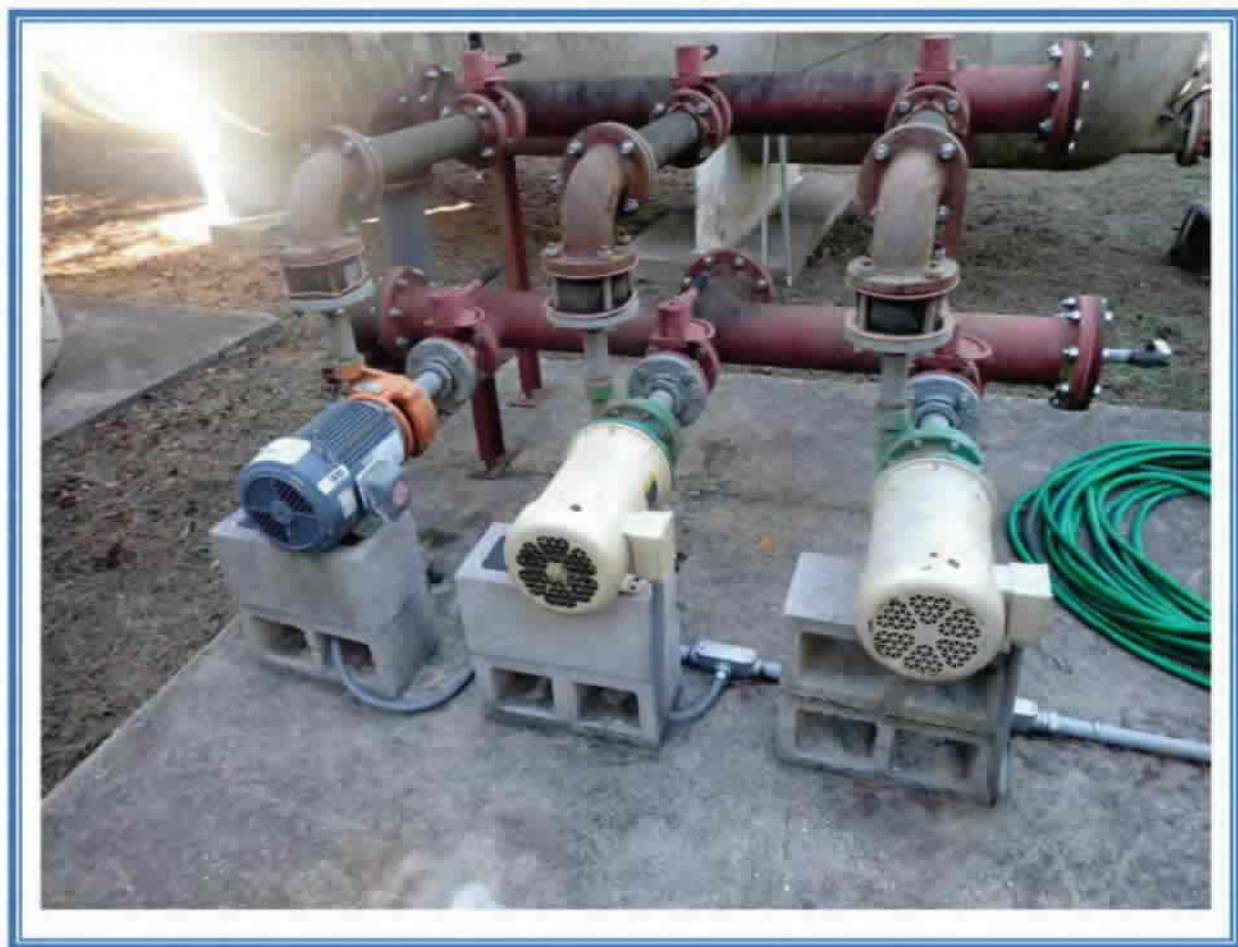
PHOTOGRAPH #6

Description: This photograph, taken by Investigator Razja Legington, shows the general area around the service pumps.

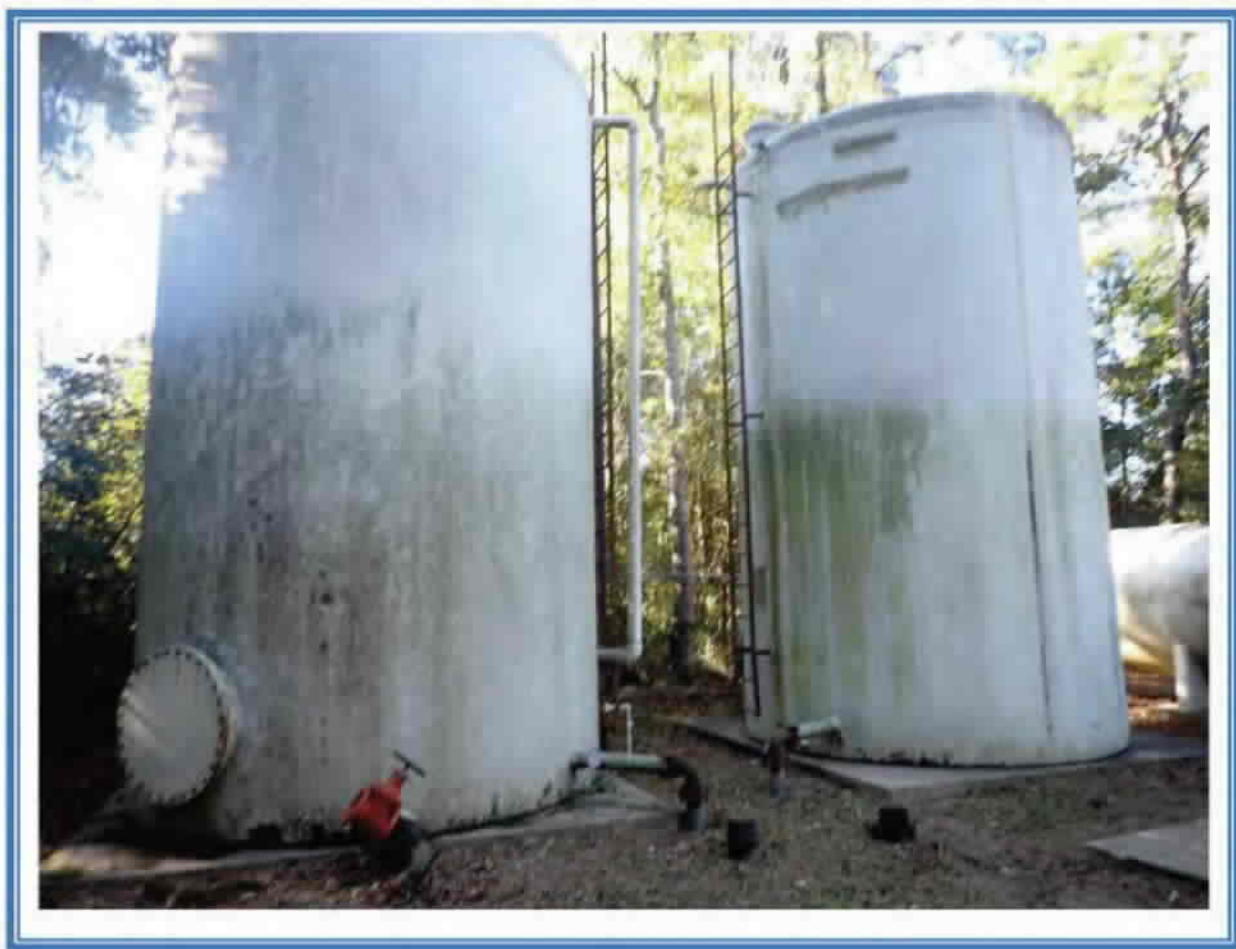
PHOTOGRAPH #7

Description: This photograph, taken by Investigator Razja Legington, shows the Ground Storage Tank No. 1 and No. 2. Both GSTs appear to have mildew building up on their exteriors.

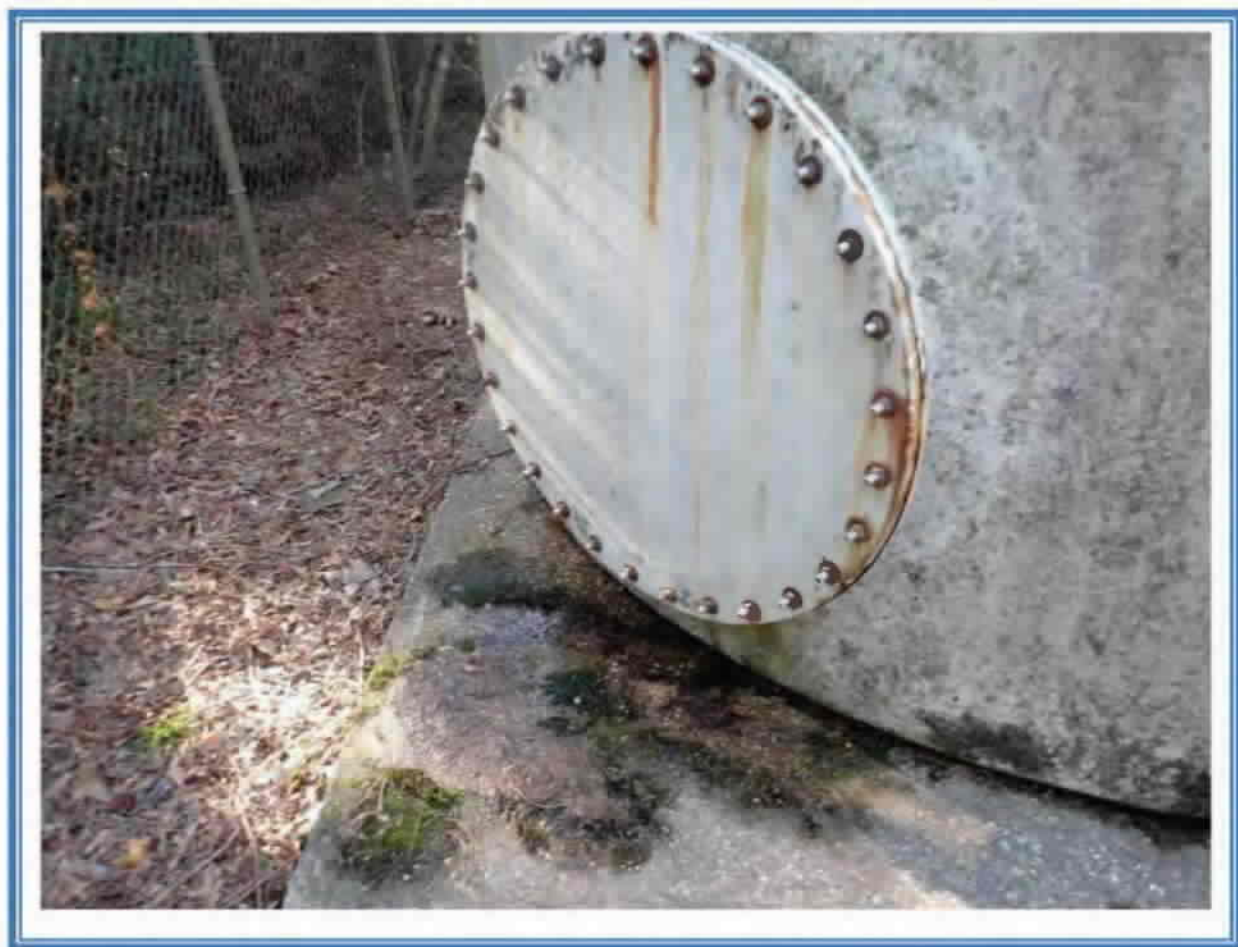
PHOTOGRAPH #8

Description: This photograph, taken by Investigator Razja Legington, shows Ground Storage Tank No. 1's access manway leaking along with rusting bolts on the device.
