Investigation Photographs

Emerald Lakes Subdivision
1500 block of Citron Court
Willis (Montgomery County), Texas
Regulated Entity No: 105348932
TCEQ PWS ID No: 1700777
Investigation Date: April 4, 2023

PHOTOGRAPHIC DOCUMENTATION

PWS ID:	1810143	Investigation Date:	5/16/2023	County:	Orange
Regulated Entity:	Claire Street Water System	TCEQ Investigator:	Jill Pickett

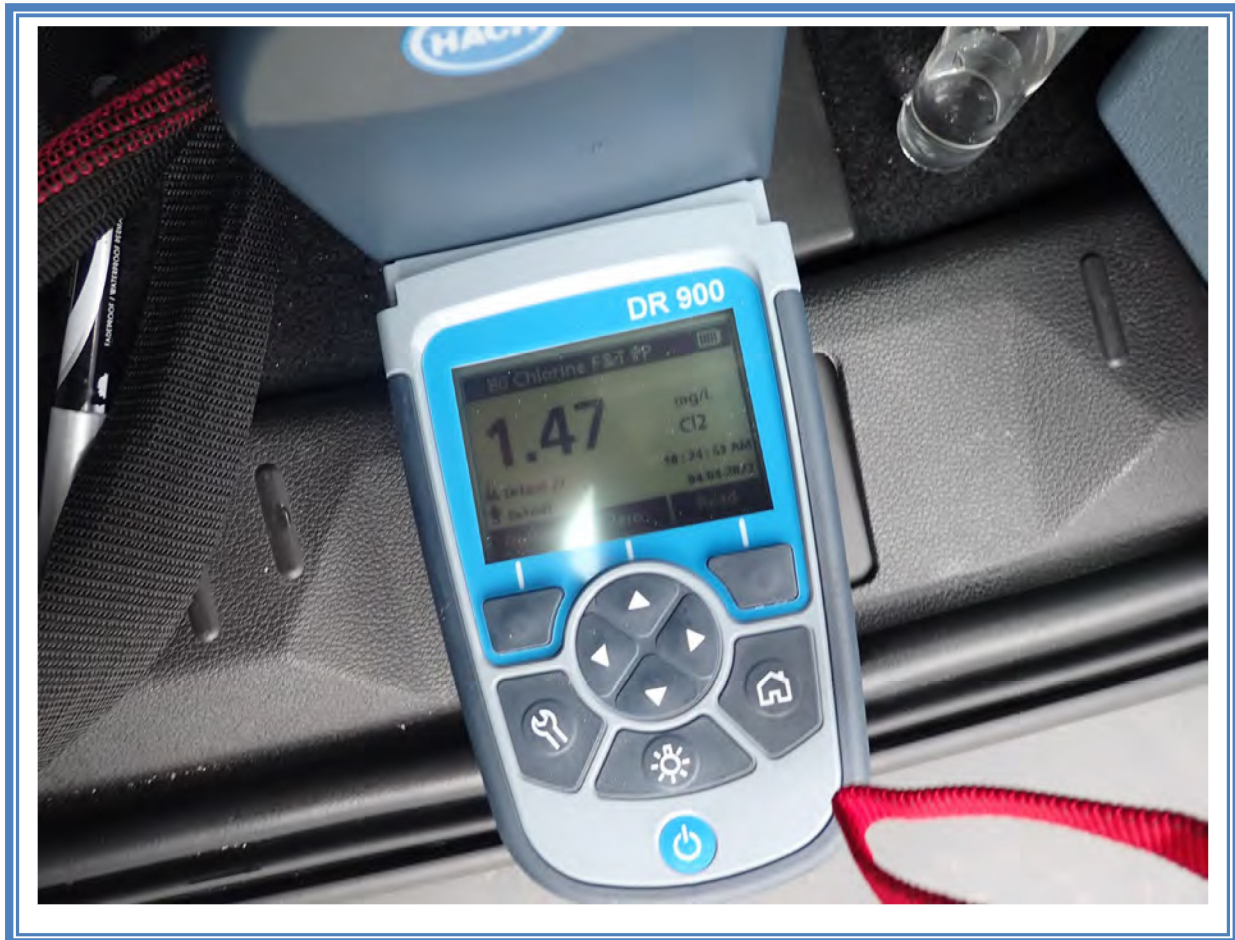
PHOTOGRAPH #1

Description: At the time of Investigation free Chlorine residual reading was 1.47 mg/L

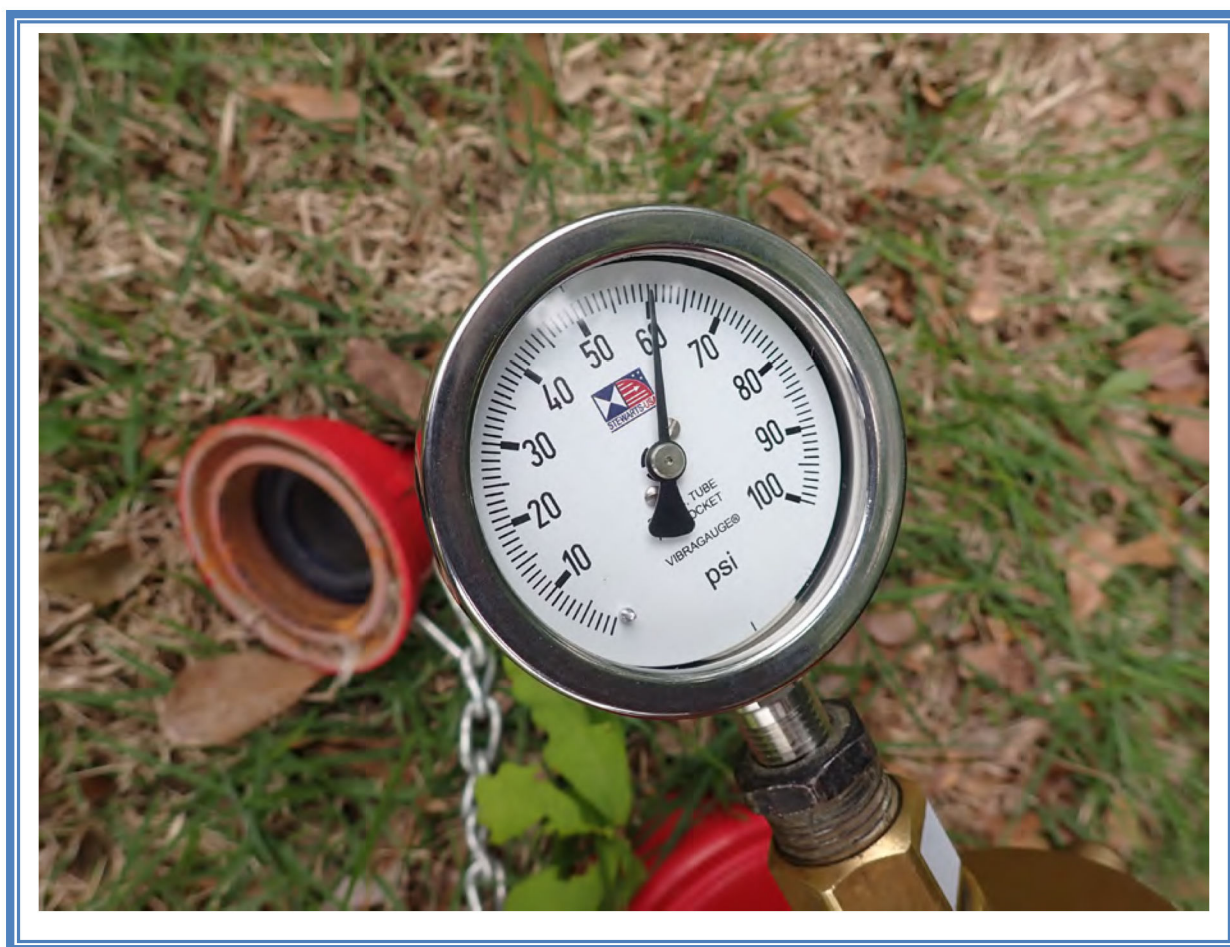
PHOTOGRAPH #3

Description: At the time of investigation, Pressure reading read 61 psi

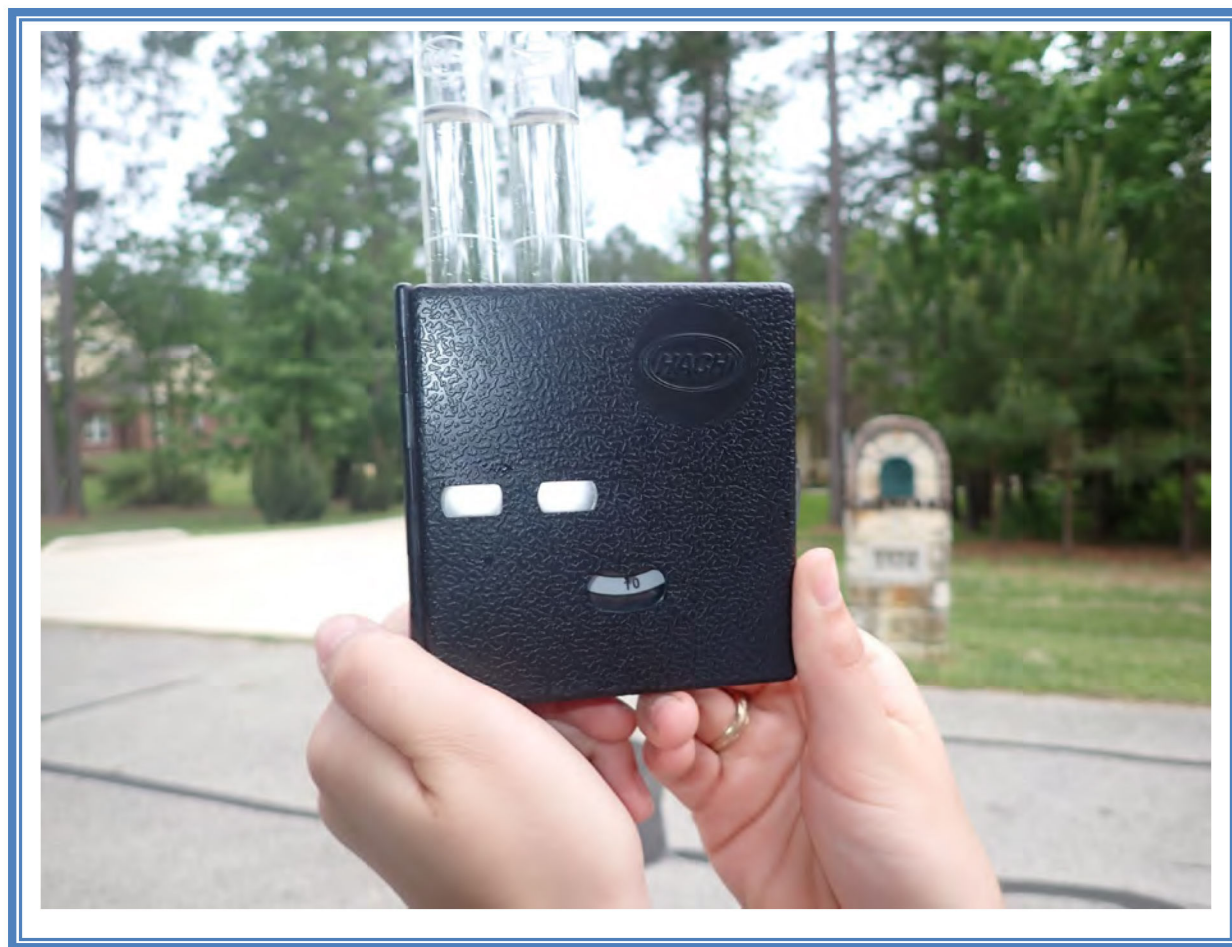
PHOTOGRAPH #4

Description: At the time of the investigation, Samples were taken from hydrant at distribution point. HACH Color Wheel Test Kit read between 5 and 10 Color Units (CU).

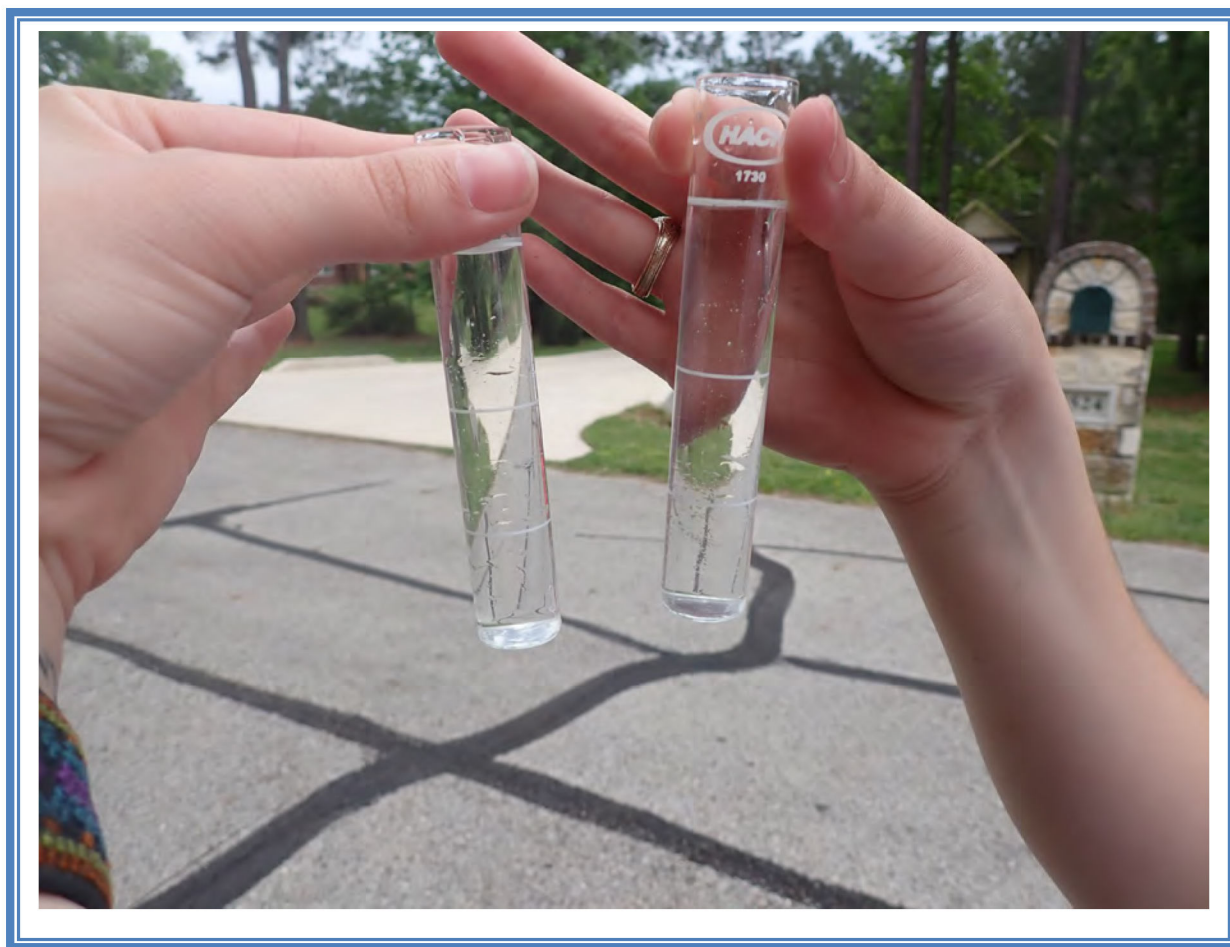
PHOTOGRAPH #5

Description: : At the time of the investigation, Samples were taken from hydrant at distribution point in preparation for HACH Color Wheel Test

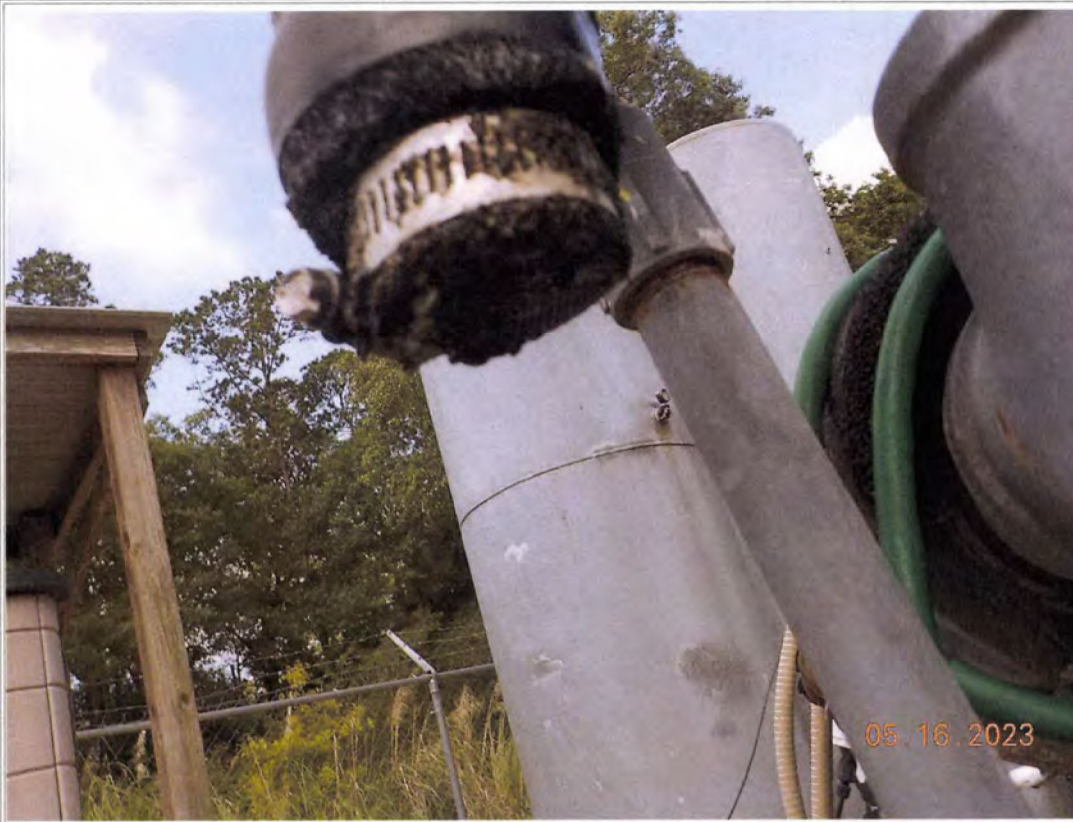
During the investigation, it was noted that the 16-mesh screen on the well vent was moldy. On June 1, 2023, the investigator received photographic documentation of new 16-mesh on the well vent. This will be noted as an additional issue.

Documentation of the 16-mesh screen on the well vent with mold.

During the inspection, it was noted that the 16-mesh screen on the well vent was moldy. On June 1, 2023, the investigator received photographic documentation of new 16-mesh on the well vent.

4	AI	--	During the investigation, it was noted that the 16-mesh screen on the well vent was moldy. It is recommended that the water system replace 16-mesh on the well vent.
5	AI	--	During the investigation, it was noted that the Plant Operations and Maintenance Manual was not updated to include the current language for Boil Water Notices (BWNs).

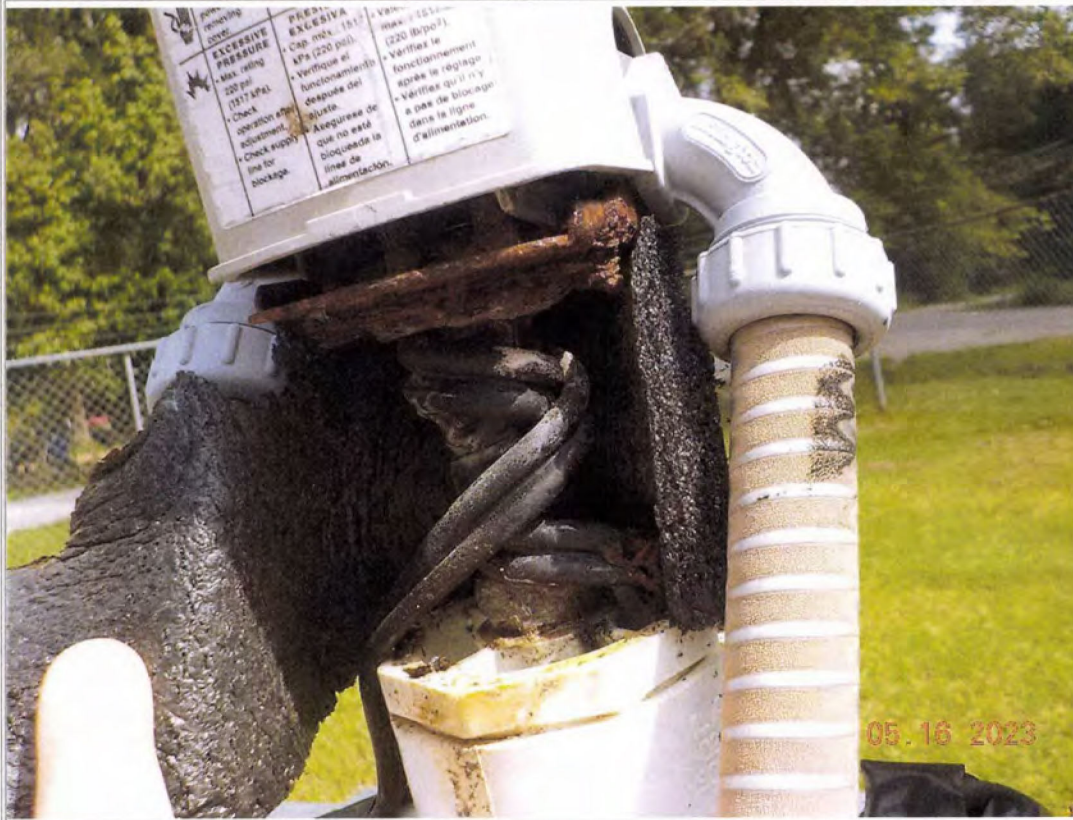
During the investigation, it was noted that the flow switch for the well meter was rusty. On June 1, 2023, the investigator received photographic documentation of a new flow switch for the well meter. This will be noted as an additional issue.

Documentation of the flow switch for the well meter with significant rust.

During the inspection, it was noted that the flow switch for the well meter was rusty. On June 1, 2023, the investigator received photographic documentation of a new flow switch for the well meter.

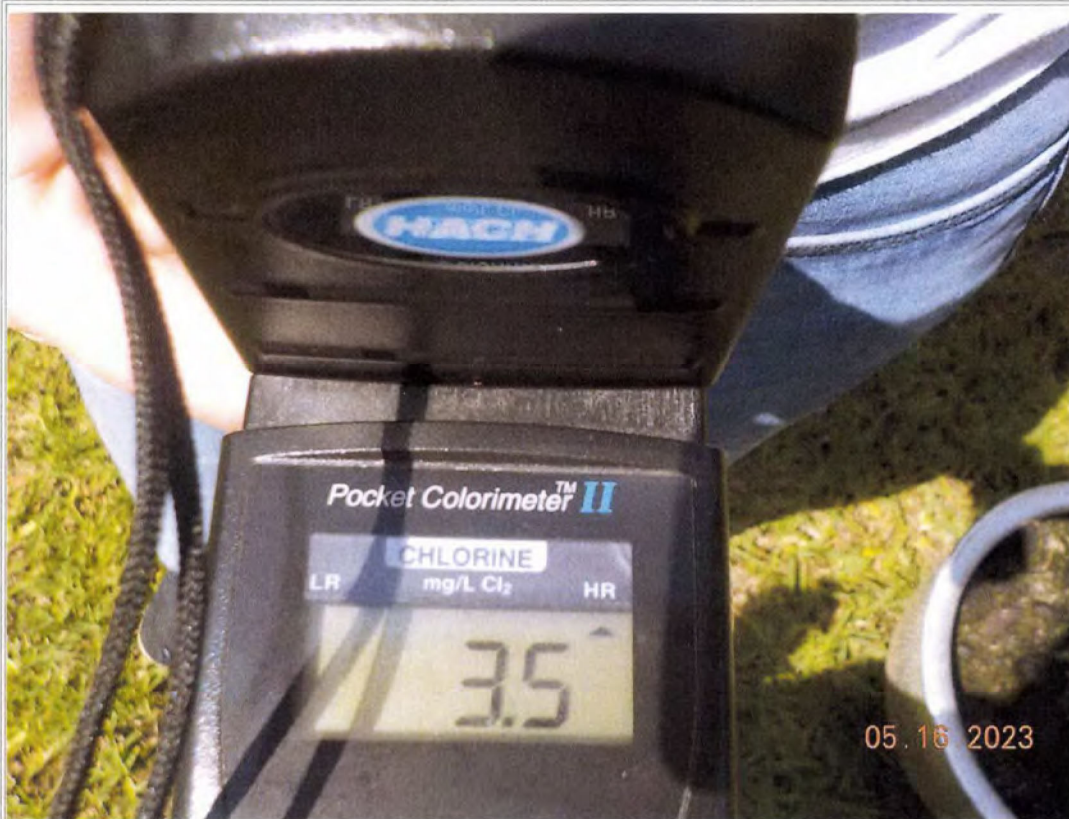
Photograph documenting the chlorine residual at 215 Claire Street after flushing for approximately 3 minutes.

Result: 3.5 mg/L.

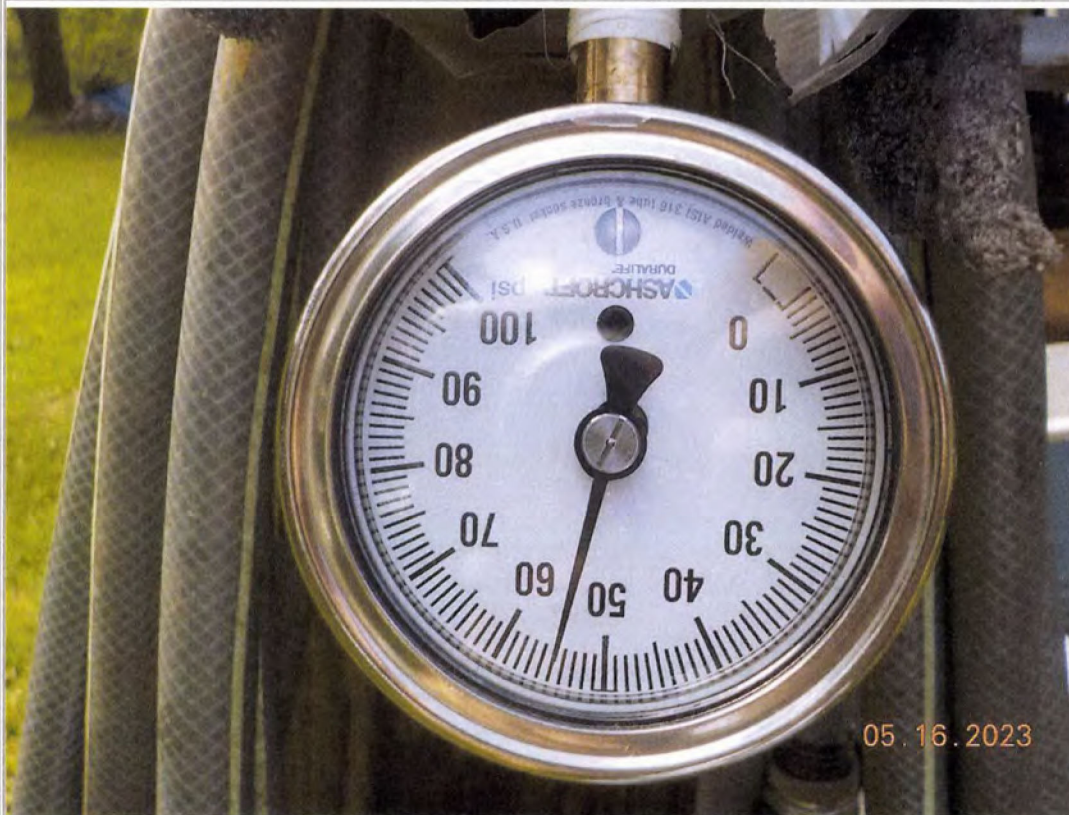
Photograph documenting the pressure reading at 215 Claire Street after flushing for approximately 3 minutes.

Result: 55 psi.
