Subject: **Project No. ~~32128~~** Infrastructure Reliability, Emergency Management, and
Homeland Security Matters

Attached for filing are ten (10) copies of the Entergy Gulf States presentation made
by Joseph F. Domino, President and CEO of Entergy TX, at the Public Meeting in
Beaumont, Texas on February 22, 2006.

Hurricane Rita Impact & Recovery

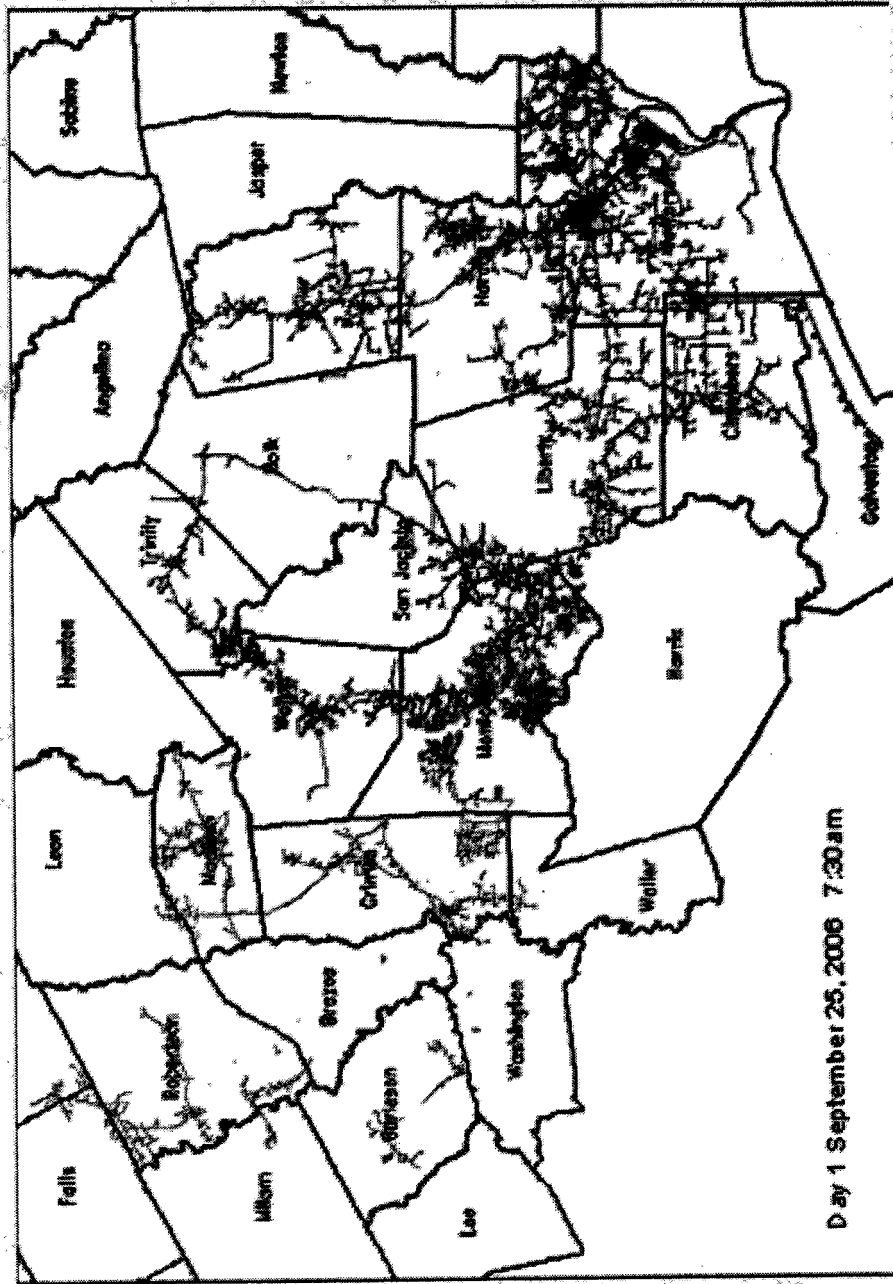
Day 1: All eastern Entergy Texas service area out
