**SOAH DOCKET NO. 473-22-0414**  
**PUC DOCKET NO. 52205**

COMPLAINT OF CR PERMIAN	§	
PROCESSING, LLC F/K/A	§	BEFORE THE STATE OFFICE OF
CAPROCK PROCESSING, LLC	§	ADMINISTRATIVE HEARINGS
AGAINST ONCOR ELECTRIC	§	
DELIVERY COMPANY LLC	§

**DIRECT TESTIMONY**

**MATT WALL**

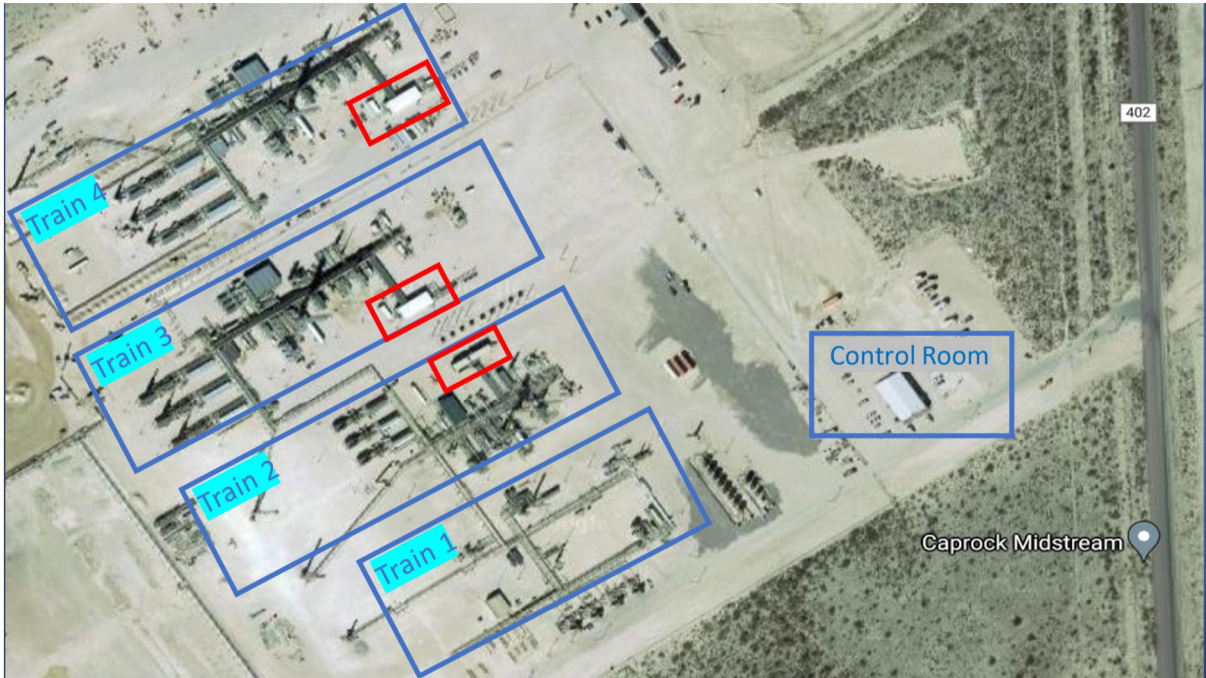
4                   **FIGURE 1: OVERVIEW OF THE PLANT (EX. 1 P. 3)**

1                   Page 3 of Exhibit 1, which is reflected in Figure 1 below, is a zoomed-in image  
2                   of the map depicted on Page 2 of Exhibit 1 that contains markings to identify different  
3                   areas of the Plant, including Trains 1, 2, 3, and 4 and the control room.

7 A. The damage occurred to Caprock's 480-volt equipment and systems in and around the  
8 MCC buildings at Trains 2, 3, and 4. These MCC buildings are located within the red  
9 boxes at Trains 2, 3, and 4 on Figure 1 above. No damage occurred to Train 1 or  
10 Caprock's 4160-volt systems at Trains 2, 3, and 4 for reasons Caprock's expert, Dr.  
11 James Dickens, will explain.

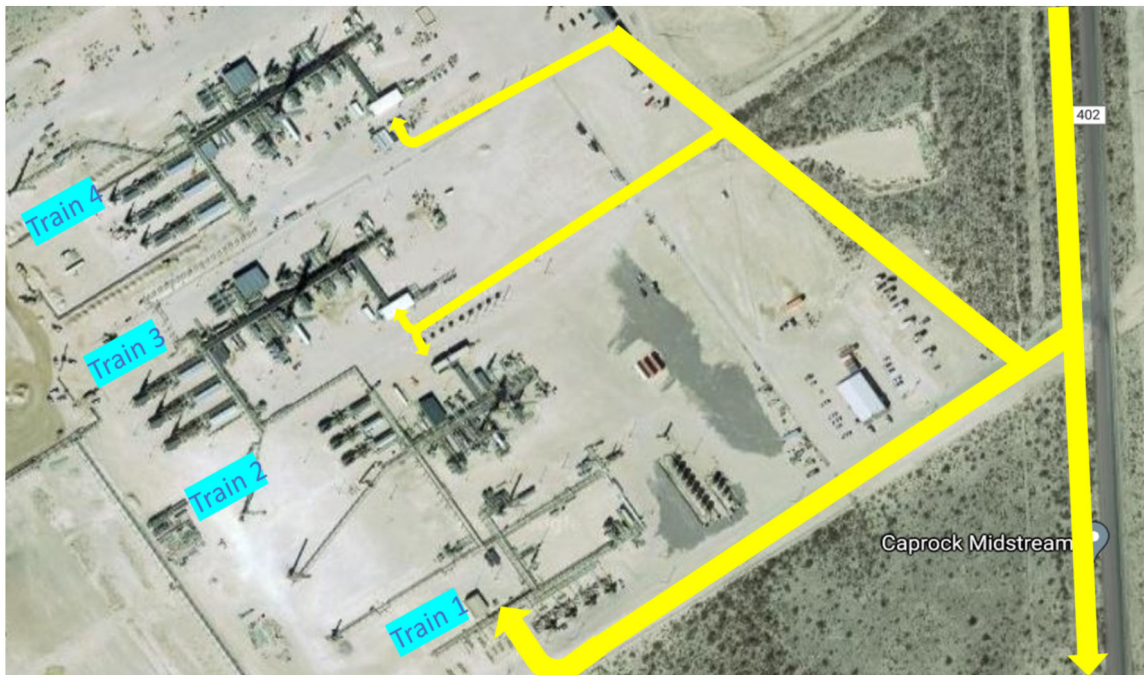
5           **FIGURE 2: OVERVIEW OF UTILITY LINES AT PLANT (EX. 1 AT P.4)**

1           Page 4 of Exhibit 1, which is reflected in Figure 2 below, is a zoomed-in image  
2           of the map from Page 2 of Exhibit 1 with markings added to identify the general layout  
3           of the utility lines and the trains to which those lines delivered electricity at the time of  
4           the Incident.

9           As shown in Figure 2, Oncor's system runs along Road 402. This system  
10          branches off into the Plant at the entrance road on the southeast corner of the Plant.  
11          Shortly after branching off from Road 402, Oncor's system splits in two directions at  
12          the pole circled in Figure 3 above.

13          First, from the pole circled on Figure 3, one set of lines run along the  
14          south/southeast fence-line of the Plant until they terminate at Oncor's transformers at  
15          Train 1. This section of lines delivers electricity to Train 1, but not Trains 2, 3, or 4.

16          Second, another section of lines run north from the pole circled in Figure 3,  
17          along a path that runs east of the Plant before turning into the Plant and terminating at  
18          Oncor's transformers located at Trains 2, 3, and 4, as illustrated in Figure 2 above. This  
19          section of lines delivers electricity to Trains 2, 3, and 4, but not Train 1.
