**ERCOT UPDATE CONCERNING
BRAUNIG UNIT 3 RELIABILITY MUST-RUN AGREEMENT**

PUC Project No. 55999, *Reports of the Electric Reliability Council of Texas*

CPS Energy Braunig Unit 3 – RMR Outage Update and Benefit Analysis

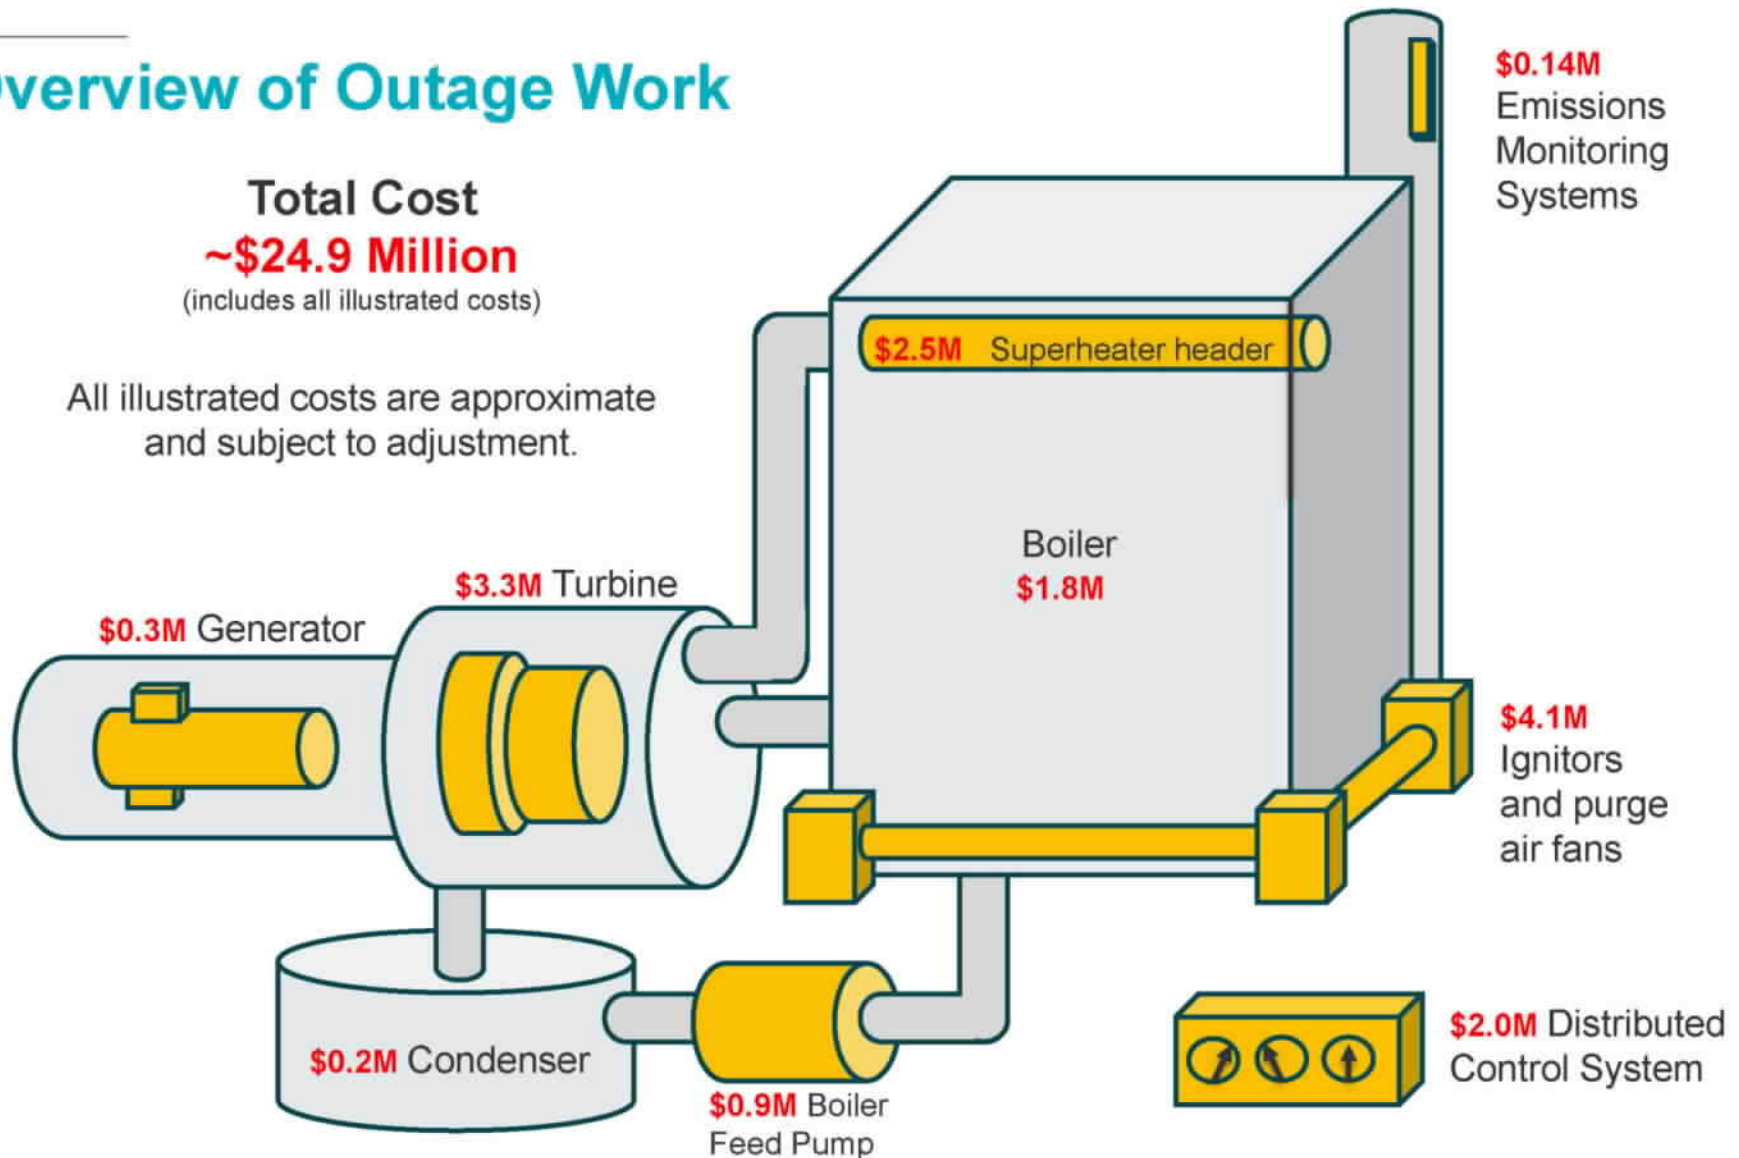
Total Cost
~\$24.9 Million
(includes all illustrated costs)

\$9.6M Misc. repairs, upgrades, and required capitol projects across the balance of plant
