Filing Receipt

Control Number - 57579

Reliability Reporting Storm Report

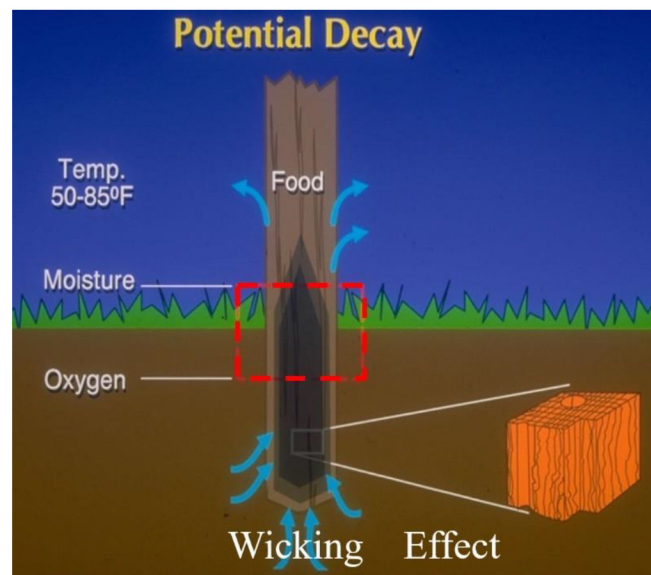
Figure 8. The most decay prone zone of a southern pine pole is limited above ground by lack of moisture and below ground by a lack of oxygen deeper than 18".

Due to the moisture limit at groundline and the oxygen limit at 18" below ground, the groundline zone (groundline to 18" below) is the most decay prone section of southern pine poles (see Figure 8). The decay most often initiates on the outer shell below ground which causes a rapid loss of pole bending strength.

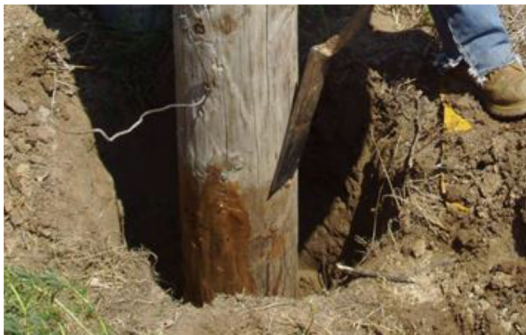
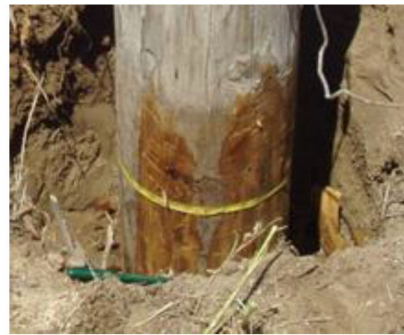
The sooner that shell rot is identified in a pole, the more original bending strength is retained, and the pole can be treated to control future deterioration. The following images show that shell rot identified early can be chipped off the pole and the effective remaining circumference is measured to determine the remaining bending strength.

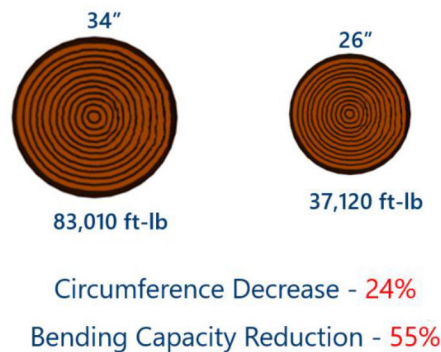
It was mentioned earlier that the outer 1" of shell supports around 50% of a wood pole's bending strength. In this example, which is drawn to scale, a 24% reduction in circumference due to external decay results in losing 55% of the bending capacity. Controlling shell rot in southern pine poles is critical to retaining the much-needed bending capacity.

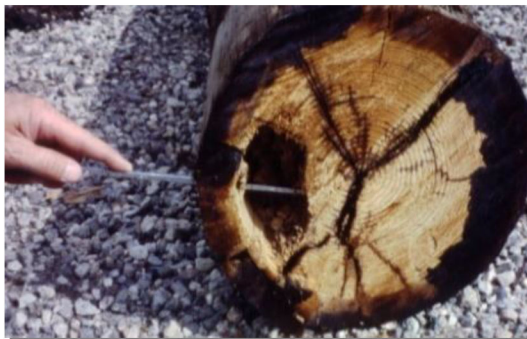
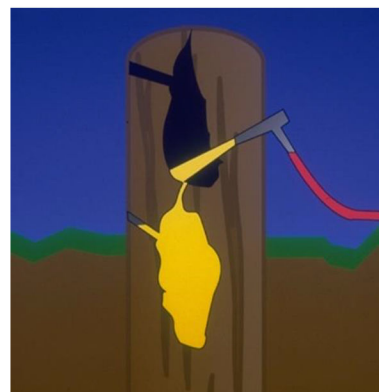
Some of the poles inspected will have existing internal voids. There is a liquid preservative treatment that only requires a splash contact with the surface of the void to help control decay until the next assessment cycle. The product, which is applied under pressure, is called Hollow Heart and included in CenterPoint's specification. Hollow Heart is only intended for use when internal decay has advanced to create a void.

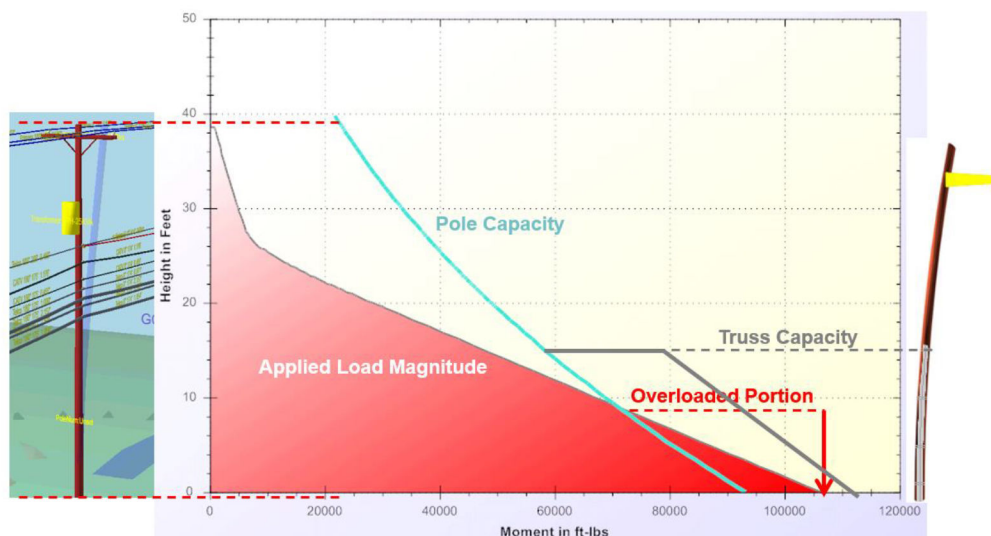
Some in-service poles may be overloaded or may need to be upgraded to support higher wind loading. A pole is not overloaded from top to bottom. As shown below, there is a location between the pole tip and groundline where the applied load becomes greater than the pole capacity.

The upgrade steel truss can increase the bending capacity of wood poles by 1, 2, or 3 classes. This system is a low cost and quick way to make wood poles more resilient.

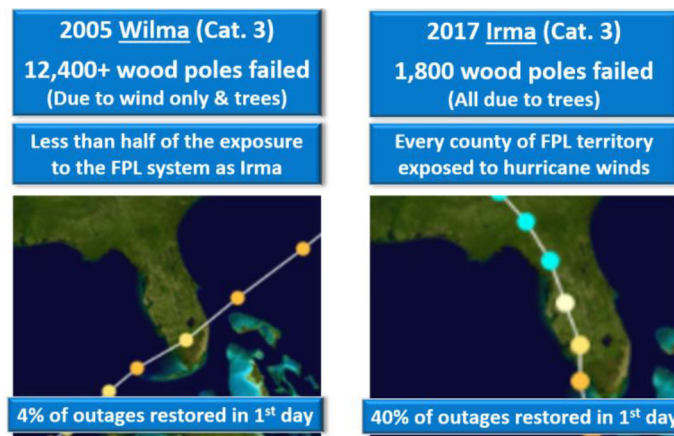
The following images show the comparative performance of the FP&L system resulting from hurricane Wilma in 2005 versus hurricane Irma in 2017. Irma covered more than twice the amount of service territory and only 1,800 poles failed compared to Wilma where 12,400 poles failed. Only 4% of the outages were restored the first day after Wilma whereas 40% of the outages were restored the first day following Irma.

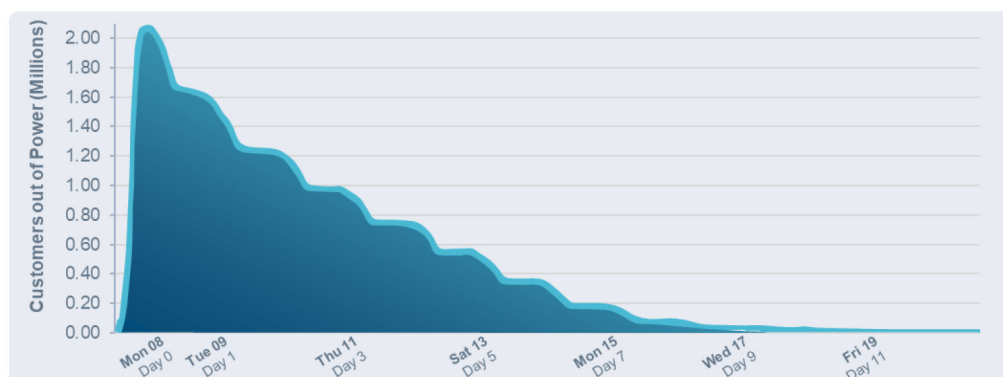
Figure ES - 1: CenterPoint's Restoration Curve for Hurricane Beryl

While the distribution system was significantly impacted, the transmission system proved resilient. CenterPoint experienced 6 substation outages (2.0%) and 15 customer substation outages (8.0%),² all of which were restored to service quickly. Only 31 transmission line segments (8.0%) experienced outages, 16 transmission structures (0.05%) required replacement, and 4 others (0.01%) needed repairs. Figure ES - 1 shows CenterPoint's restoration curve for Hurricane Beryl. The blue line represents the number of customers without power due to Hurricane Beryl on each specific day.

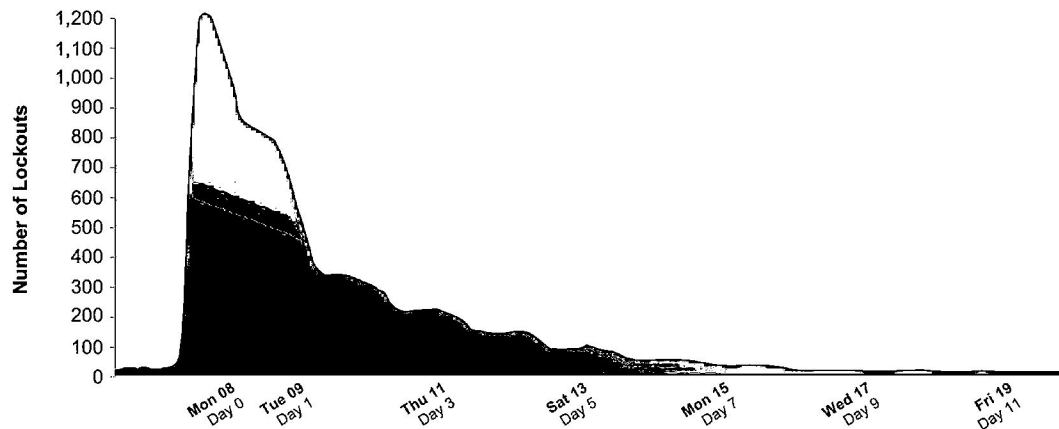
Figure ES - 2: Distribution Feeder Lockouts During Hurricane Beryl

The extensive number of distribution circuits lockouts was the major technical restoration challenge Beryl presented. CenterPoint's long overhead circuits with few field sectionalizing devices,³ resulted in distribution circuit breakers protecting large areas of the system. Patrolling for and repairing damage to such large areas contributes to longer restoration times. As shown in Figure ES - 2, distribution circuit breaker lockouts peaked at 1,202, these being almost exclusively from the 1,675 overhead circuits on the CEHE system. Circuit re-energization results from Monday afternoon and Tuesday show significant progress, but also show the magnitude of the challenge, as 316 distribution circuits remained deenergized on Tuesday night, 36 hours after Beryl left CEHE's territory.

PA observed the need for more sectionalization on circuits. The current midstream devices and circuit end ties do not offer adequate sectionalization to prevent lockouts. To bolster the resiliency of the system, PA found that all circuits should be reinforced up to the first protective device located outside of the substation. This protective device should be placed at the first lateral off the backbone circuit. Enhancing circuits may require a combination of strategies, such as targeted vegetation management, the installation of covered conductors or tree wire, and the potential undergrounding of lines. A comprehensive analysis should be performed on a circuit-by-circuit basis, with the ultimate objective of significantly reducing feeder lockouts and improving overall grid stability.

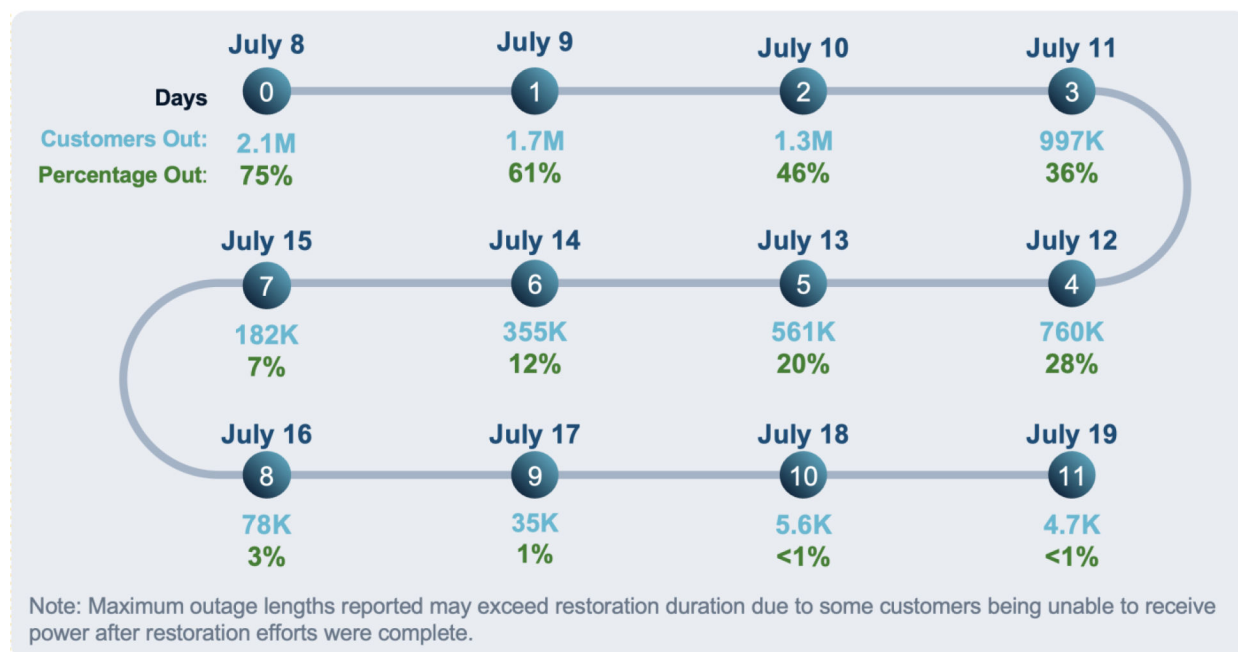
Figure 2 - 2: Customer Peak Outages Per Day Post-Beryl

The combination of high winds, over a foot of rainfall, and surge flooding led to downed trees, poles, and power lines, resulting in more than 2.1 million CEHE customers in the Greater Houston area losing power. Beryl caused significant flash flooding, power outages, and damage to vegetation creating a difficult environment for utility and emergency response crews to operate in. Multiple deaths were reported due to trees falling on homes and heavy rain caused several roadways in the area to become flooded with officials needing to perform almost 50 high water rescues by 3:30PM.⁸ Figure 2 - 2 presents a daily breakdown of customer outages, detailing the extent of power loss experienced over the first nine days of the storm restoration period.

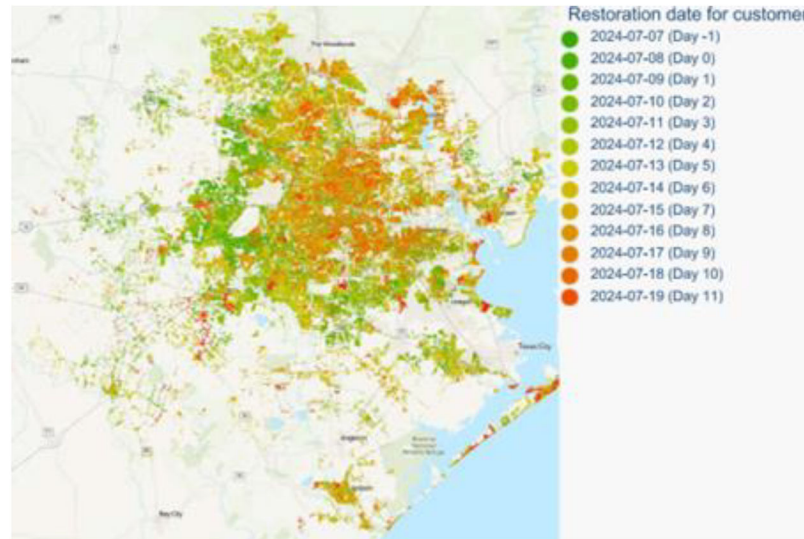
Figure 2 - 3: Map of Customer Restoration Dates

Following the initial power outage, nearly two hundred thousand customers remained without electricity for over a week as CenterPoint continued its restoration efforts.

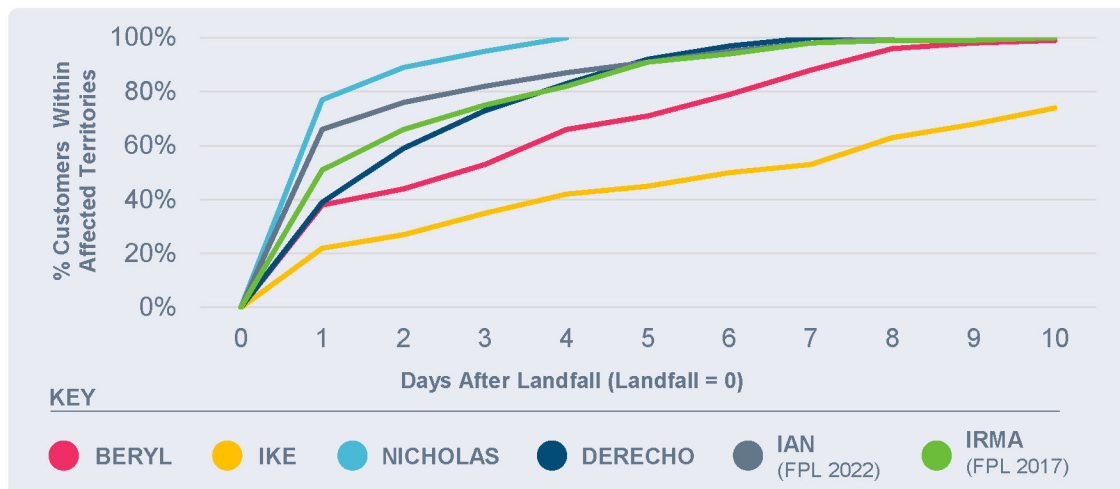
Figure 2 - 5: Restoration Curves for Comparable Storms

Despite the vast number of crews deployed, the widespread damage to the distribution infrastructure resulted in a long duration effort. The restoration curve for Beryl was flatter during the earlier days of the response, with a similar shape to Ike's, when compared to other similar storms in Houston. This flat start to the curve indicates a challenge in quickly restoring power to a large portion of affected customers due to the significantly larger quantity of damage locations caused by Beryl and Ike compared to the other storms. As shown in Figure 2 - 5, PA leveraged restoration data from Florida Power & Light (FPL), which is a leader in infrastructure resiliency and hurricane response, for an industry comparison.

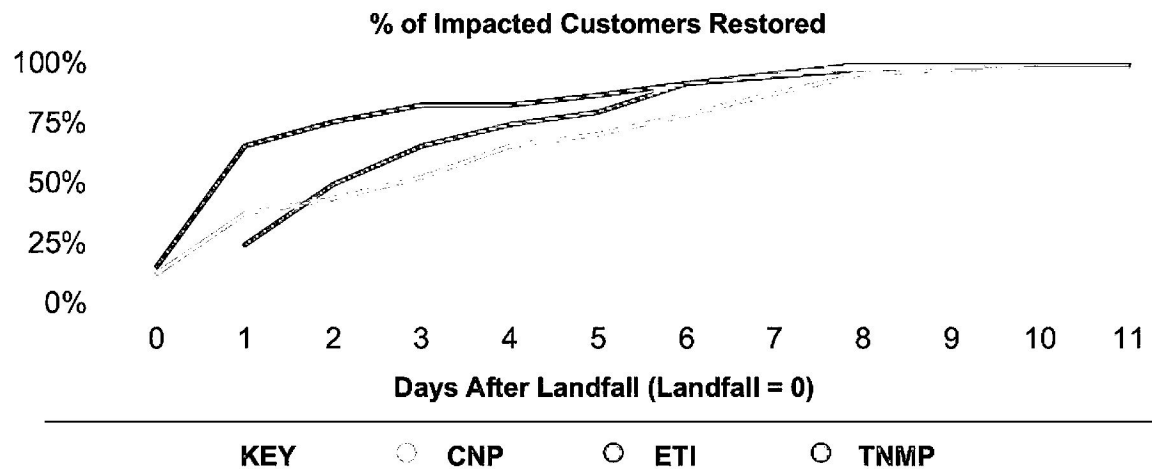
Figure 2 - 7: Beryl Restoration Curves of Peer Utilities²⁰

As crews operated in each territory, customer restoration timelines varied across the three utilities, as illustrated in Figure 2 - 7. ETI achieved the fastest restoration timeline, fully restoring service to all customers by July 16, followed by TNMP on July 17 and CenterPoint on July 19. TNMP's restoration curve indicates it experienced the largest initial step of outage restorations, with over 80% of customers restored by July 11, just three days after Beryl made landfall.
