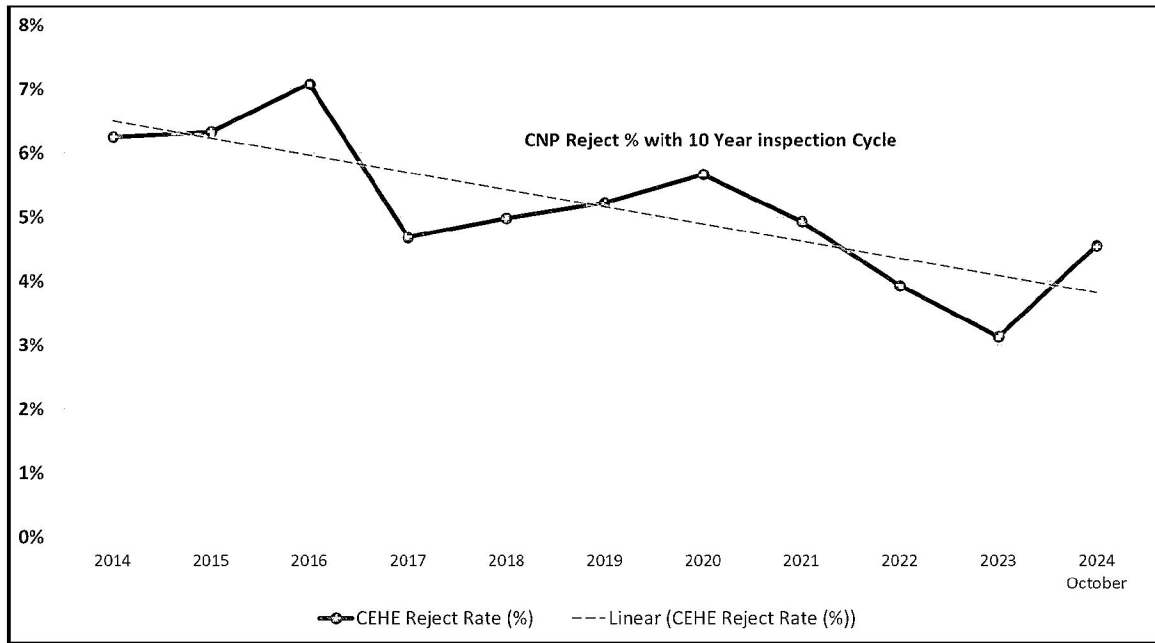
Figure RMP-12
CenterPoint Houston Reject Rate for Poles Inspected

15 A. No. Relying on the Osmose report from 1999, Mr. Ivey concludes that the
16 Company has a history of high pole reject rates. The Company’s pole reject rates
17 have followed a distinct downward trend of the rate of reject poles since 2014, as
18 shown below. This trend illustrates the efficacy of the Company’s Pole Inspection
19 Program at the current process and pace.

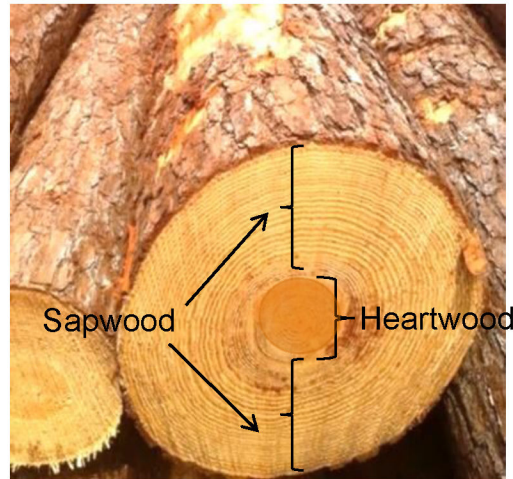
Figure 1. The cross section of a Southern Pine pole

The species of the pole involved in this incident was Southern Yellow Pine. Pine poles are a thick sapwood species that readily accepts preservatives deep into the sapwood. (see Figure 1).

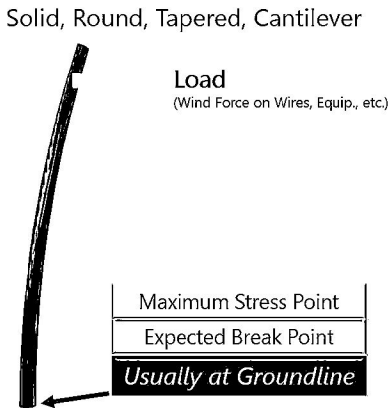
Figure 6. The maximum stress point due to bending loads for poles up to at least 60 feet in length is usually at the groundline.

In this cantilever structural configuration, the maximum stress point along the pole is where the circumference is 1.5 times the circumference of the load point (see Figure 6). The maximum stress point is the theoretical location where a wood pole is expected to break due to maximum bending stress. Wood poles are not a very homogeneous material so defects or variation in pole properties may cause a pole to break a short distance above ground due to bending loads.

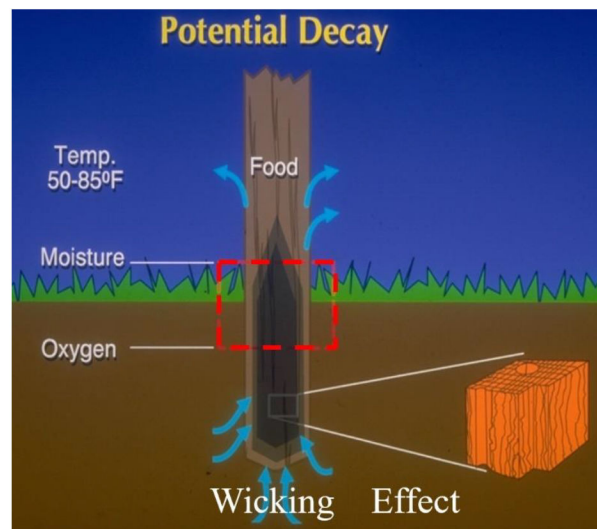
Figure 8. The most decay prone zone of a southern pine pole is limited above ground by lack of moisture and below ground by a lack of oxygen deeper than 18".

Due to the moisture limit at groundline and the oxygen limit at 18" below ground, the groundline zone (groundline to 18" below) is the most decay prone section of southern pine poles (see Figure 8). The decay most often initiates on the outer shell below ground which causes a rapid loss of pole bending strength.

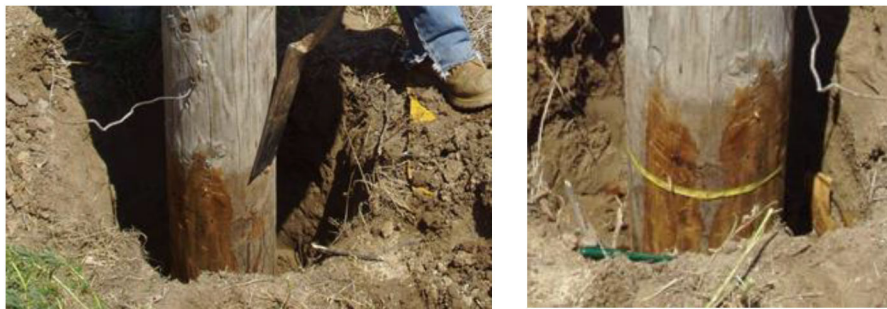
The sooner that shell rot is identified in a pole, the more original bending strength is retained, and the pole can be treated to control future deterioration. The following images show that shell rot identified early can be chipped off the pole and the effective remaining circumference is measured to determine the remaining bending strength.

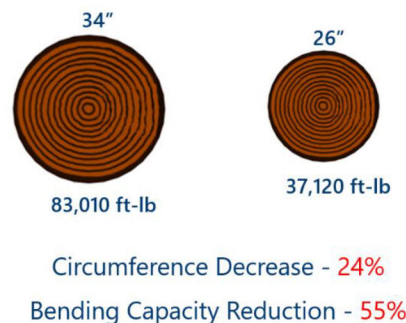
It was mentioned earlier that the outer 1" of shell supports around 50% of a wood pole's bending strength. In this example, which is drawn to scale, a 24% reduction in circumference due to external decay results in losing 55% of the bending capacity. Controlling shell rot in southern pine poles is critical to retaining the much-needed bending capacity.

As shown in the examples above, shell rot generally forms rather evenly around the outer shell. Removing the shell rot and measuring the circumference of the remaining sound wood is a good method for determining the remaining bending strength as a percentage of original strength. That pole now has the bending capacity of a sound pole having a circumference equal to the effective circumference.
