2002-2003 CenterPoint Energy Repeating Circuit Report

Kingwood Ckt 44 (KW44) – 4,576 customers

Repeating Indices: 10% SAIFI

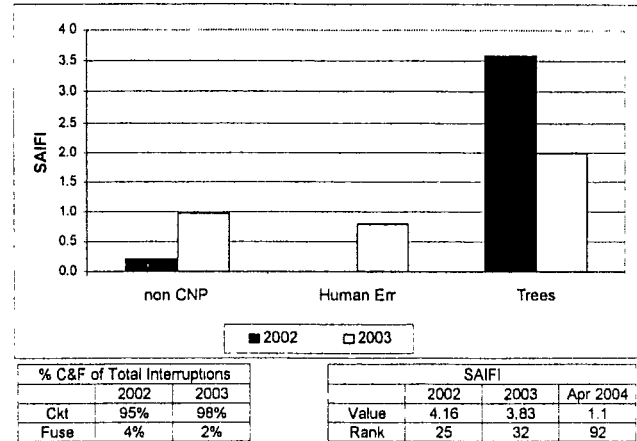
- In the non-CNP category, 26% of yearly SAIFI was due to a circuit level interruption caused by customer owned equipment.
- In the Human Err category, 20% of yearly SAIFI was due to a circuit level interruption that occurred during the Service Restoration Process.

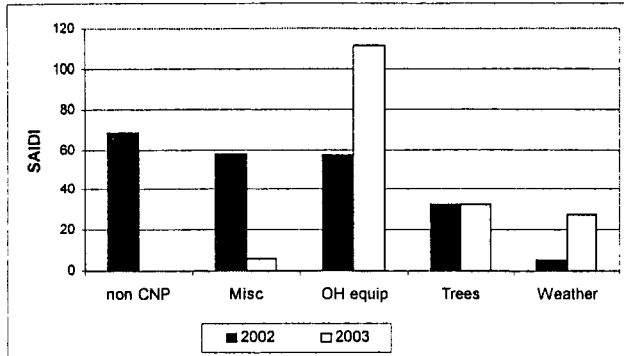
% C&F of Total Interruptions		
	2002	2003
Ckt	85%	75%
Fuse	12%	21%

SAIDI			
	2002	2003	Apr 2004
Value	236.70	196.65	3.99
Rank	119	99	893

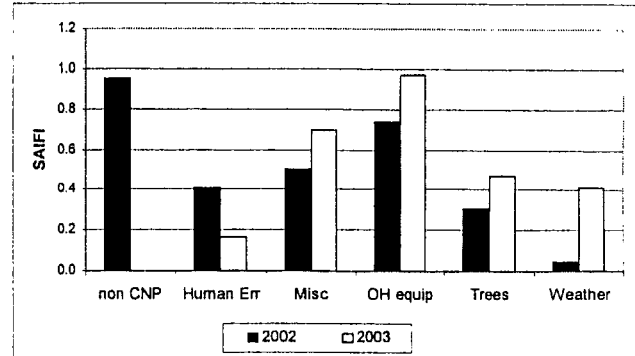
% C&F of Total Interruptions		
	2002	2003
Ckt	89%	90%
Fuse	9%	8%

SAIFI			
	2002	2003	Apr 2004
Value	3.07	2.99	0.04
Rank	75	66	869

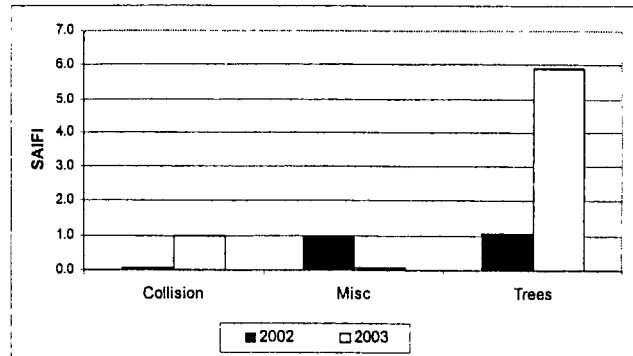
% C&F of Total Interruptions		
	2002	2003
Ckt	87%	97%
Fuse	11%	3%

SAIFI			
	2002	2003	Apr 2004
Value	2.46	8.12	0.13
Rank	119	1	463

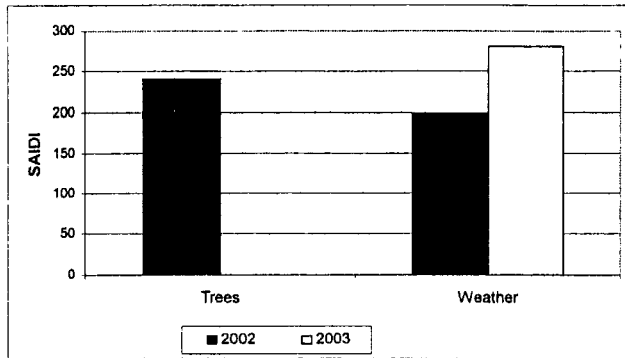
% C&F of Total Interruptions		
	2002	2003
Ckt	0%	0%
Fuse	95%	96%

SAIDI			
	2002	2003	Apr 2004
Value	467.67	295.12	6.41
Rank	8	28	767

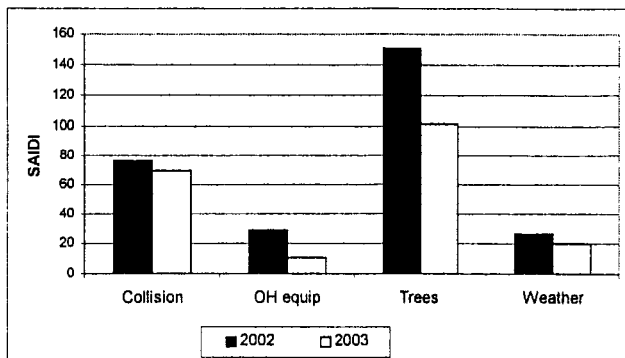
% C&F of Total Interruptions		
	2002	2003
Ckt	50%	67%
Fuse	45%	29%

SAIDI			
	2002	2003	Apr 2004
Value	306.46	229.82	29.14
Rank	49	62	311

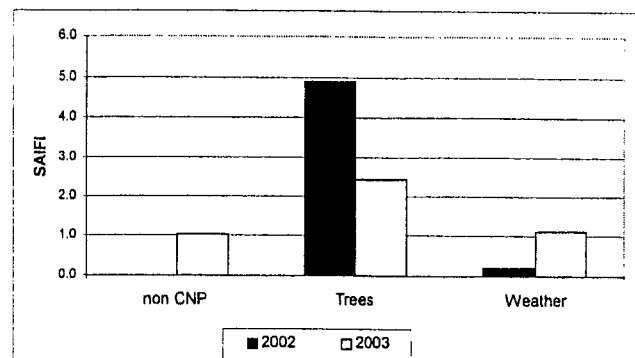
% C&F of Total Interruptions		
	2002	2003
Ckt	89%	89%
Fuse	10%	9%

SAIFI			
	2002	2003	Apr 2004
Value	6.77	5.87	0.12
Rank	6	3	507

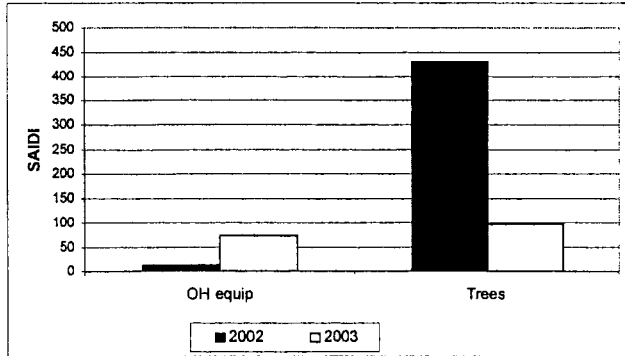
% C&F of Total Interruptions		
	2002	2003
Ckt	90%	76%
Fuse	9%	22%

SAIDI			
	2002	2003	Apr 2004
Value	474.54	201.72	32.46
Rank	5	92	289

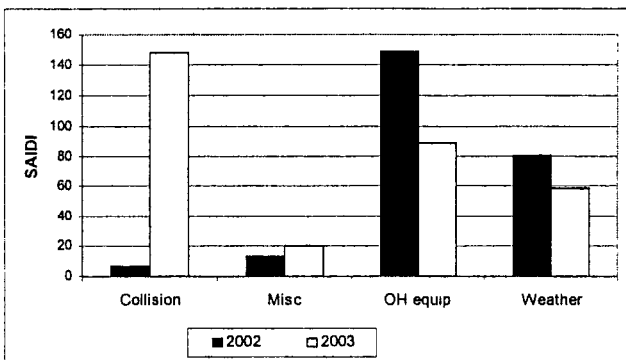
% C&F of Total Interruptions		
	2002	2003
Ckt	0%	0%
Fuse	98%	99%

SAIDI			
	2002	2003	Apr 2004
Value	255.66	333.19	8.50
Rank	88	19	680

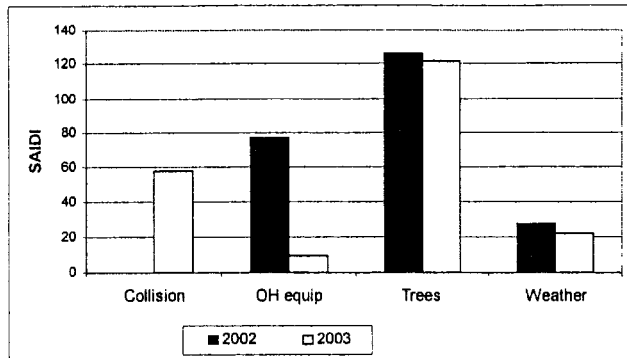
% C&F of Total Interruptions		
	2002	2003
Ckt	50%	29%
Fuse	47%	62%

SAIDI			
	2002	2003	Apr 2004
Value	237.67	231.73	29.65
Rank	117	60	304

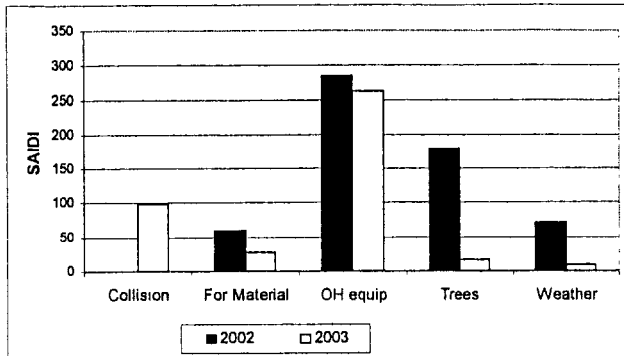
% C&F of Total Interruptions		
	2002	2003
Ckt	60%	22%
Fuse	36%	72%

SAIDI			
	2002	2003	Apr 2004
Value	638.99	480.08	76.49
Rank	2	3	102

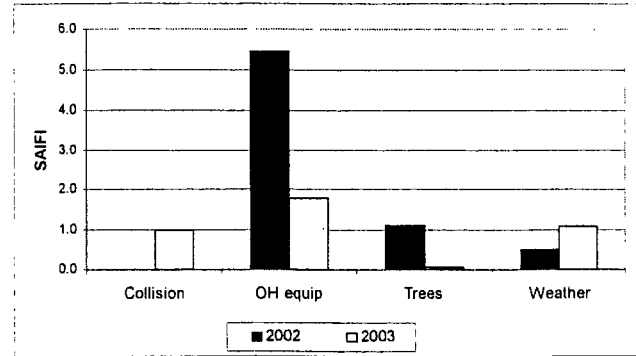
% C&F of Total Interruptions		
	2002	2003
Ckt	83%	45%
Fuse	14%	52%

SAIFI			
	2002	2003	Apr 2004
Value	7.69	4.47	1.37
Rank	2	17	35

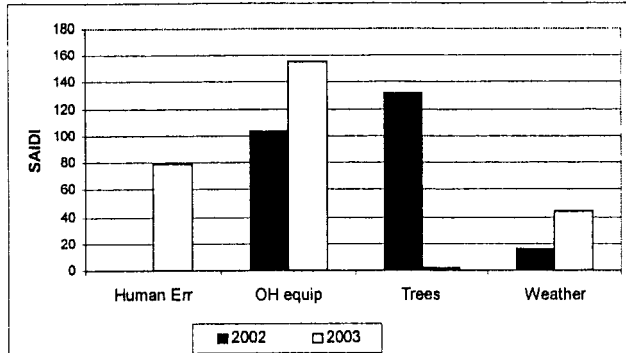
% C&F of Total Interruptions		
	2002	2003
Ckt	82%	69%
Fuse	14%	27%

SAIDI			
	2002	2003	Apr 2004
Value	265.30	310.52	59.35
Rank	75	20	150

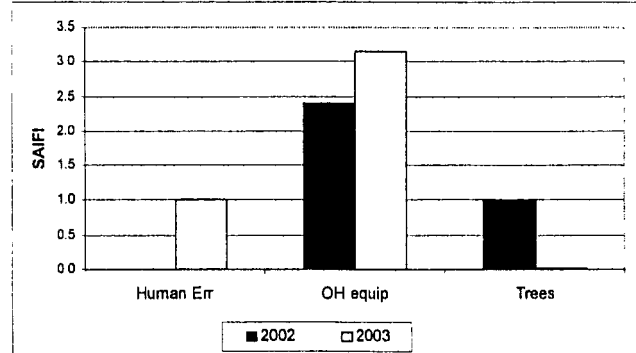
% C&F of Total Interruptions		
	2002	2003
Ckt	88%	84%
Fuse	9%	14%

SAIFI			
	2002	2003	Apr 2004
Value	3.71	4.79	0.93
Rank	35	13	180

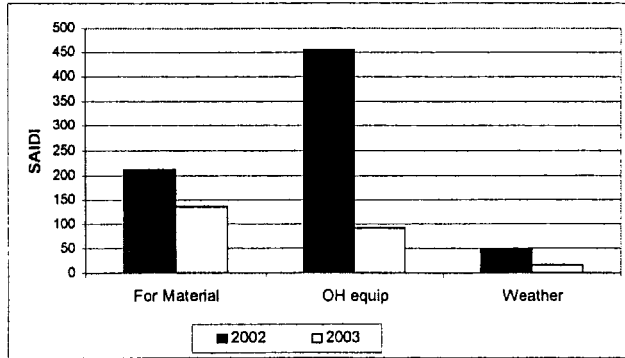
% C&F of Total Interruptions		
	2002	2003
Ckt	97%	88%
Fuse	3%	6%

SAIDI			
	2002	2003	Apr 2004
Value	724.31	260.81	2.66
Rank	1	44	976

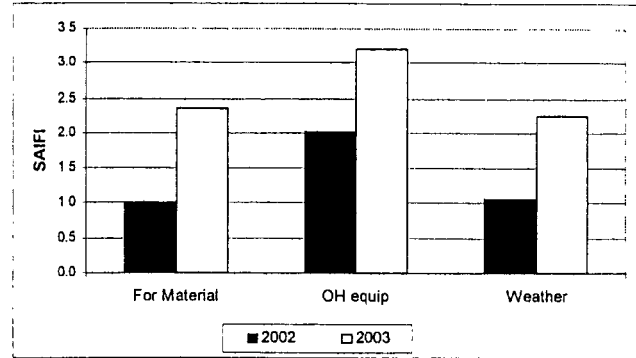
% C&F of Total Interruptions		
	2002	2003
Ckt	96%	96%
Fuse	4%	3%

SAIFI			
	2002	2003	Apr 2004
Value	4.16	7.98	0.04
Rank	23	2	933

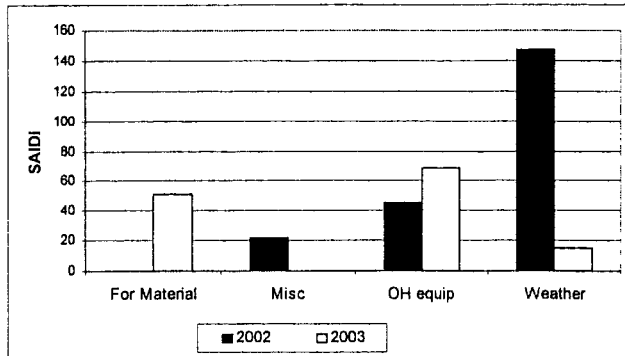
% C&F of Total Interruptions		
	2002	2003
Ckt	60%	60%
Fuse	33%	19%

SAIDI			
	2002	2003	Apr 2004
Value	251.76	186.86	51.08
Rank	92	117	181

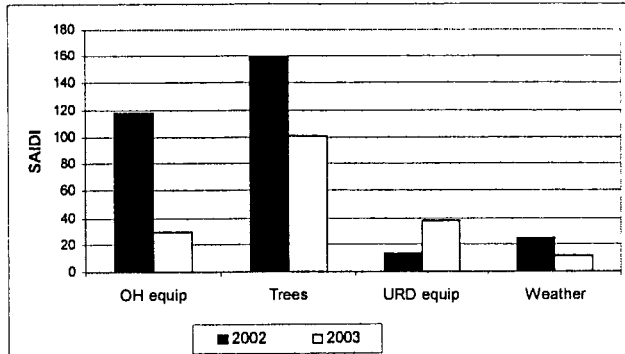
% C&F of Total Interruptions		
	2002	2003
Ckt	76%	59%
Fuse	20%	39%

SAIDI			
	2002	2003	Apr 2004
Value	330.58	182.60	11.03
Rank	38	124	589

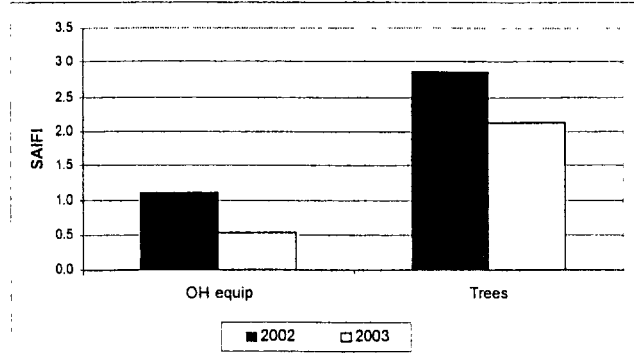
% C&F of Total Interruptions		
	2002	2003
Ckt	90%	85%
Fuse	10%	15%

SAIFI			
	2002	2003	Apr 2004
Value	4.28	2.93	0.08
Rank	21	73	642

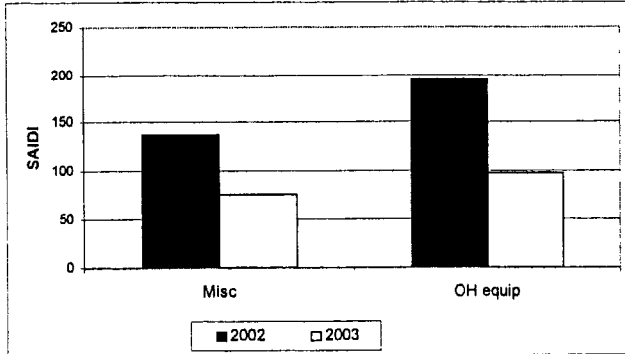
% C&F of Total Interruptions		
	2002	2003
Ckt	93%	72%
Fuse	6%	28%

SAIDI			
	2002	2003	Apr 2004
Value	347.94	188.63	56.73
Rank	33	110	157

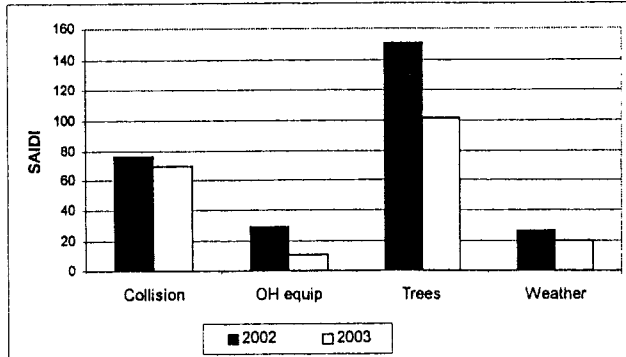
% C&F of Total Interruptions		
	2002	2003
Ckt	50%	67%
Fuse	45%	29%

SAIDI			
	2002	2003	Apr 2004
Value	306.46	229.82	29.14
Rank	49	62	311

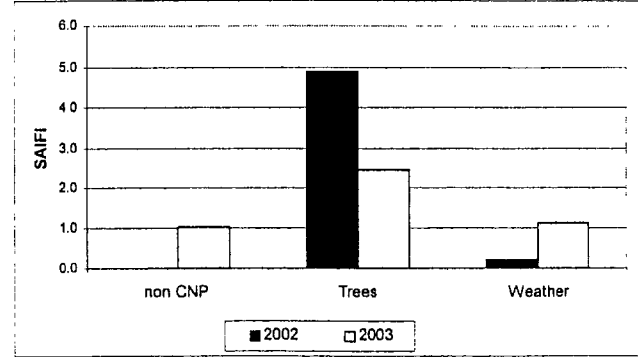
% C&F of Total Interruptions		
	2002	2003
Ckt	89%	89%
Fuse	10%	9%

SAIFI			
	2002	2003	Apr 2004
Value	6.77	5.87	0.12
Rank	6	3	507

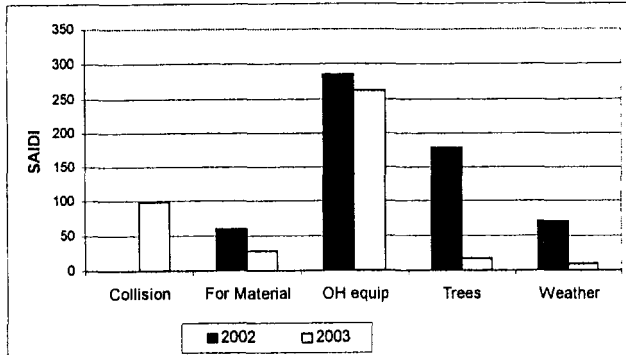
% C&F of Total Interruptions		
	2002	2003
Ckt	60%	22%
Fuse	36%	72%

SAIDI			
	2002	2003	Apr 2004
Value	638.99	460.08	76.49
Rank	2	3	102

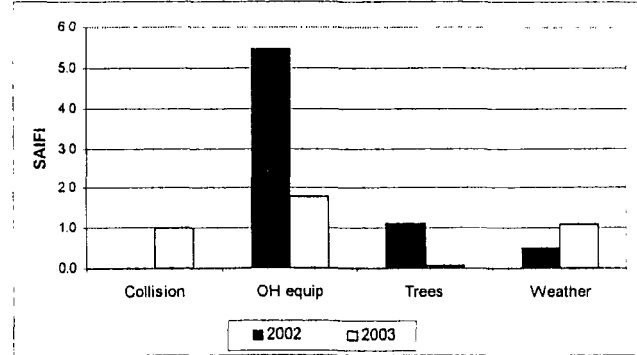
% C&F of Total Interruptions		
	2002	2003
Ckt	83%	45%
Fuse	14%	52%

SAIFI			
	2002	2003	Apr 2004
Value	7.69	4.47	1.37
Rank	2	17	35
