RE: Bayer Water System - Investigation No. 1073563

Name of System: BAYER WATER SYSTEM

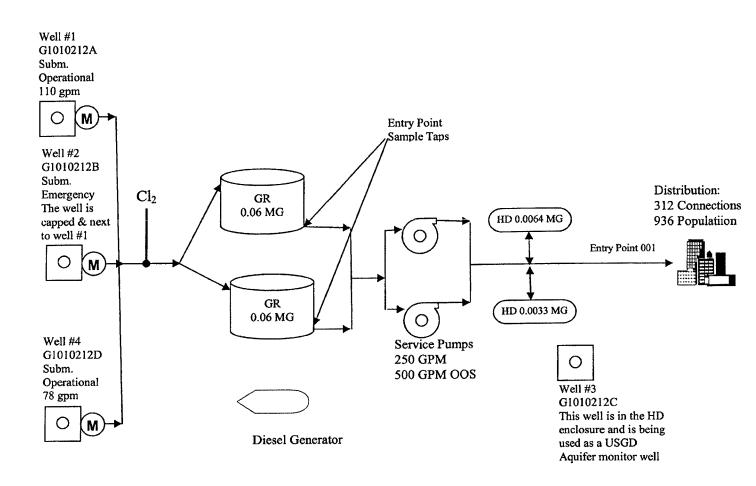
26718 Aldine Westfield

Labelling: owner=s source names and TCEQ wtrsrc code designation, types of treatment and chemicals, entry points to distribution, entry point sample taps, booster disinfection, distribution connections and layout (if possible).
