PROJECT NO. 54467

CY 2022 ELECTRIC UTILITY	§	PUBLIC UTILITY COMMISSION
SERVICE QUALITY REPORT UNDER	§	
16 TAC § 25.81	§	OF TEXAS

**ENERGY TEXAS, INC. REPORT IN RESPONSE TO THE COMMISSION'S
DECEMBER 19, 2022 ORDER**

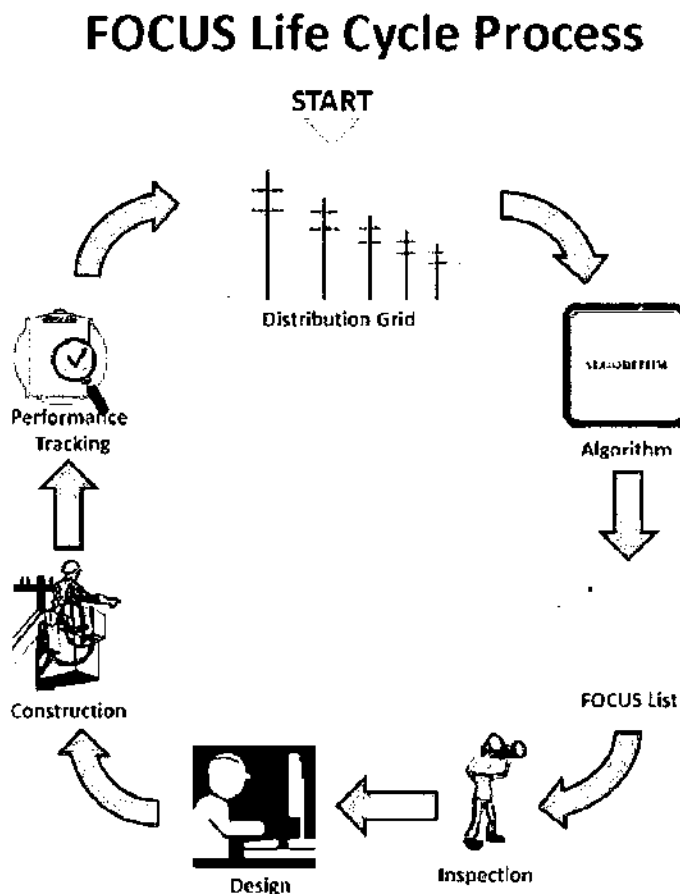
Find, Observe, Correct, Understand, Succeed (“FOCUS”) program – The FOCUS program is designed to identify underperforming devices (breakers, reclosers, fuses) based on an algorithm of customer interruptions and outage frequency created by the Asset Management team. The Reliability organization coordinates a full protection zone inspection of selected devices to increase the basic insulation level of the structure, relocate arrestors downstream of fuses, install guy strain insulators, and address any imminent failure issues. Since 2020, ETI has completed approximately 90 FOCUS projects, including 56 on line fuses, 20 on reclosers, and 15 on breakers. This program helps reduce CM through mitigation of interruptions, including installation of sectionalizing devices to help restore unaffected zones. The FOCUS life cycle process is provided as Figure 3 below.

Figure 3 – FOCUS Life Cycle Process

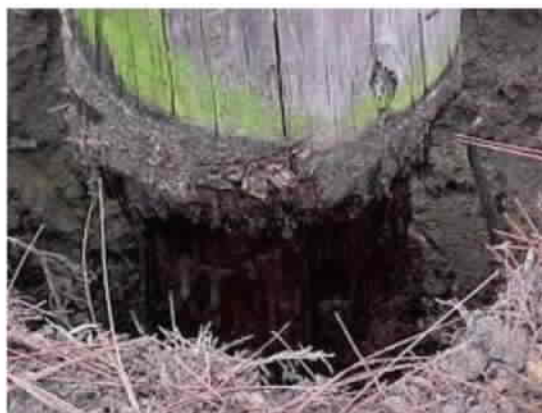
Pole inspection program – The pole inspection program (including inspection of the attached overhead facilities) complies with the requirements in the National Electric Safety Code (“NESC”) for such a program, and ETI has a target 10-year pole inspection cycle. The two inspection methods that ETI utilizes are the “full excavation method” and the “selective sound and bore method.” The “full excavation method” involves excavating wood poles to effectively treat and prevent decay at groundline and below (see Figure 5 below). The “selective sound and bore method” involves sounding and selective boring on wood poles to identify those that do not meet NESC loading criteria and to treat internal decay. Since 2017, ETI has restored 9,293 poles and replaced approximately 400 poles as part of the pole inspection program. These replacements are only those attributable to the pole inspection program, and do not take into account additional replacements that ETI has conducted in response to severe weather events, or in other project types such as revenue, mandated, etc. This program is critical in mitigating pole failures, which directly reduces CM, given the longer restoration times required to set a new pole and install framing.

Figure 5 – Below Ground Pole Decay

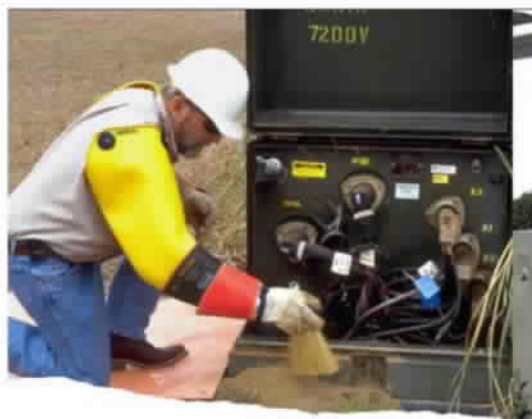
Padmount transformer inspections – This program, recently instituted in 2019, is to inspect and identify padmount transformers connected to underground electrical facilities to be proactively replaced prior to failure. Transformers are inspected as needed based on the performance of upstream devices to ensure they are in good working condition. This program reduces CM by mitigating potential causes of interruptions.

Figure 6 – Padmount Transformer
