PROJECT NO. 54467

CY 2022 ELECTRIC UTILITY  
SERVICE QUALITY REPORTS  
UNDER 16 TAC § 25.81

**AEP Texas Inc.'s Additional Report Related to Electric Service Quality**

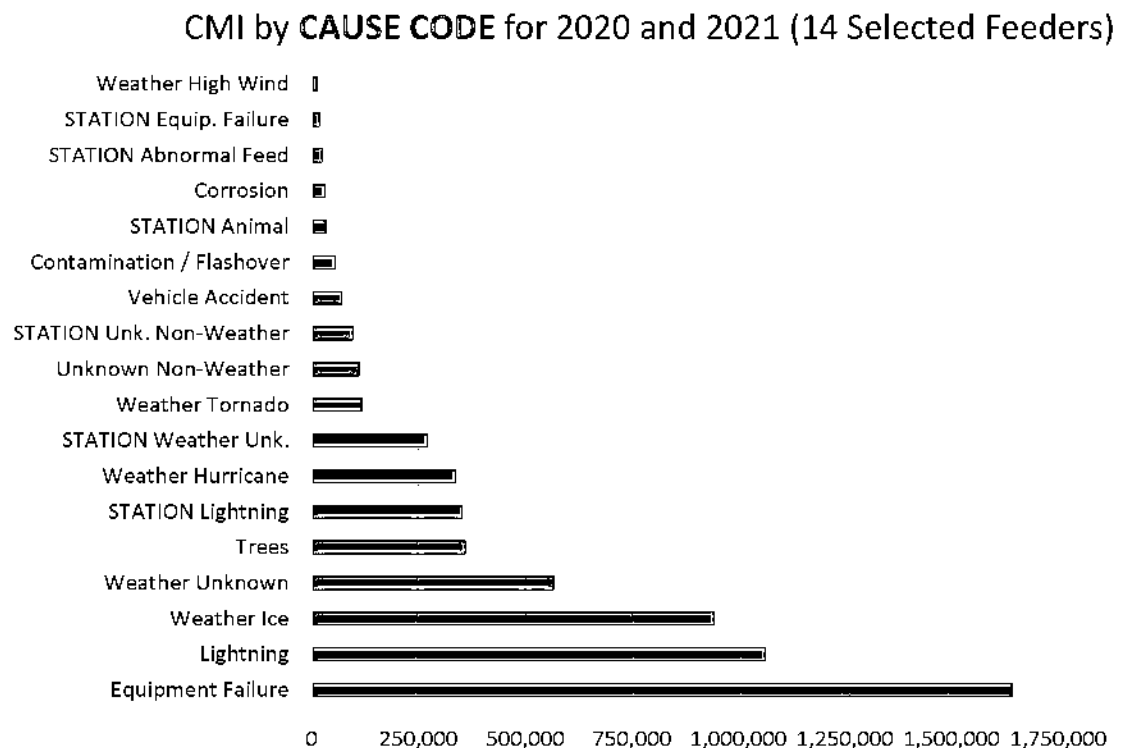
Figure 1 provides an overview of the reported causes of AEP Texas's outages for the fourteen feeders examined in 2020 and 2021. The highest cause is equipment failure at 27% (1,640,913 CMI of the total 6,105,549). Lightning was the second highest cause of outages at 17.4% (1,061,762 CMI of the total 6,105,539 CMI).

Other cause codes for CMI in Figure 1, are trees, station lightning, hurricane, and station – weather – unknown. Tree outages, which are monitored by the Forestry group who conduct spot trimming for reliability such as targeting feeders with high SAIDI due to trees. The single station lightning outage was covered in the lightning section above. Hurricane outages were small pockets of outages that were delayed because of access or customer request that were not included in the major event exclusion. The station – weather – unknown CMI resulted from one outage at the Crestonio substation when the station high side fuses blew on an afternoon in May 2020, during a weather event.

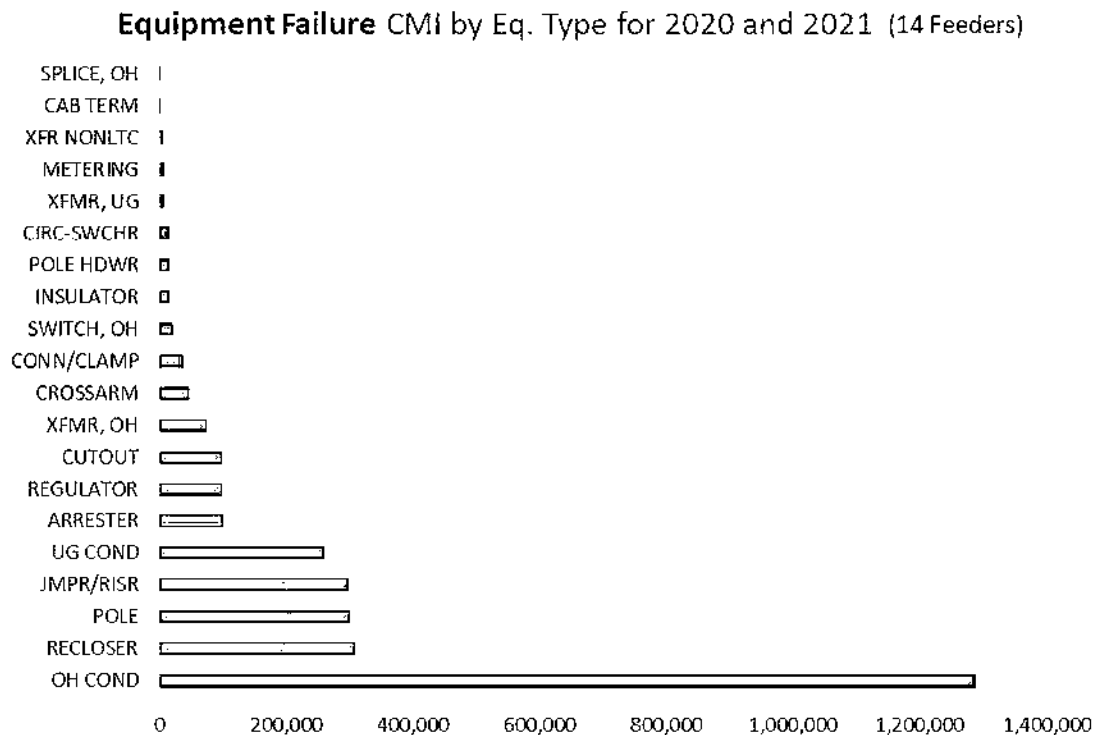
Figure 2 shows that by far, the most common equipment failure is overhead conductor. Further analysis shows that ten of the fourteen feeders had conductor failures with the most common wire size being #2 AA and AAA. The largest conductor size experiencing failures was #4/OAA. All but one of the #4/OAA failures were on Alazan 94CS620, which has undergone several reconductor projects and an automation project.

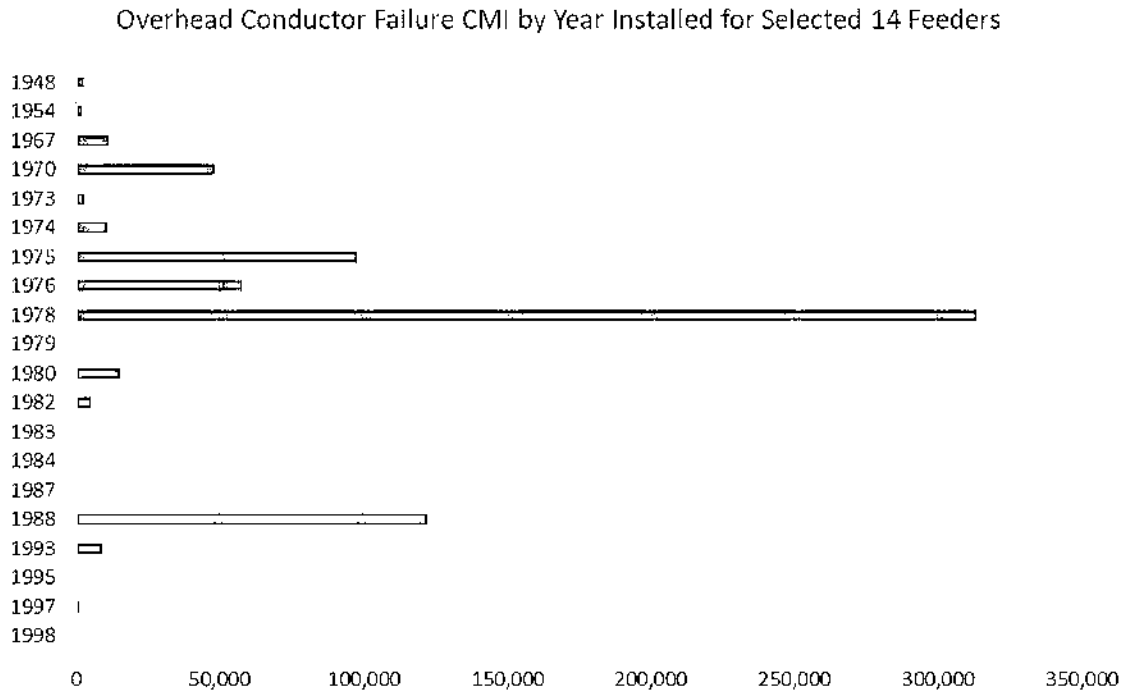
Based on the age of the conductors that experienced failure, the highest incident of failure is #2AA conductor that was installed in the 1970's. #2A primary conductor makes up 61.2% of the 30,936 miles of overhead primary conductor on AEP Texas's distribution system. Figure 4 below depicts the installation years of the overhead conductor failures for the selected 14 feeders from 2020 and 2021. The conductor failure CMI is plotted by the year that it was installed. The years from 1970 to 1978 show the most failures.

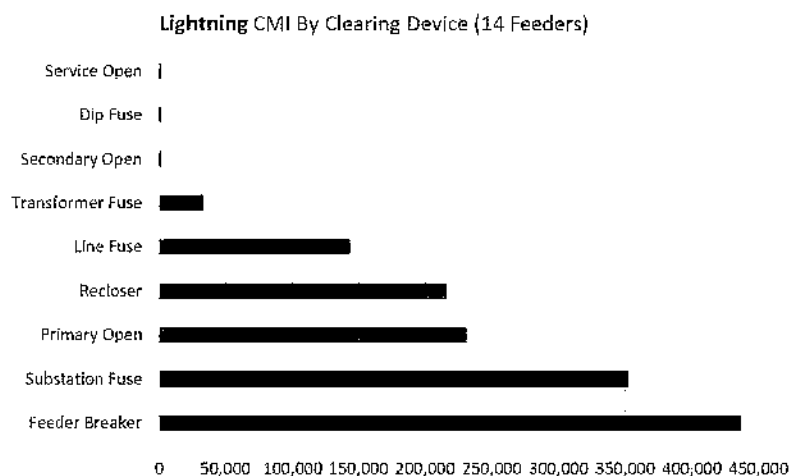
Figure 5 explores the second highest cause of outages on the 14 selected feeders, lightning, which accounted for 17.4% of the outage minutes or 1,061,762 CMI from 214 outages. Figure 5 shows the CMI totals due to lightning by clearing device. This gives an indication where AEP Texas could focus our lightning mitigation efforts.

The most outage minutes from lightning occurred at the feeder breaker level. Seven of the fourteen feeders experienced feeder breaker lockouts due to lightning. These circuits were also all in rural areas. Lightning mitigation efforts should first be focused in the feeder breaker zones<sup>1</sup>, especially on rural circuits. The second highest cause was lightning in the substation. This was due to one interruption at the Crestonio substation where lightning caused the transformer high-side fuse to blow. Lightning mitigation in the subs is done with the design of the sub using overhead static wire and arresters at different voltages. There were three outages that contributed to the “primary open” category. These were primary jumpers or wire that separated interrupting the lightning faults. These types of failures are addressed in AEP Texas’s new design standards, such as including arrester stations at corners or dead-ends. There were fourteen recloser outages on six feeders again in the rural areas such as Alazan, Cabaniss, Crestonio, and La Pryor. In eleven of the fourteen recloser outages, the reclosers were successfully closed after locking out, with no problems found. This indicates that coordination studies are needed to change the type and settings on the reclosers to clear temporary lightning faults. Line fuses cleared sixty-six of the lightning outages on eleven of the feeders:

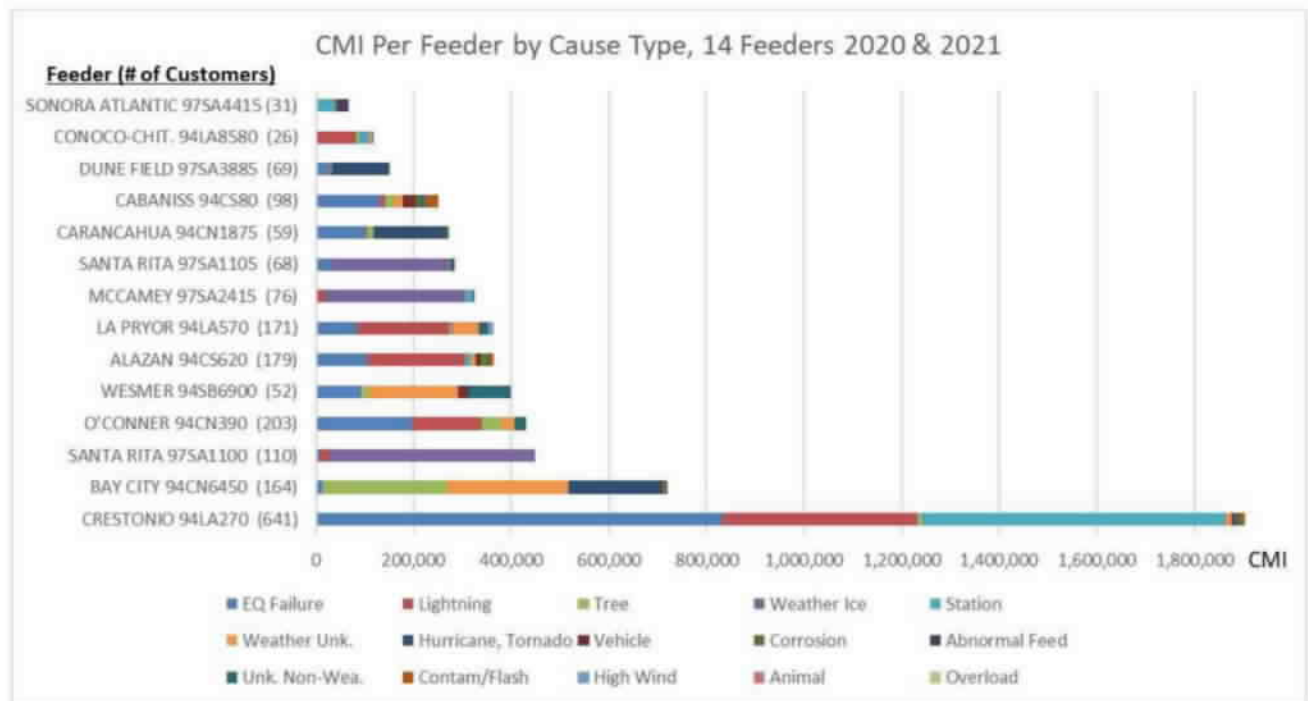
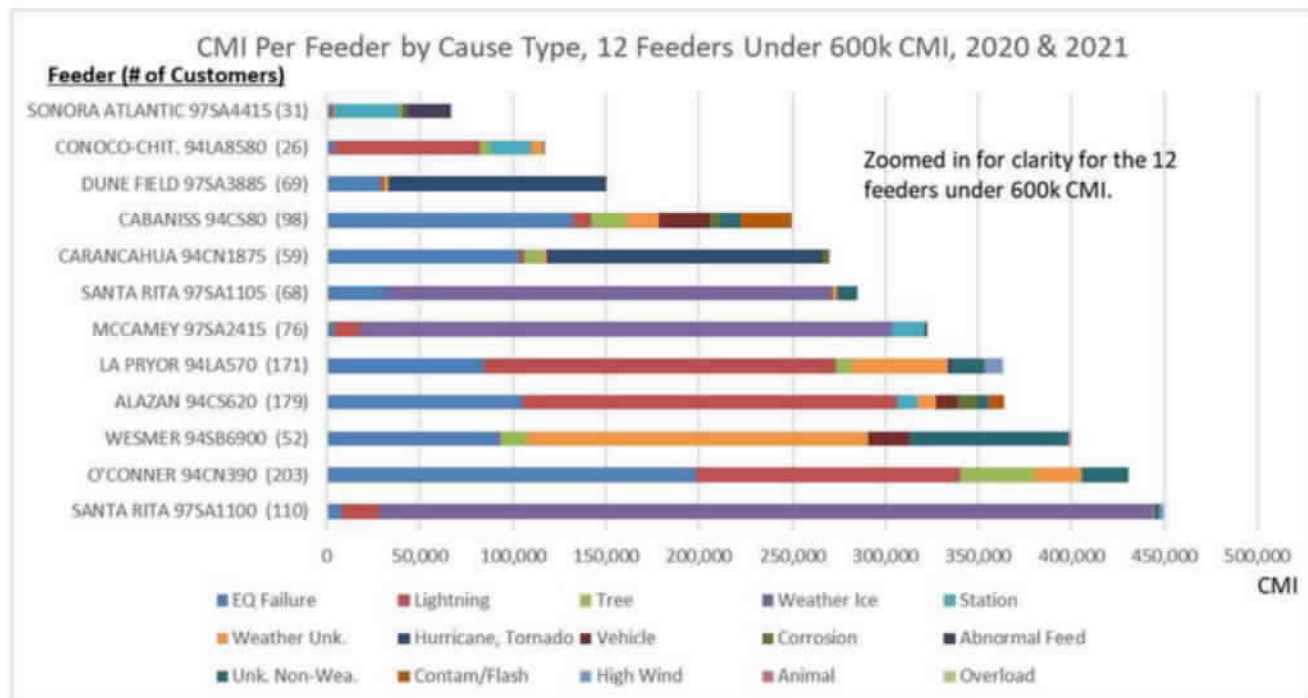
The following two charts show the CMI per feeder by cause type. The second chart provides the same data as the first chart, on a smaller scale to provide a closer view of the cause type for the 12 feeders with lower CMIs than Bay City and Crestonio.

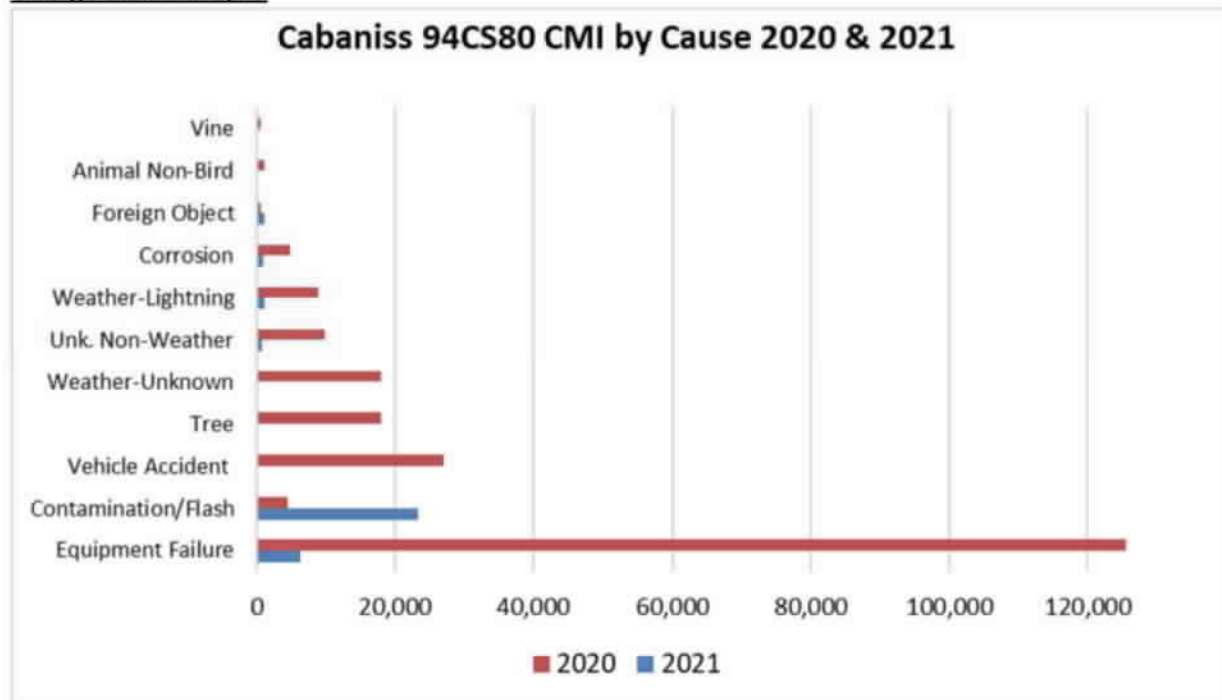
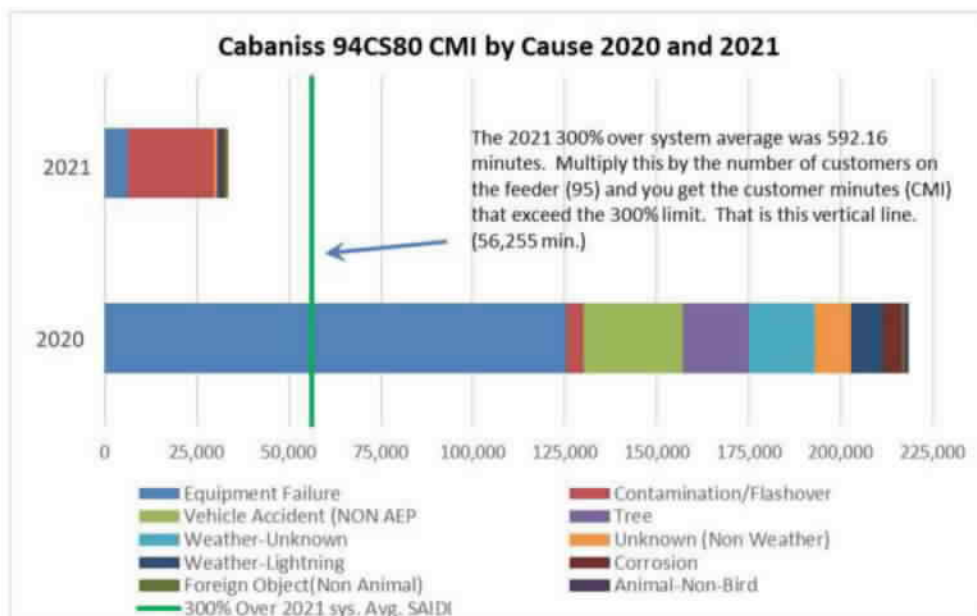
## Outage Cause Graphs

The green line on the graph represents the number of customer minutes interrupted it takes for this feeder with 95 customers to exceed the 300% over system SAIDI average. The number of customers (95) times the 300% over system SAIDI average for 2021 (592.16 minutes) gives a total of 56,255 CMI. Customer minutes interrupted past this line indicates a service quality violation if it repeats for consecutive years.

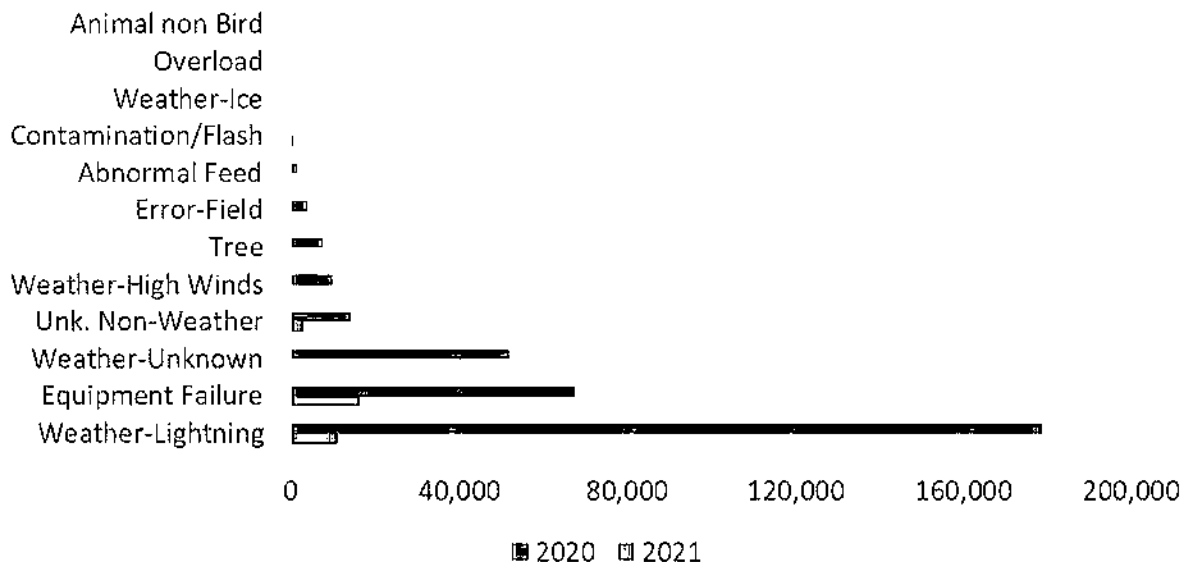
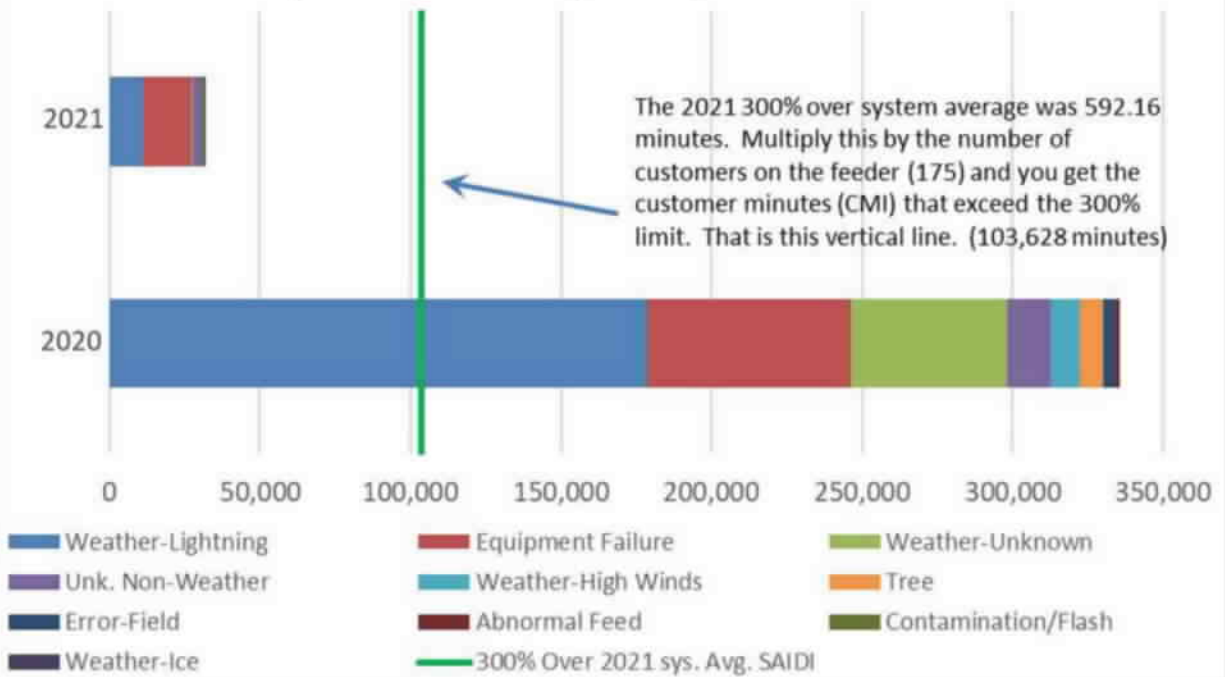
**La Pryor 94LA570 CMI by Cause Code for 2020 & 2021**

### La Pryor 94LA570 Yearly CMI by Cause 2020 & 2021

- Outage causes have varied. In 2019, the major causes were unknown, field switching error, and trees. In 2020, major causes were weather, lightning, and equipment failure. 37% of the outage minutes for the year 2020 occurred on May 5, 2020 during an after-hours lightning storm where the breaker locked out and the line was picked up from an adjacent circuit.

- Lightning caused 178,675 CMI in 2020, or 53% of the outage minutes for the year. Of those lightning outages, 91% were cleared at the feeder breaker level, 6.8% at line fuses, and 2.5% by recloser.

- Equipment failure caused 67,597 CMI in 2020. The most outage minutes, 52%, came from failed primary jumpers locking out the breaker three times. The second highest cause was arrester failures at 28% of the equipment failure CMI, and third was an outage with a broken pole and two broken crossarms.

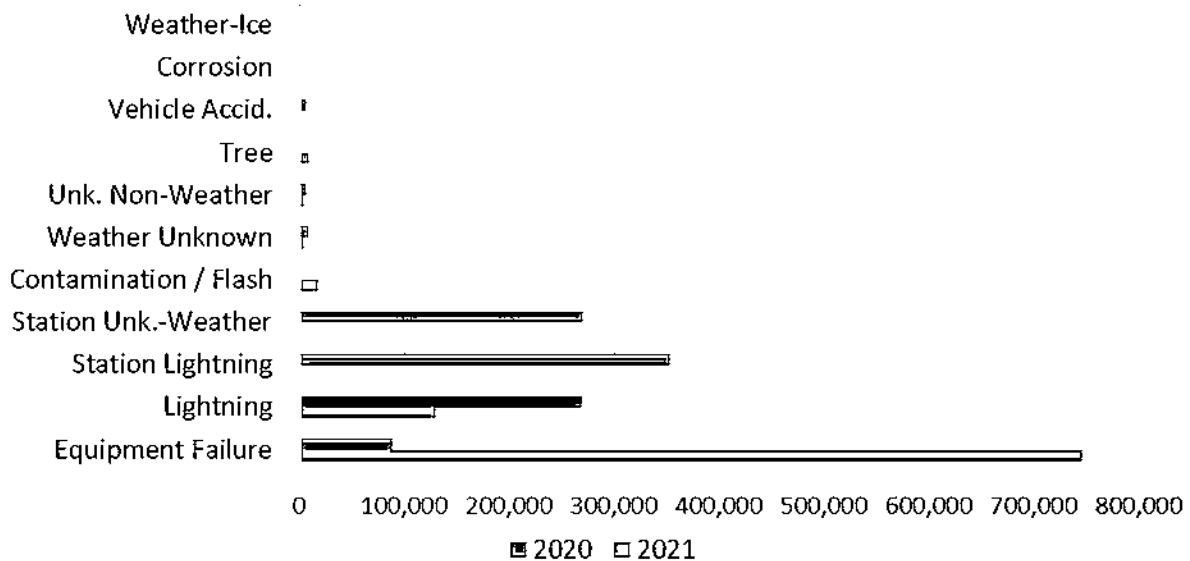
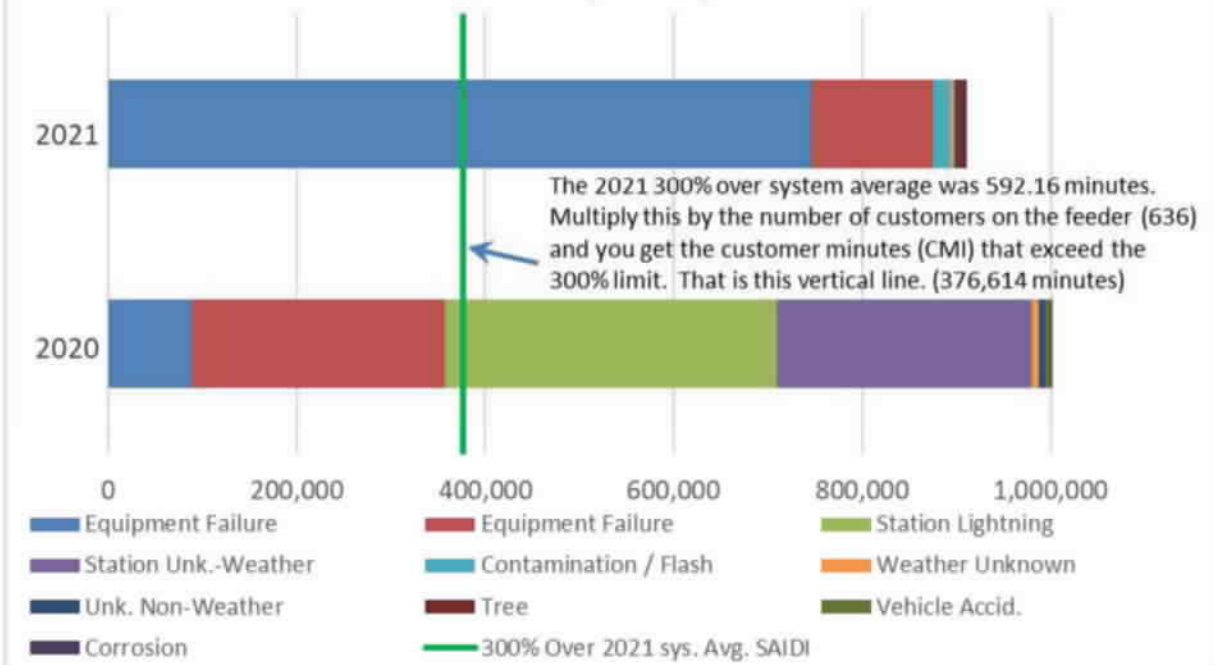
**Crestonio 94LA270 CMI by Cause Code for 2020 & 2021**

### Crestonio 94LA270 Yearly CMI by Cause 2020 & 2021
