**INVESTIGATION OF EMERGENCY
PREPAREDNESS AND RESPONSE BY
UTILITIES IN HOUSTON AND
SURROUNDING COMMUNITIES**

**RESPONSE OF ENTERGY TEXAS, INC.
TO COMMISSION STAFF'S FIRST REQUEST FOR INFORMATION:
STAFF 1:56 THROUGH 120**

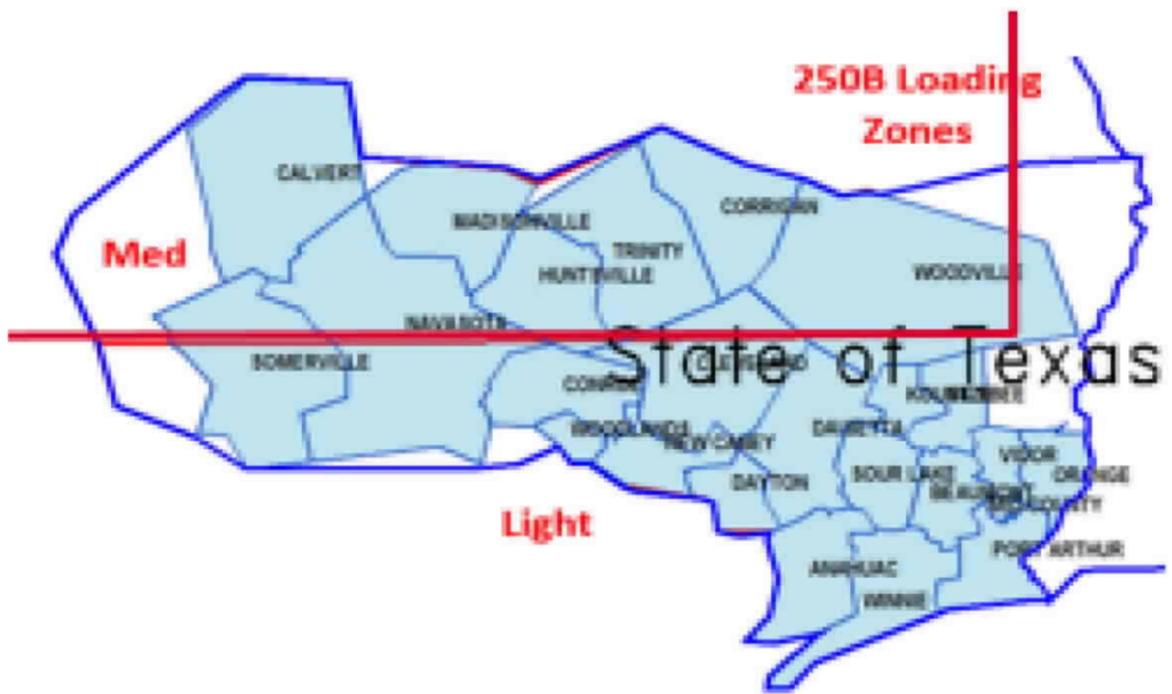
NESC 250C From the adoption of Entergy's new Extreme Wind Standard, new distribution construction is built to Entergy's Extreme Wind Speed standards.
