Pole Inspection Spec 125 Exemption Form

PUC PROJECT NO. 56822

**AEP TEXAS INC.'S RESPONSE TO COMMISSION STAFF'S
FIRST REQUEST FOR INFORMATION**

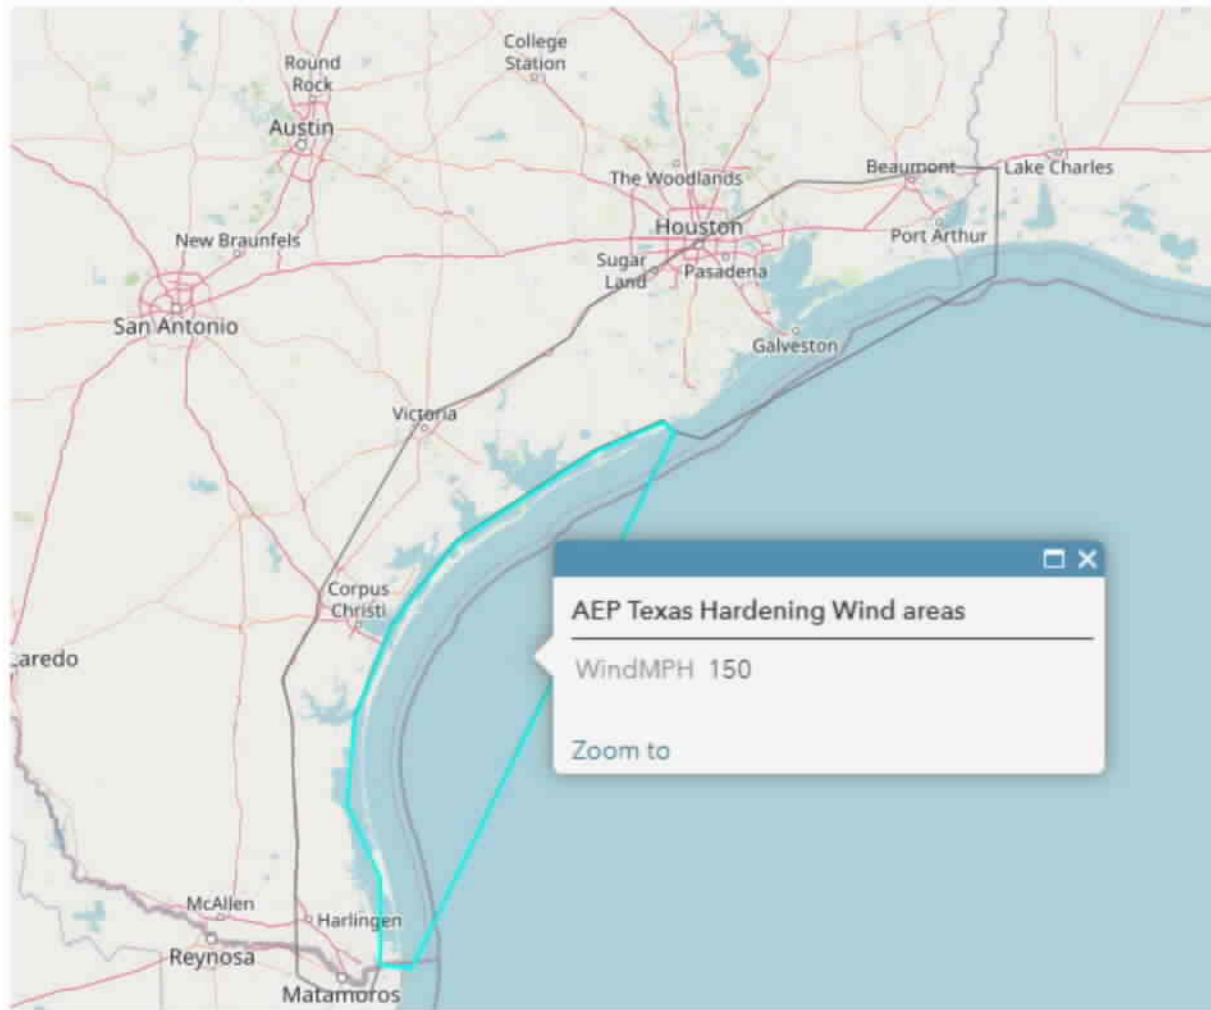
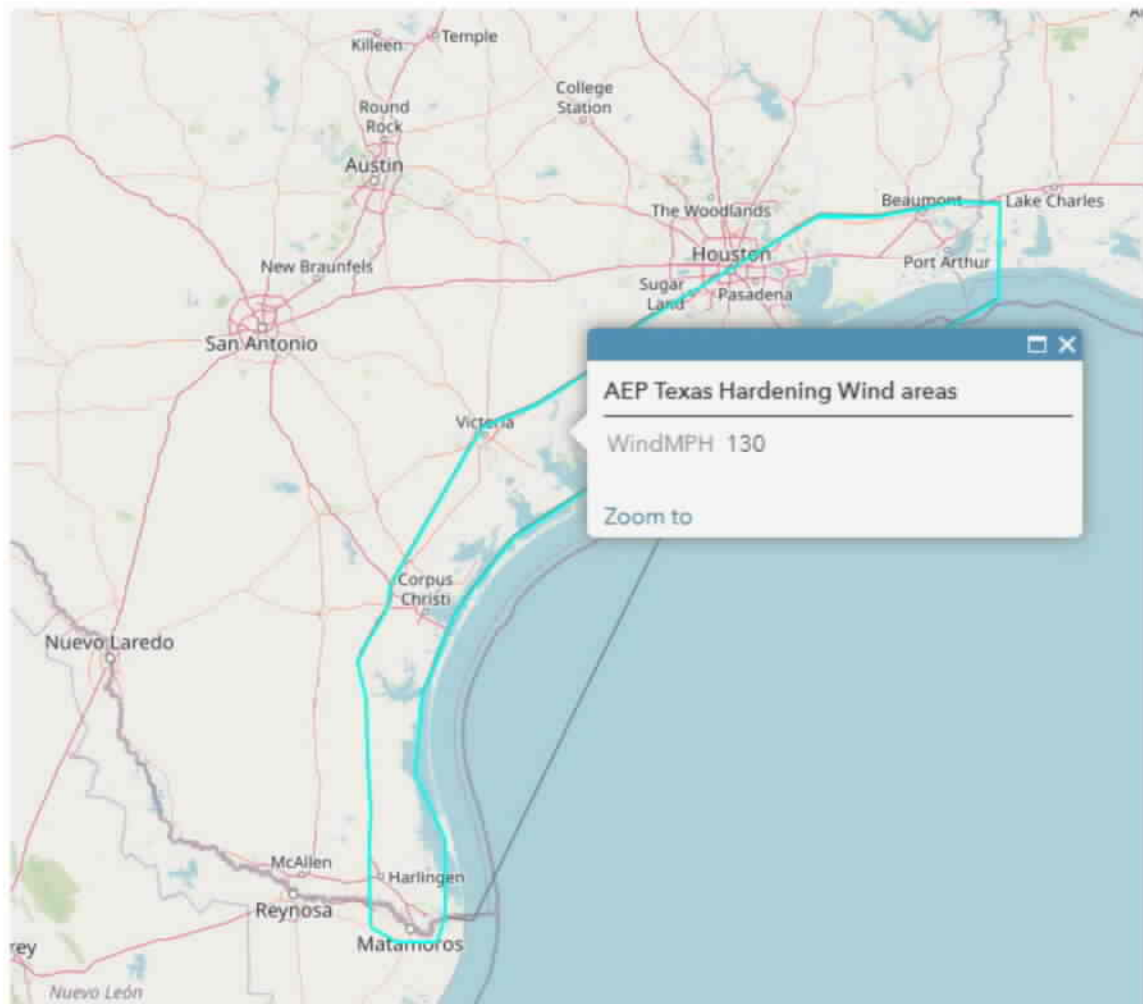
Near the Texas Gulf coast, two high wind load cases are applied to all distribution structures, regardless of pole height or height of attached facilities. These load cases use the NESC Rule 250C associated strength and load factors. Very near the coast, the wind speed is 150mph and just inland from that a 130mph wind speed is used.

In the Heavy Zone, the resiliency load case of 1" ice, 4lbs/ft² wind, 0deg F using NESC Rule 250B associated strength and load factors is applied to poles, guys, and anchors. The other conductor supporting components are designed to NESC Heavy Zone requirements. This makes the pole the stronger component in the structure and ideally the last element to fail as it is the hardest element of the structure to replace.

In the Light Zone (non-coastal), the resiliency load case of 0 ice, 20lb/ft² wind, 30deg F using NESC Rule 250B associated strength and load factors is applied to poles, guys, and anchors. The other conductor supporting components are designed to NESC Light Zone requirements. This makes the pole the stronger component in the structure and ideally the last element to fail as it is the hardest element of the structure to replace. The NESC Light Loading Zone uses 0 ice, 9lb/ft² wind at 30deg F. The additional wind load for AEP Light Zone resiliency load case increases the longitudinal tension and significantly more transverse loading the poles.
