**SOAH DOCKET NO 473-25-11558
DOCKET NO. 57579**

APPLICATION OF CENTERPOINT ENERGY HOUSTON ELECTRIC, LLC FOR APPROVAL OF ITS 2026-2028 TRANSMISSION AND DISTRIBUTION SYSTEM RESILIENCY PLAN	§ § § §	BEFORE THE STATE OFFICE OF ADMINISTRATIVE HEARINGS
---	----------------------------	---

**Material Condition Assessment and
Benchmarking Study
of the Commonwealth Edison
Company Delivery System**

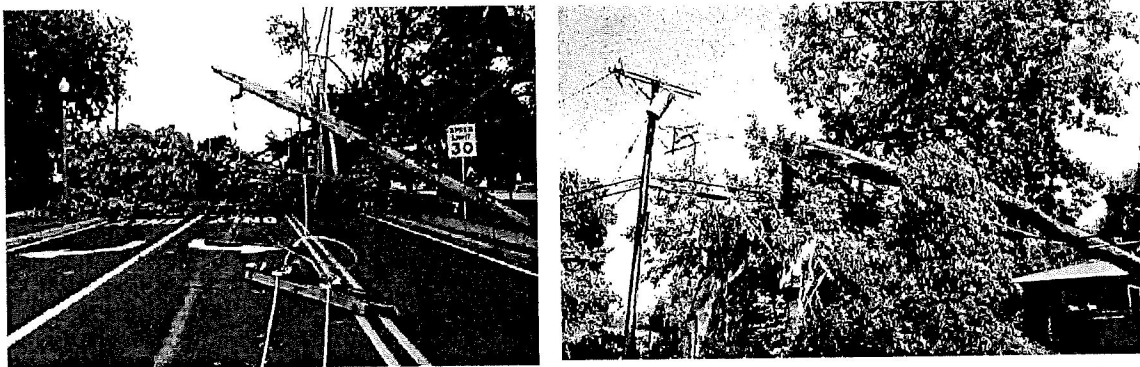
Figure 3. Example Storm Damage from Uprooted Tress

These results indicate several hundred poles were broken or severely damaged, but many of these likely were due to uprooted trees or large limbs that fell directly onto overhead lines, thereby causing poles to break upon impact. A typical example of the type of damage caused by uprooted trees is illustrated in Figure 3. Error! Reference source not found..

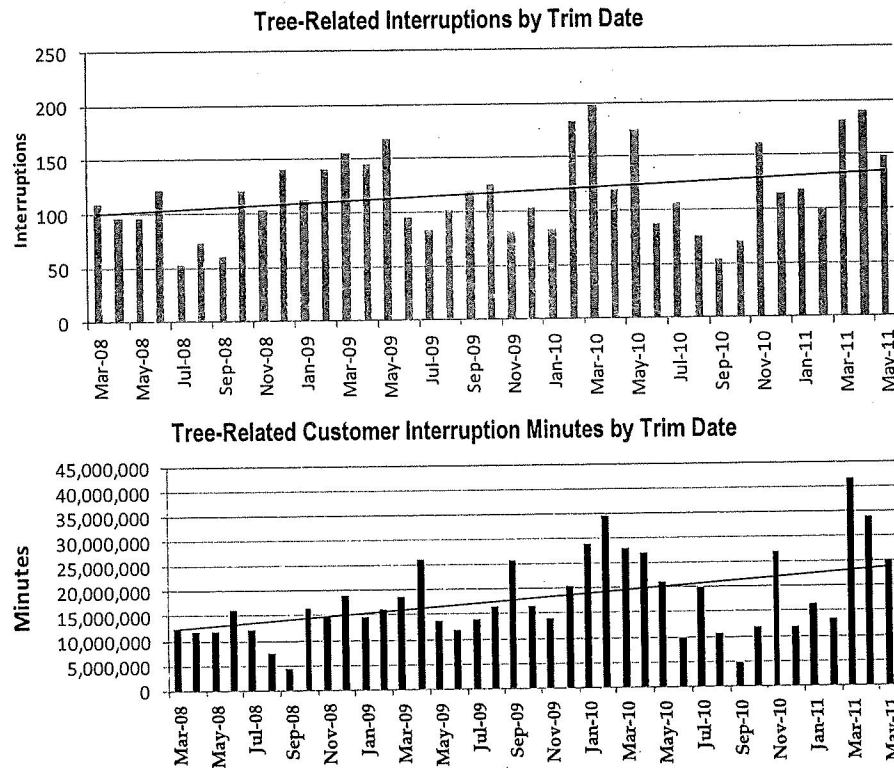
Figure 4. Tree-Related Interruptions

Because of the share of interruptions that were tree-related among the total group of storm-related interruptions, it is important to critically examine the data and test the premise that tree-related interruptions should increase as the time since the date of the last trimming increases. If this premise cannot be confirmed, it is highly likely that many of the tree-related interruptions that occurred during the summer 2011 storms were caused by uprooted trees and large limbs falling onto lines that typically are beyond the ComEd's trimming clearance standards. To assess the relationship between tree-related interruptions and prior trimming cycles, Navigant compared the number of interruptions during the summer 2011 storms as a function of last date trimmed. Results are presented in Figure 4 for total customer interruptions and minutes.

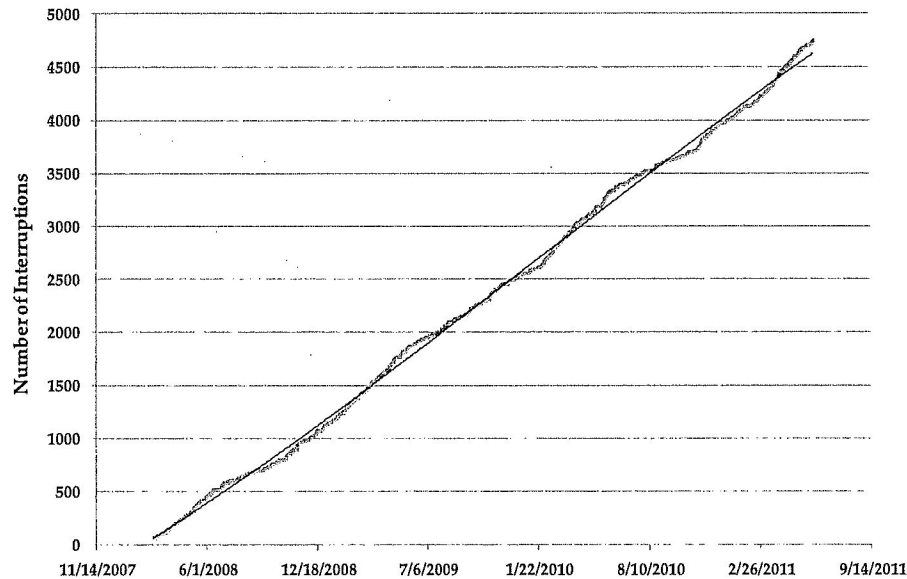
Figure 5. Cumulative Tree-Related Interruptions by Trim Date

Figure 5 presents the above results on a cumulative basis. Using data provided by ComEd, trim dates for each circuit with a tree-related outage were determined. The data was then divided into monthly buckets based upon the trim date for each circuit. The number of interruptions for each month then was calculated and plotted in Figure 5. Results indicate a highly linear relationship, when a downward slope would be expected if tree-related interruptions during the storms were caused by limbs within the ICC trim zones. Results suggest tree-related interruptions were independent of whether or not the trees along the feeder were recently trimmed or had been trimmed several years earlier.

A statistical analysis was performed using a P-Test to test the hypothesis that the trim date does not correlate to the number of interruptions on a circuit.⁴ This indicated an absence of correlation between trim date and subsequent interruptions; that is, the trim date is not correlated to the number of interruptions that resulted during these outages.

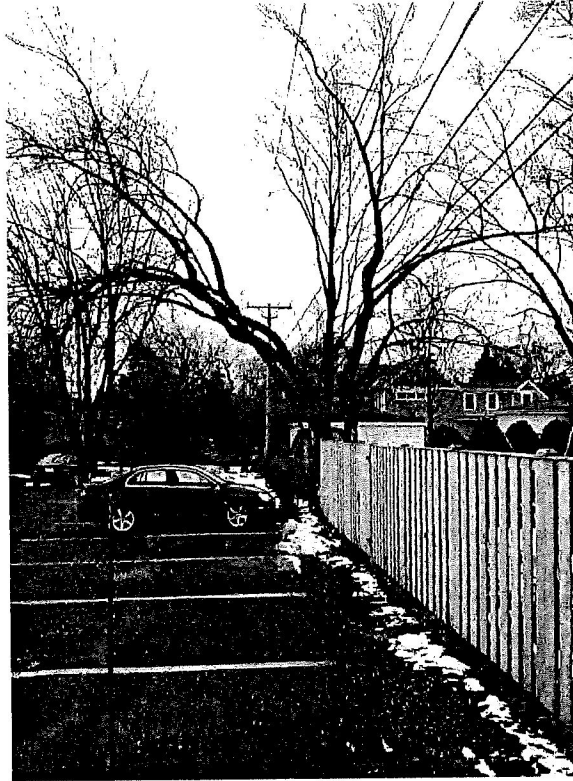
Figure 6. Three-Phase Rear Lot Overhead Distribution (Rolling Meadows)

In all towns inspected, field inspection results confirmed that many three-phase main line sections and lateral taps are located in rear lots or alleys. Many of these lines, particularly those in residential areas, are located in heavily treed areas, with mature species and limbs that often formed a canopy above overhead lines. Some of the most heavily vegetated areas with the largest trees and densest vegetation are located in towns closest to Lake Michigan. Figure 6 illustrates one example of this type of construction.

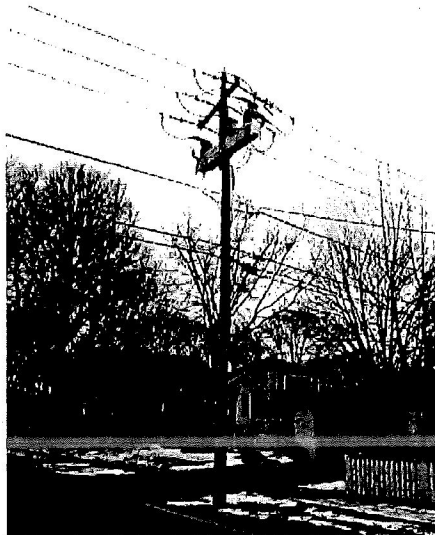
Figure 8. Intelli-Rupter on 12.47 kV Line (Rolling Meadows)

To identify and confirm distribution protection practices, Navigant interviewed ComEd's engineering staff, reviewed distribution one-line diagrams, and conducted field inspections. In regions impacted by the storm and system wide, ComEd's protection practices conform to those typically employed by utilities with similar feeder length and outage exposure. These include use of line fuses on lateral taps and auto-transfer schemes using mid- and end-of-line reclosers. Table 5 confirms that longer lines serving a large number of customers are protected by line reclosers; many of them are part of an auto-sectionalizing scheme. Field observations confirm the presence of many reclosers and auto-sectionalizing schemes (Figure 8 illustrates one example).

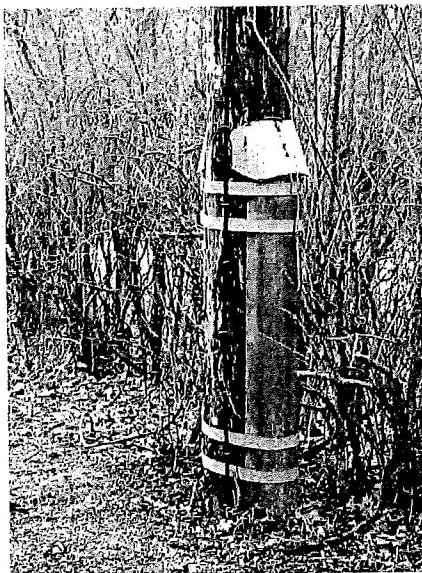
Figure 14. C-Truss Pole Reinforcement (Rockford)

Navigant views ComEd's practices of inspecting and treating poles to extend their service lives, and replacing poles only when tests indicate replacement is the only cost-effective option, as consistent with utility asset management practices and pole inspection processes. ComEd's actual practices are in contrast to recommendations in some states that ostensibly suggest poles should be replaced when they reach an age threshold – 40 to 50 years. This would markedly increase the pole replace rate, at significant cost, applying criterion unsupported by inspection results, internal strength measurements, and remaining pole life based on commonly accepted engineering principles and prudent utility practices.

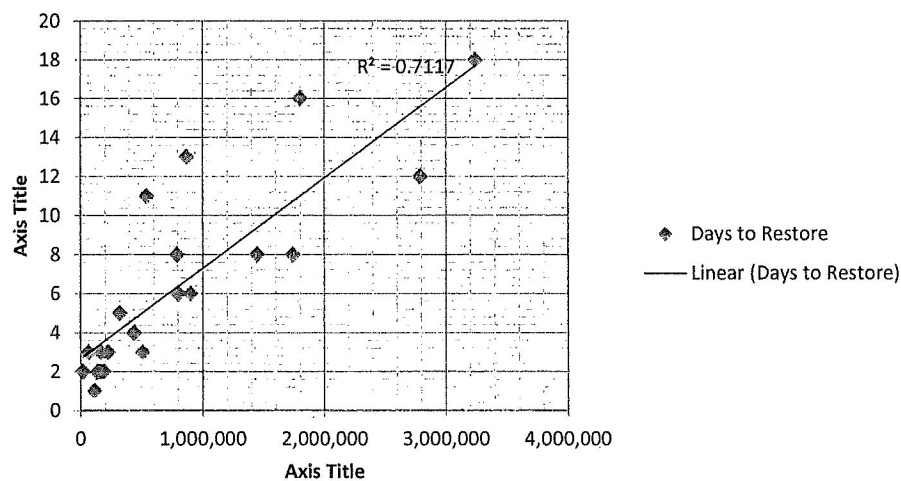
Figure 23. Days to Restore from Table 10, 2003-2011 Major Storms

The “days to restore” data for ComEd included in Table 10 is based on initial outage time out and last customer connected. Other utilities exclude outliers such as smaller number of customers requiring additional significant work. For example, during Tropical Storm Irene, PSE&G’s maximum restoration time was reported at 6.5 days, even though small pockets of 1,150 customers were still without power due to flooding and damage requiring safety inspections. The data from Table 10 was plotted a scatter diagram (Figure 23 below). Table 10 demonstrates a linear relationship between the number of customers out and the number of days to restore. Based on this analysis, we can conclude that ComEd’s restoration performance is in line with that of other utilities across the U.S.
