Control Number: 43241

Re: Notice of Violation for the Comprehensive Compliance Investigation at:
Demi John I S Water System, 207 Flounder Circle, Brazoria County, Texas
Regulated Entity No.101192078, TCEQ ID No. 0200234 Investigation No.1095457

Summary of Investigation Findings

DEMI JOHN I S WATER SYSTEM

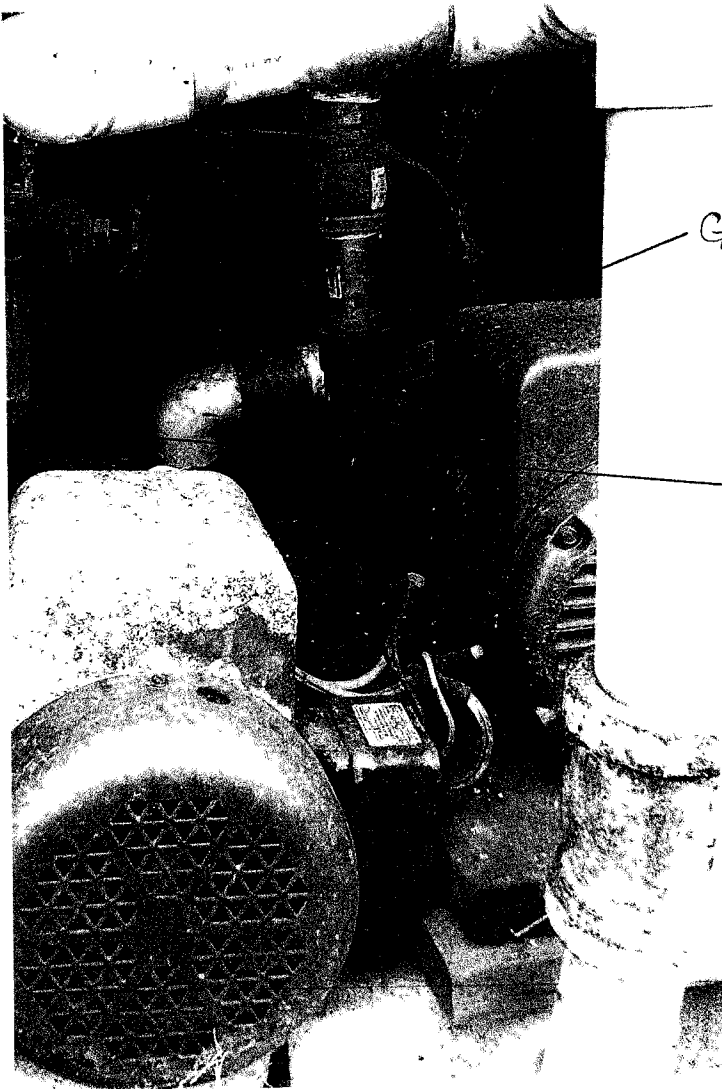
GOULDS MODEL 3BF1J1A0

Failure to provide a minimum service pump capacity such that each pump station or pressure plane must have two or more pumps with a total capacity of 2.0 gallons per minute per connection – There are two service pumps at the water plant with the following nameplates:

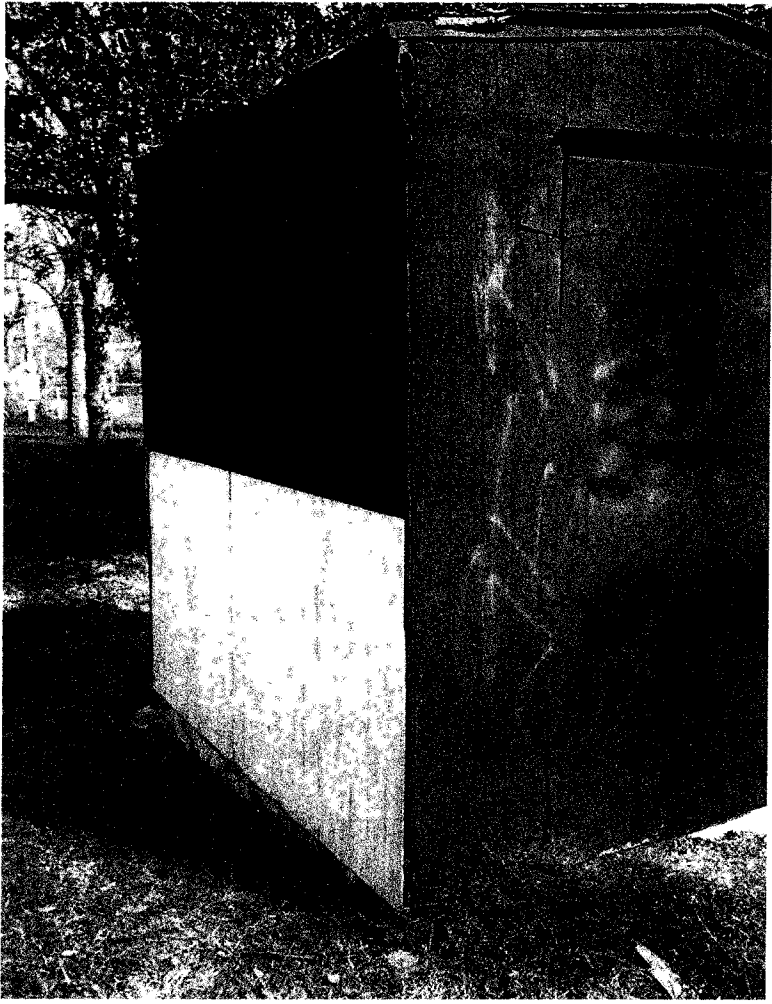
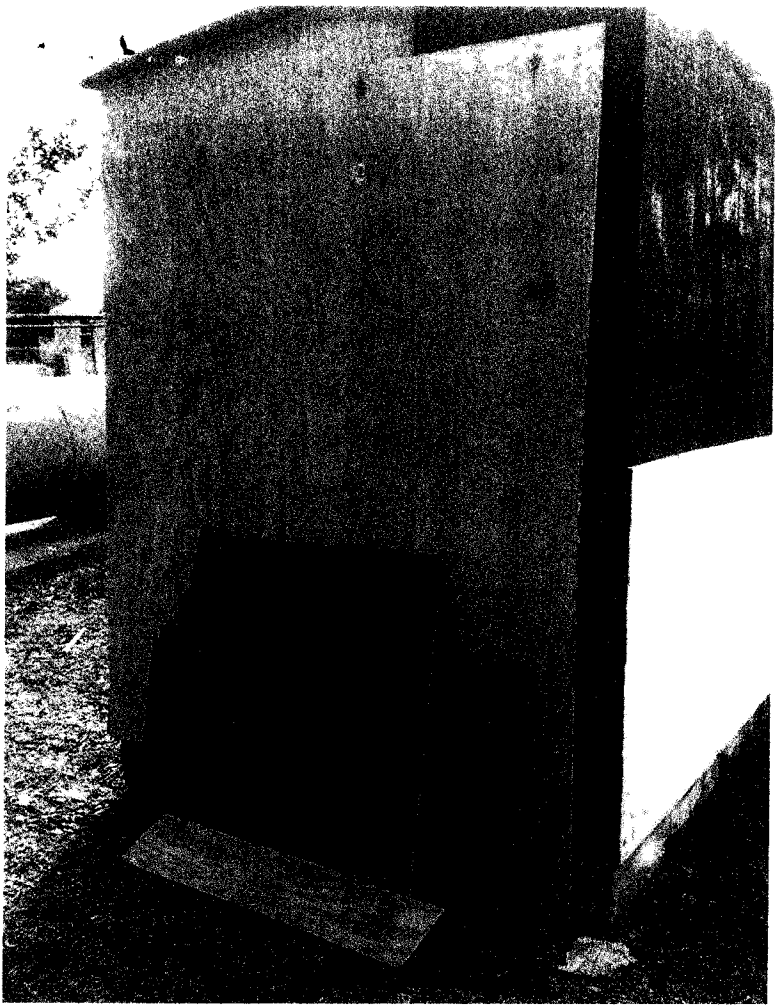
3-1

Failure to properly maintain the regulated entity by not repairing the damage well house buildings.

Recommended Corrective Action: Submit copy of photos or work orders to verify that the well houses have been repaired.

Resolution: On February 10, 2012, pictures were fax to show that the well house buildings were repaired.
