City of Three Rivers City of Three Rivers Alleged Violations

Here are some copies and pictures of the corrective action of the Alleged Violations.

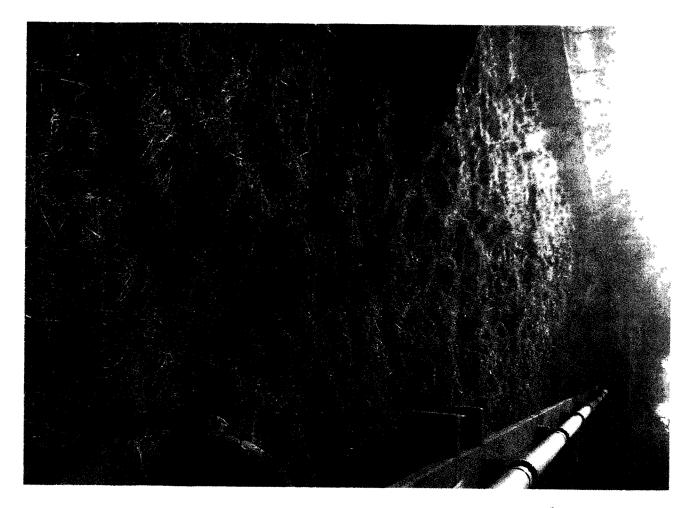
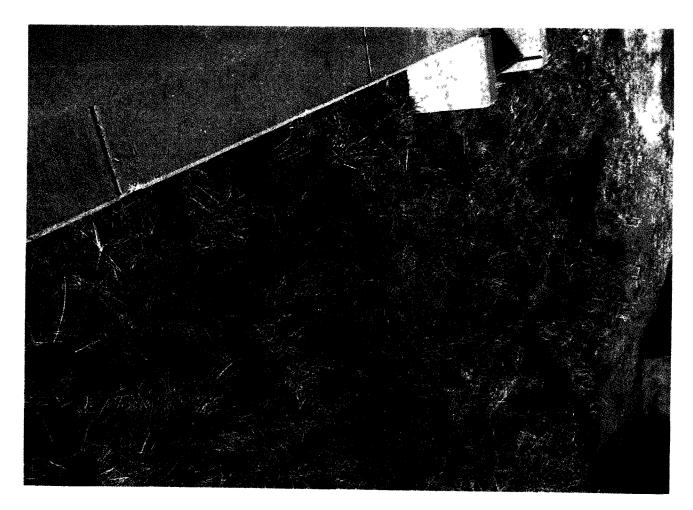
Track Number 399804

Track #399804 It was documented during the investagation that numerous cattails were growing in the drying beds. Attached are pictures showing where we have cut down the cattails on one side and started hualing sludge from the other

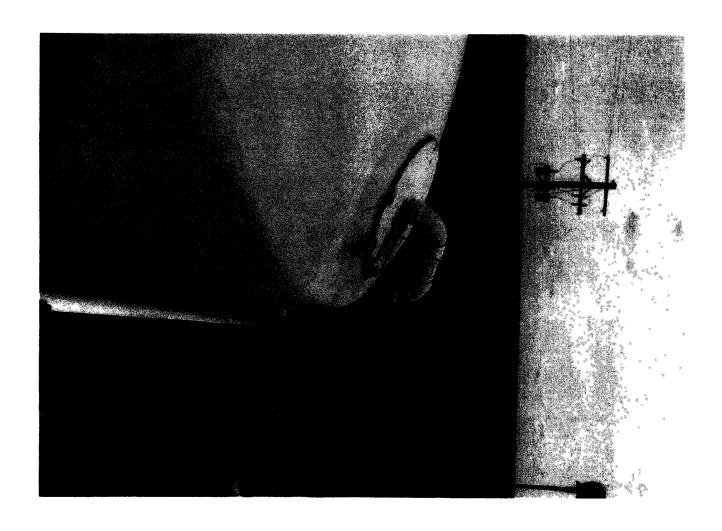
Track Number 473290

Track # 473290 Attached are pictures of the goose neck vents and the small hole on top of the roof on the wheeler tanks

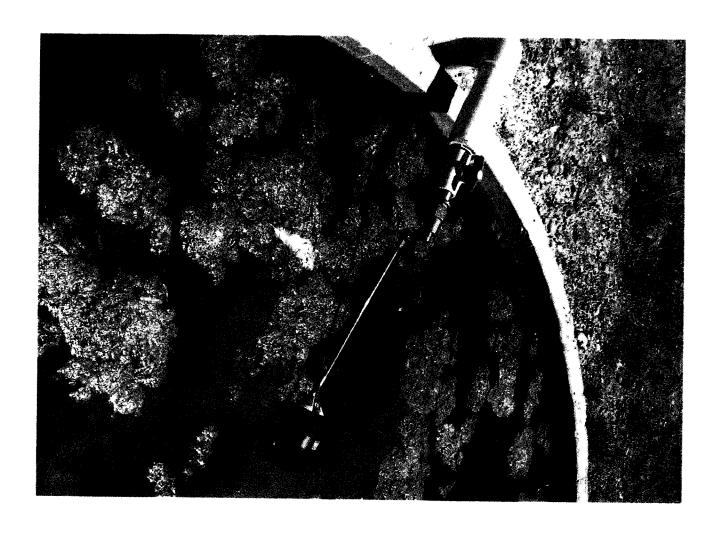
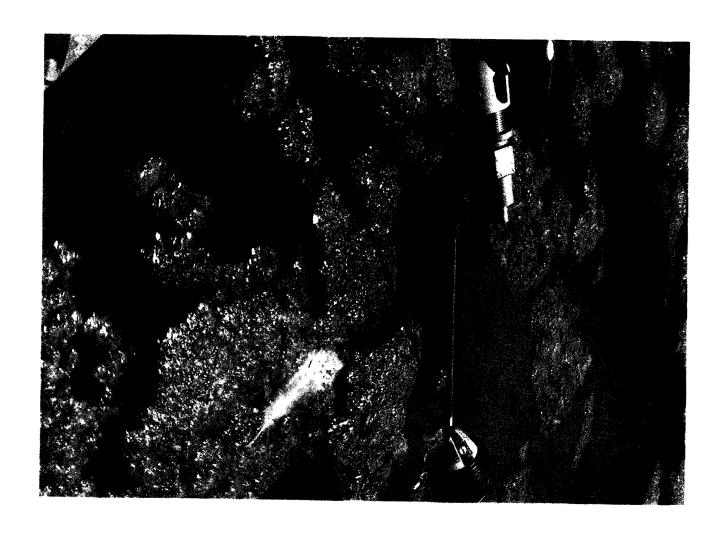
Track Number 473294

Track # 473294 Attached are pictures of a air gap installed on the water trough located at the Woodward Well

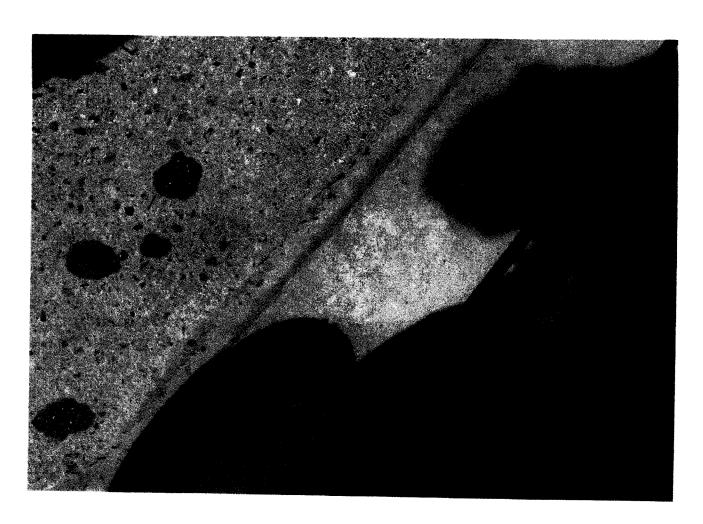
Track Number 473295

Track # 473295 Attached are pictures of our properly sealed clear well
