BERYL PREPARATION AND RESPONSE

FRANCINE PREPARATION AND RESPONSE

Hurricane Beryl After-Action Report for CenterPoint Energy, Inc.

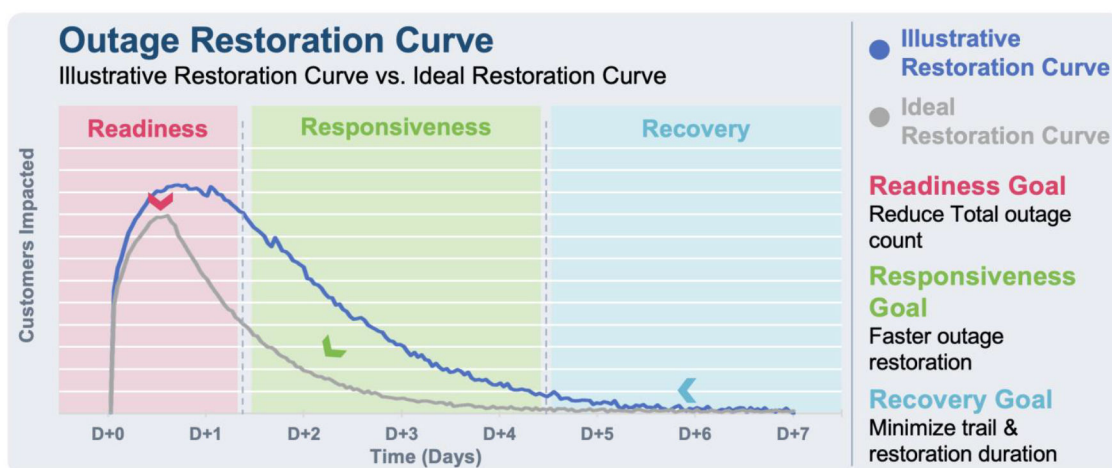
Figure 1 - 1: Illustrative Restoration Curve

Beryl's storm restoration curve provided valuable context and a foundation for conducting an after-action review of the restoration effort. The storm restoration curve contains valuable customer experience information and demonstrates the resilience of the electric system, offering insights that can be leveraged to identify both process improvements and necessary investments in the system. This curve accurately portrays the overall customer outage experience during the event, distinguishing between those who are restored with minimal effort and those who experience prolonged outages, while also identifying areas that warrant targeted hardening or mitigation projects in the long term.

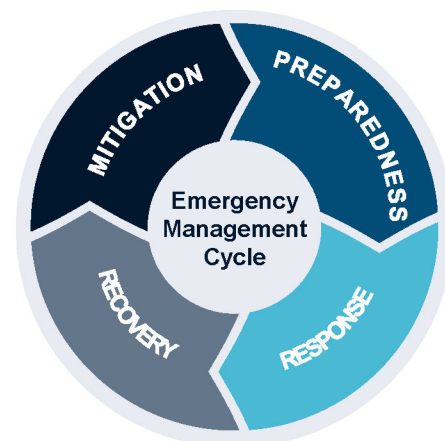
Figure 3 - 1: Emergency Management Cycle

An industry-leading standard is to follow the emergency management cycle (see Figure 3 - 1), which highlights continuous improvement of emergency management through four iterative steps: preparedness, response, recovery, and mitigation.
